**BUCKEYE LAKE DAM
FAIRFIELD AND LICKING COUNTIES, OHIO**

EVALUATION OF EXISTING SHEET PILING

**OHIO DEPARTMENT OF NATURAL RESOURCES
DIVISION OF ENGINEERING**

**DODSON-LINDBLOM ASSOCIATES, INC
COLUMBUS, OHIO**

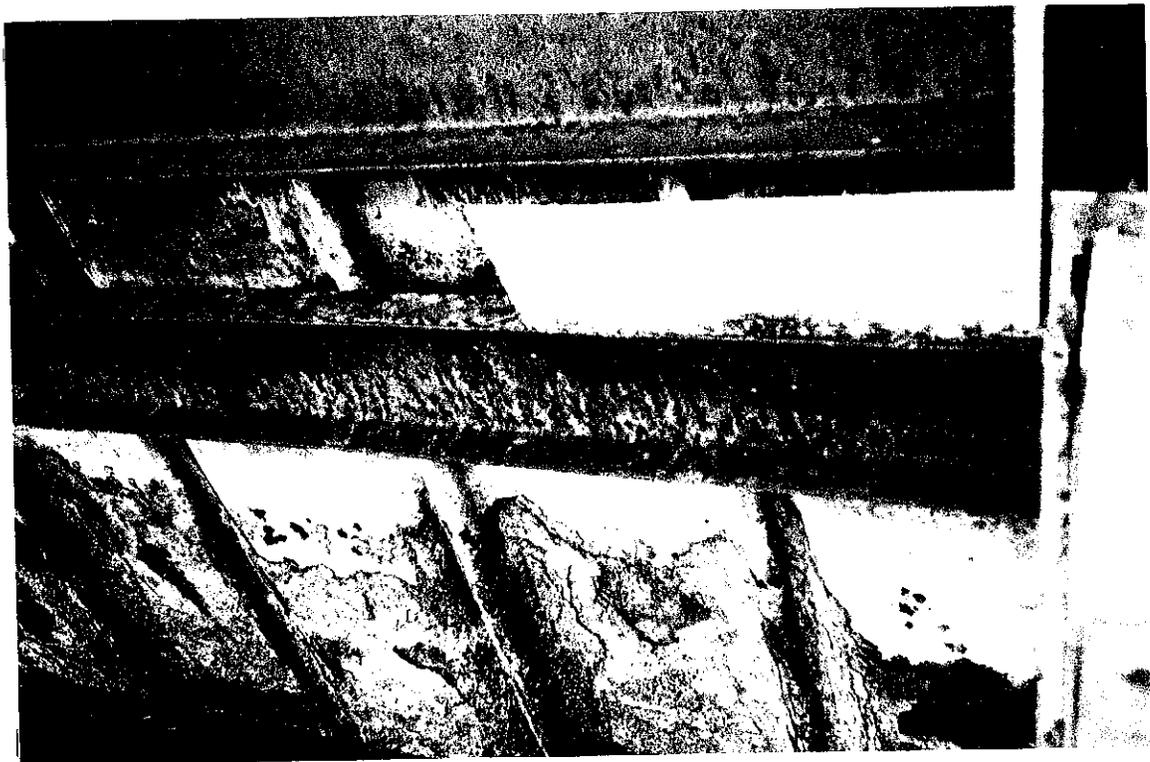
During normal summer pool conditions, the visual condition of the piling exposed above the waterline appears to be quite good. No excessive rusting or corrosion is noted. However, during site visits made following the winter drawdown of 1994-1995, it was noted that significant corrosion and scaling was apparent along some reaches on North Bank at an elevation below the normal summer pool. (See photos in Attachment A).

Photo 1. Typical corrosion and scaling on sheet piling installed during the 1940's.

As stated previously, the parapet option requires that the existing piling provide a suitable foundation for the installation. The 1940's vintage piling is obviously near or at the end of its expected useful life. Further, the existing I-beam atop the piling is unsuitable for installation of the parapet. Therefore, the existing 1940's sheet piling located between Sta. 101+00 and 112+50 (approximately 1100 linear feet) should be replaced. The proposed replacement piling will be of a corrosion-resistant alloy and will extend up to the required top-of-dam elevation of 896.5.
