REPORT
BUCKEYE LAKE DAM STABILITY STUDY
BUCKEYE LAKE STATE PARK
FAIRFIELD, LICKING, AND PERRY COUNTIES, OHIO
DNR 736 730-96-034

PROJECT No. 95-1590
MAY 1997

PREPARED FOR:
OHIO DEPARTMENT OF NATURAL RESOURCES
COLUMBUS, OHIO

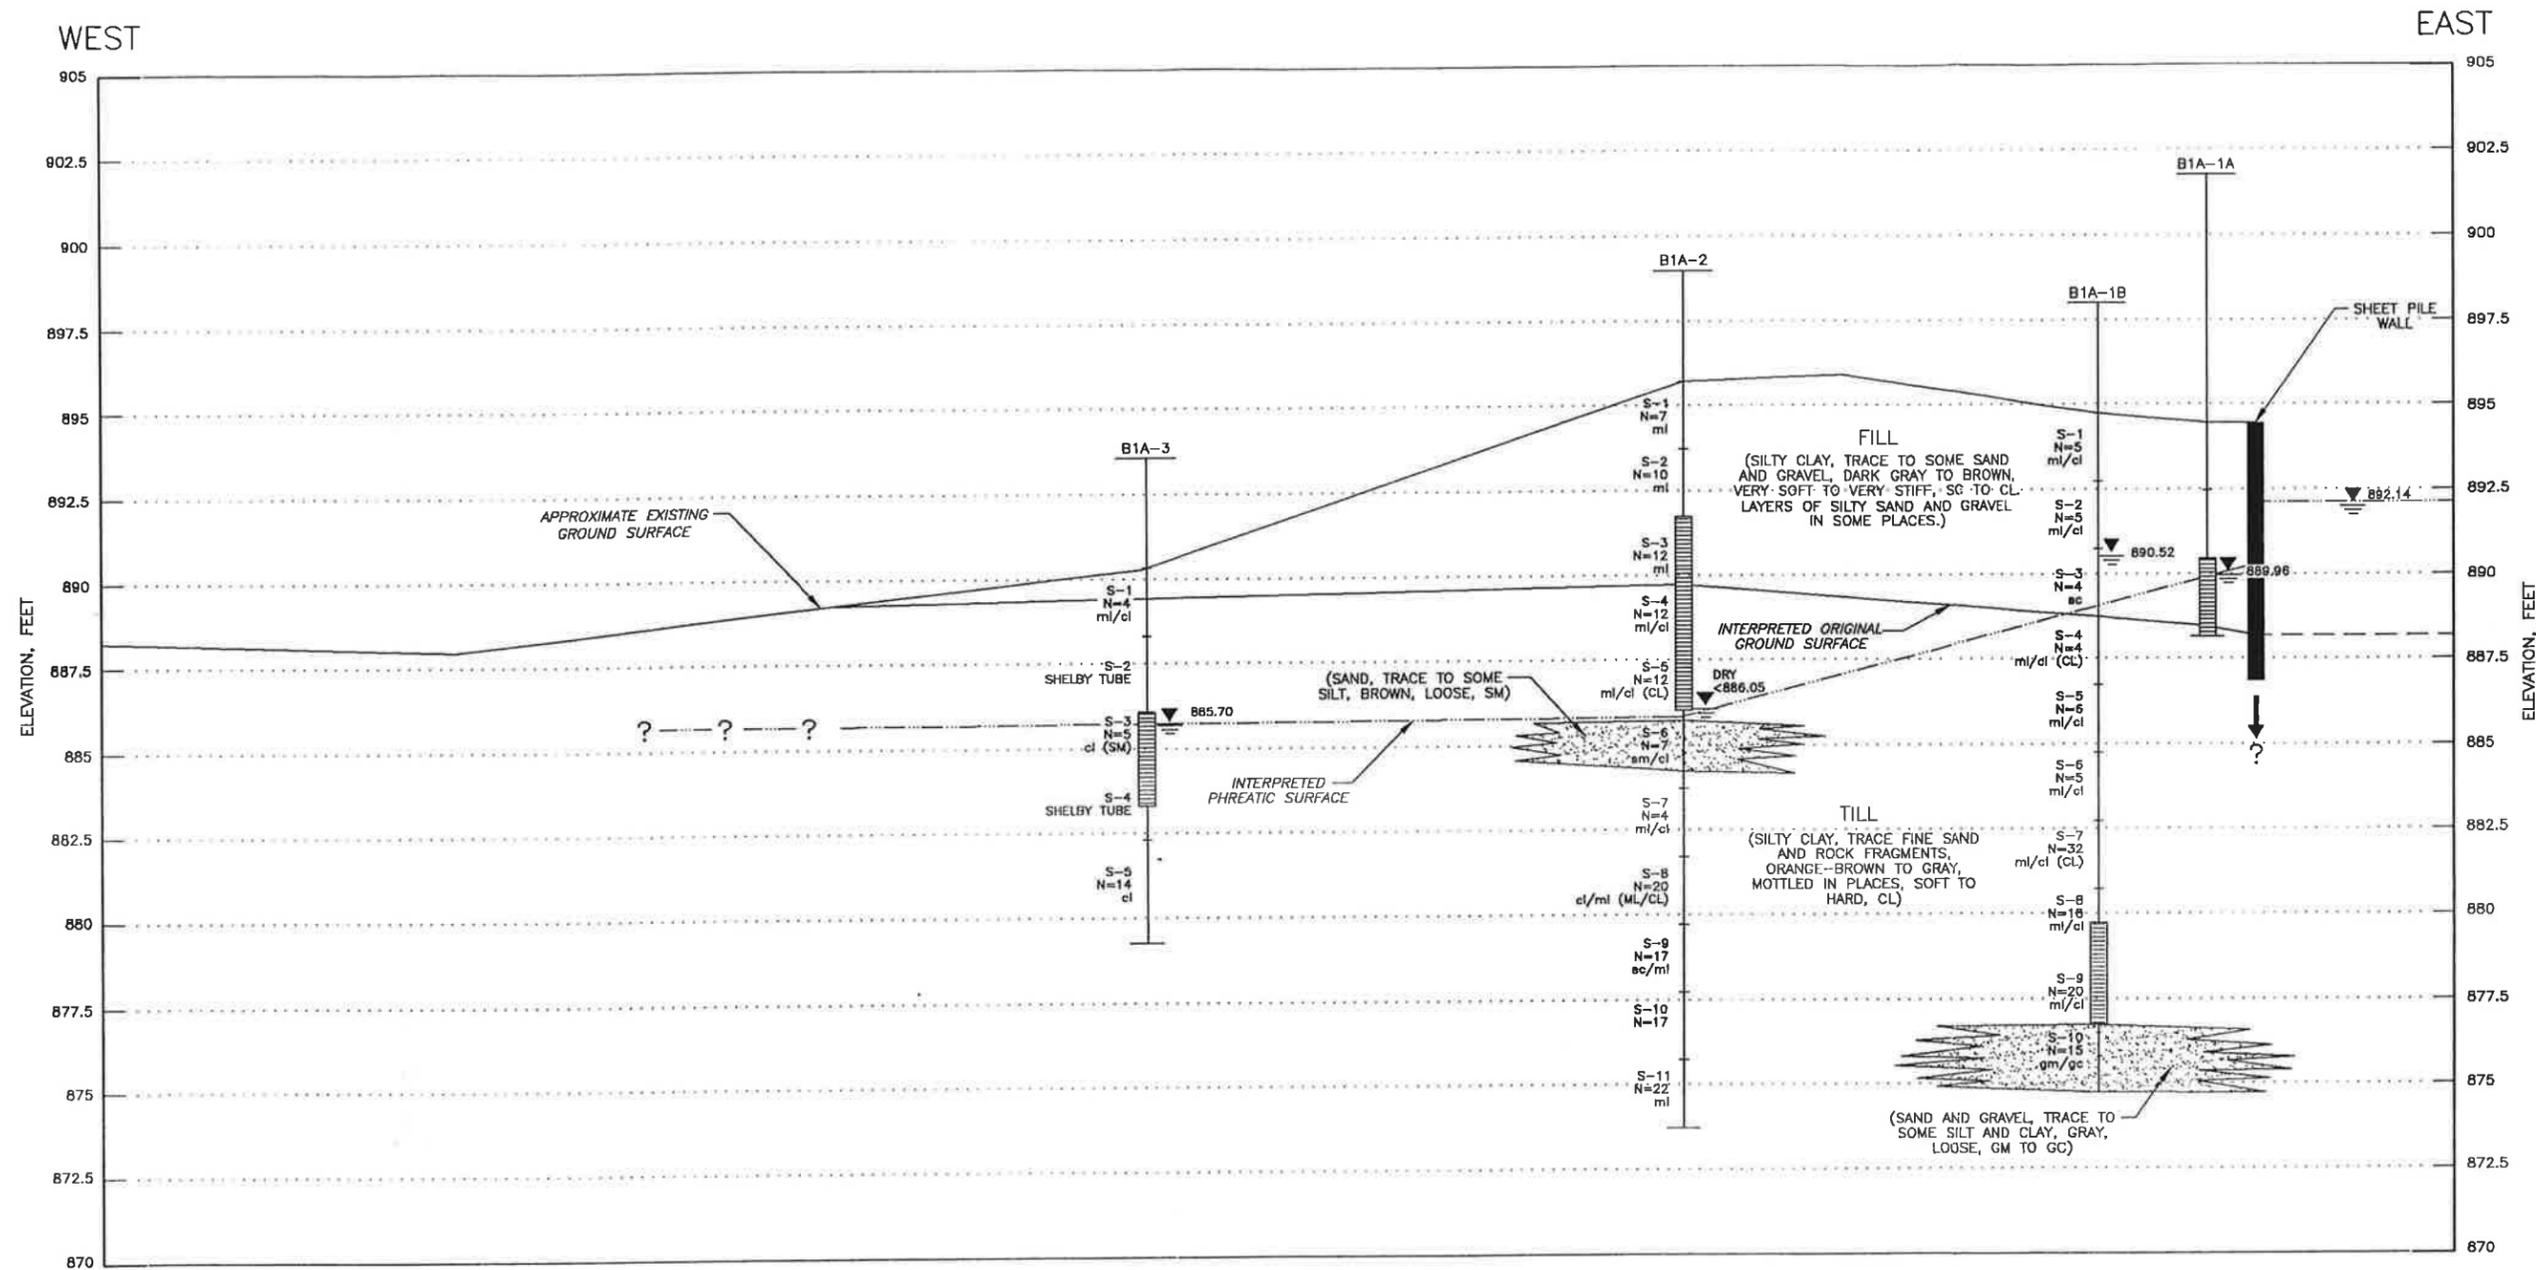
FIGURE 2-3

3.4 SECTION 1A SUBSURFACE CONDITIONS

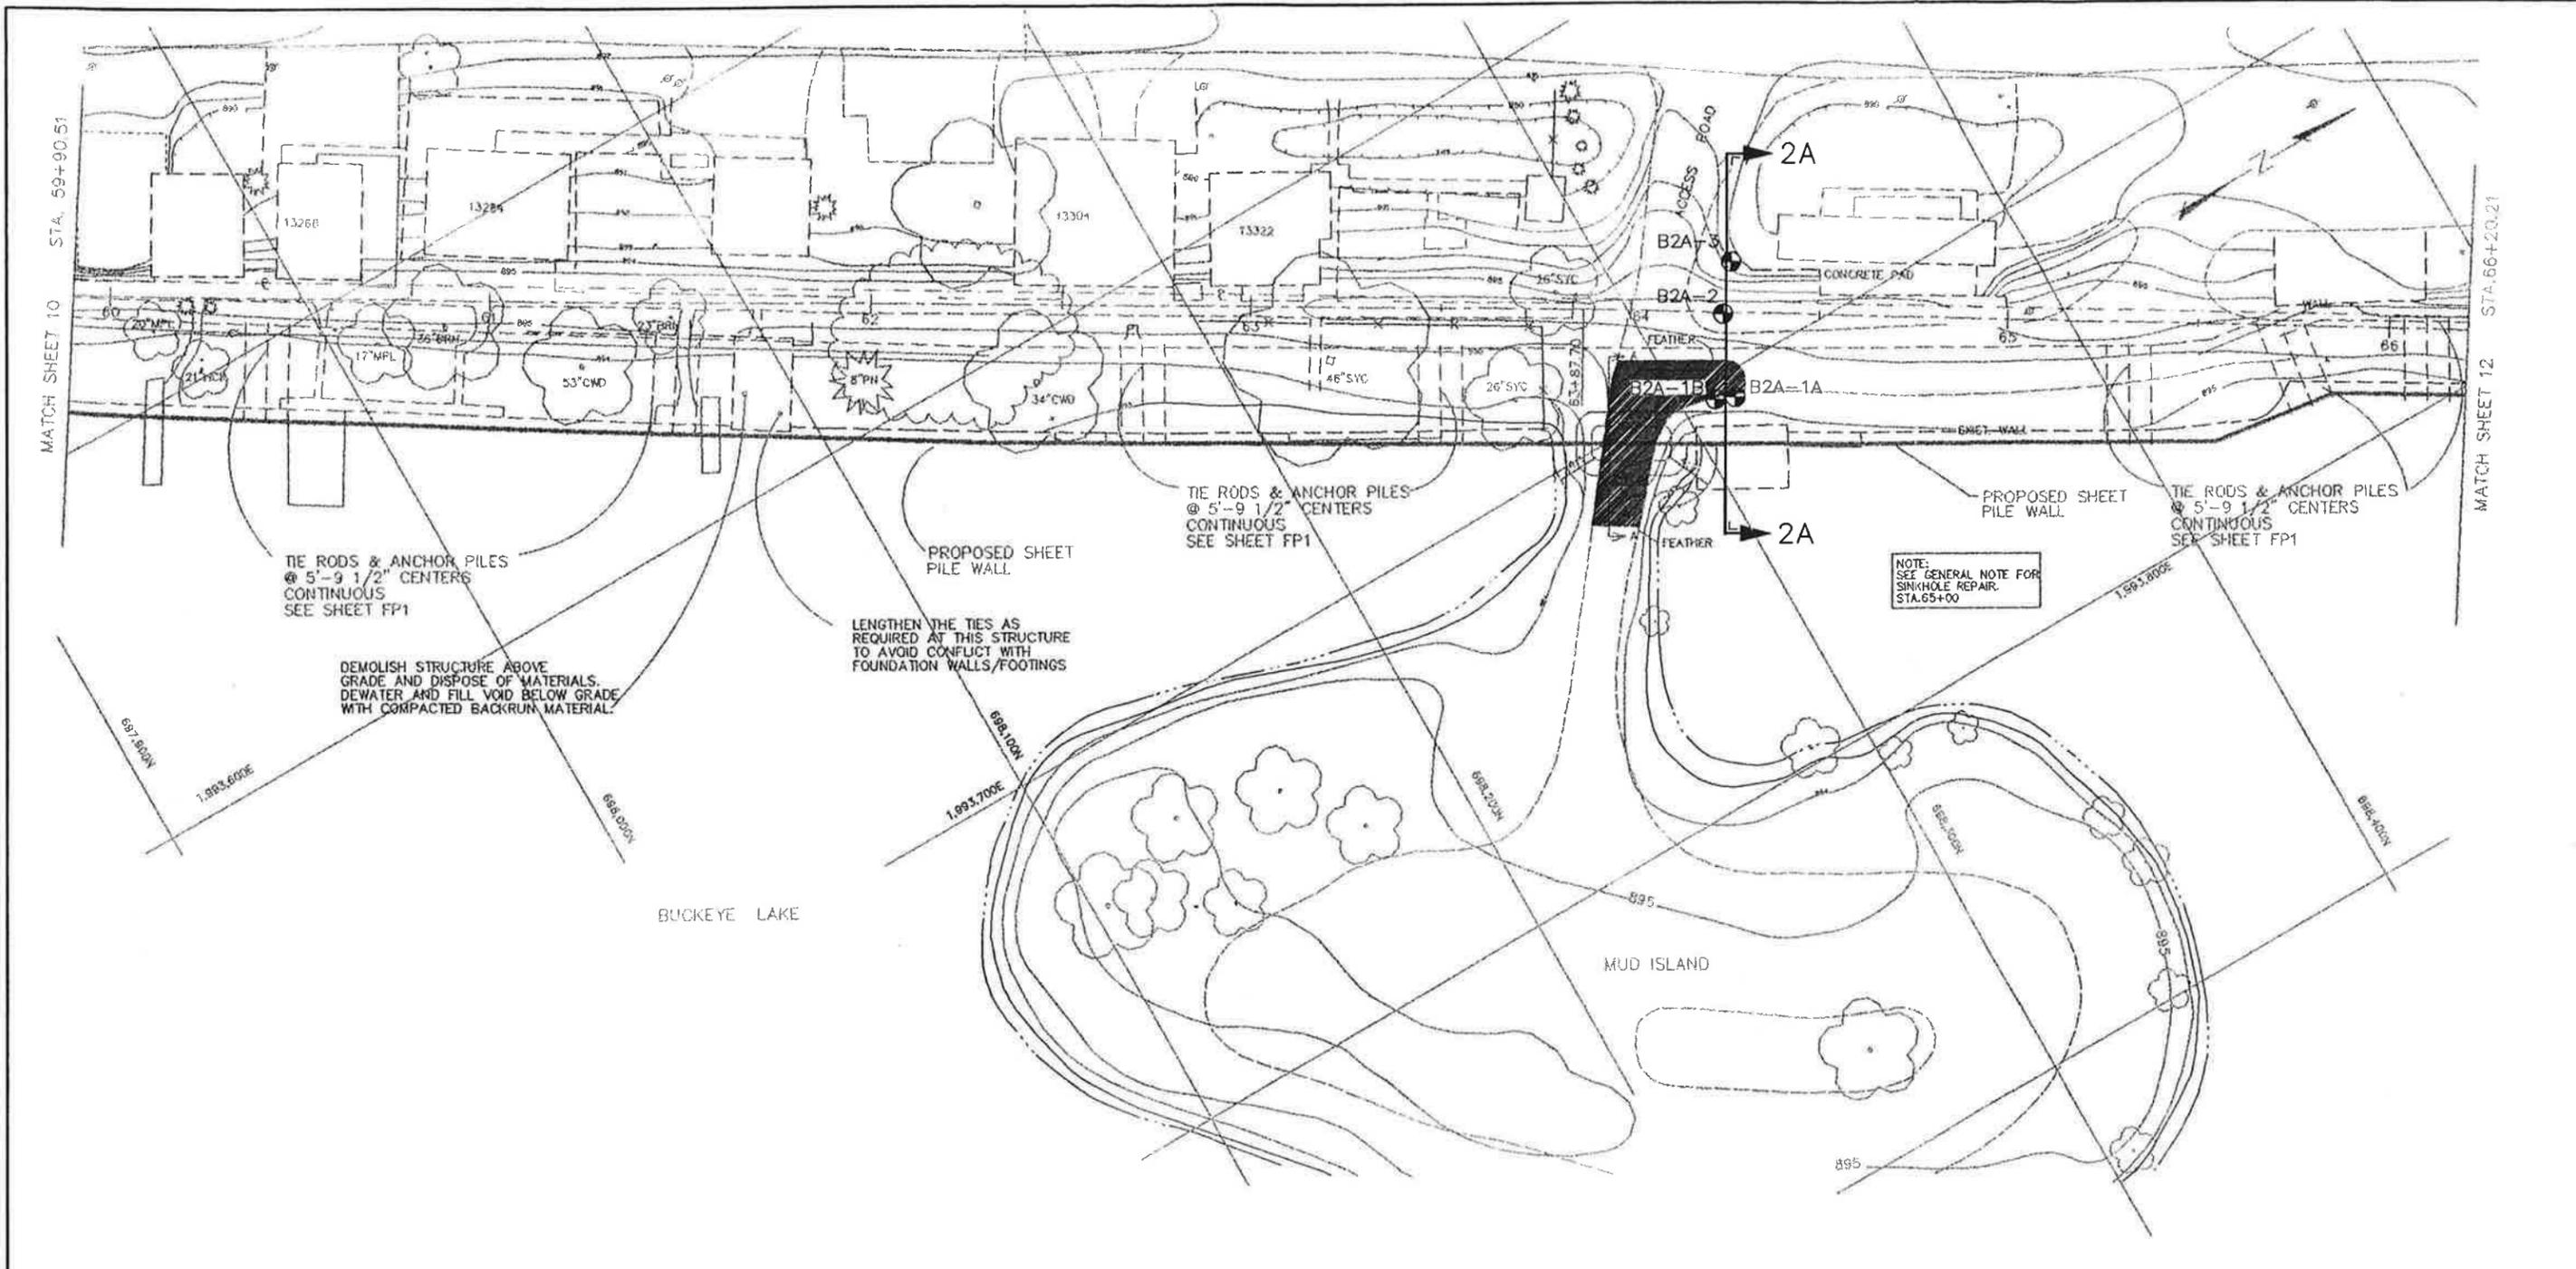
FIGURE 2-4

DEMOLISH STRUCTURE ABOVE GRADE AND DISPOSE OF MATERIALS. DEWATER AND FILL VOID BELOW GRADE WITH COMPACTED BACKFILL MATERIAL.

NOTE: SEE GENERAL NOTE FOR SINKHOLE REPAIR STA. 65+00

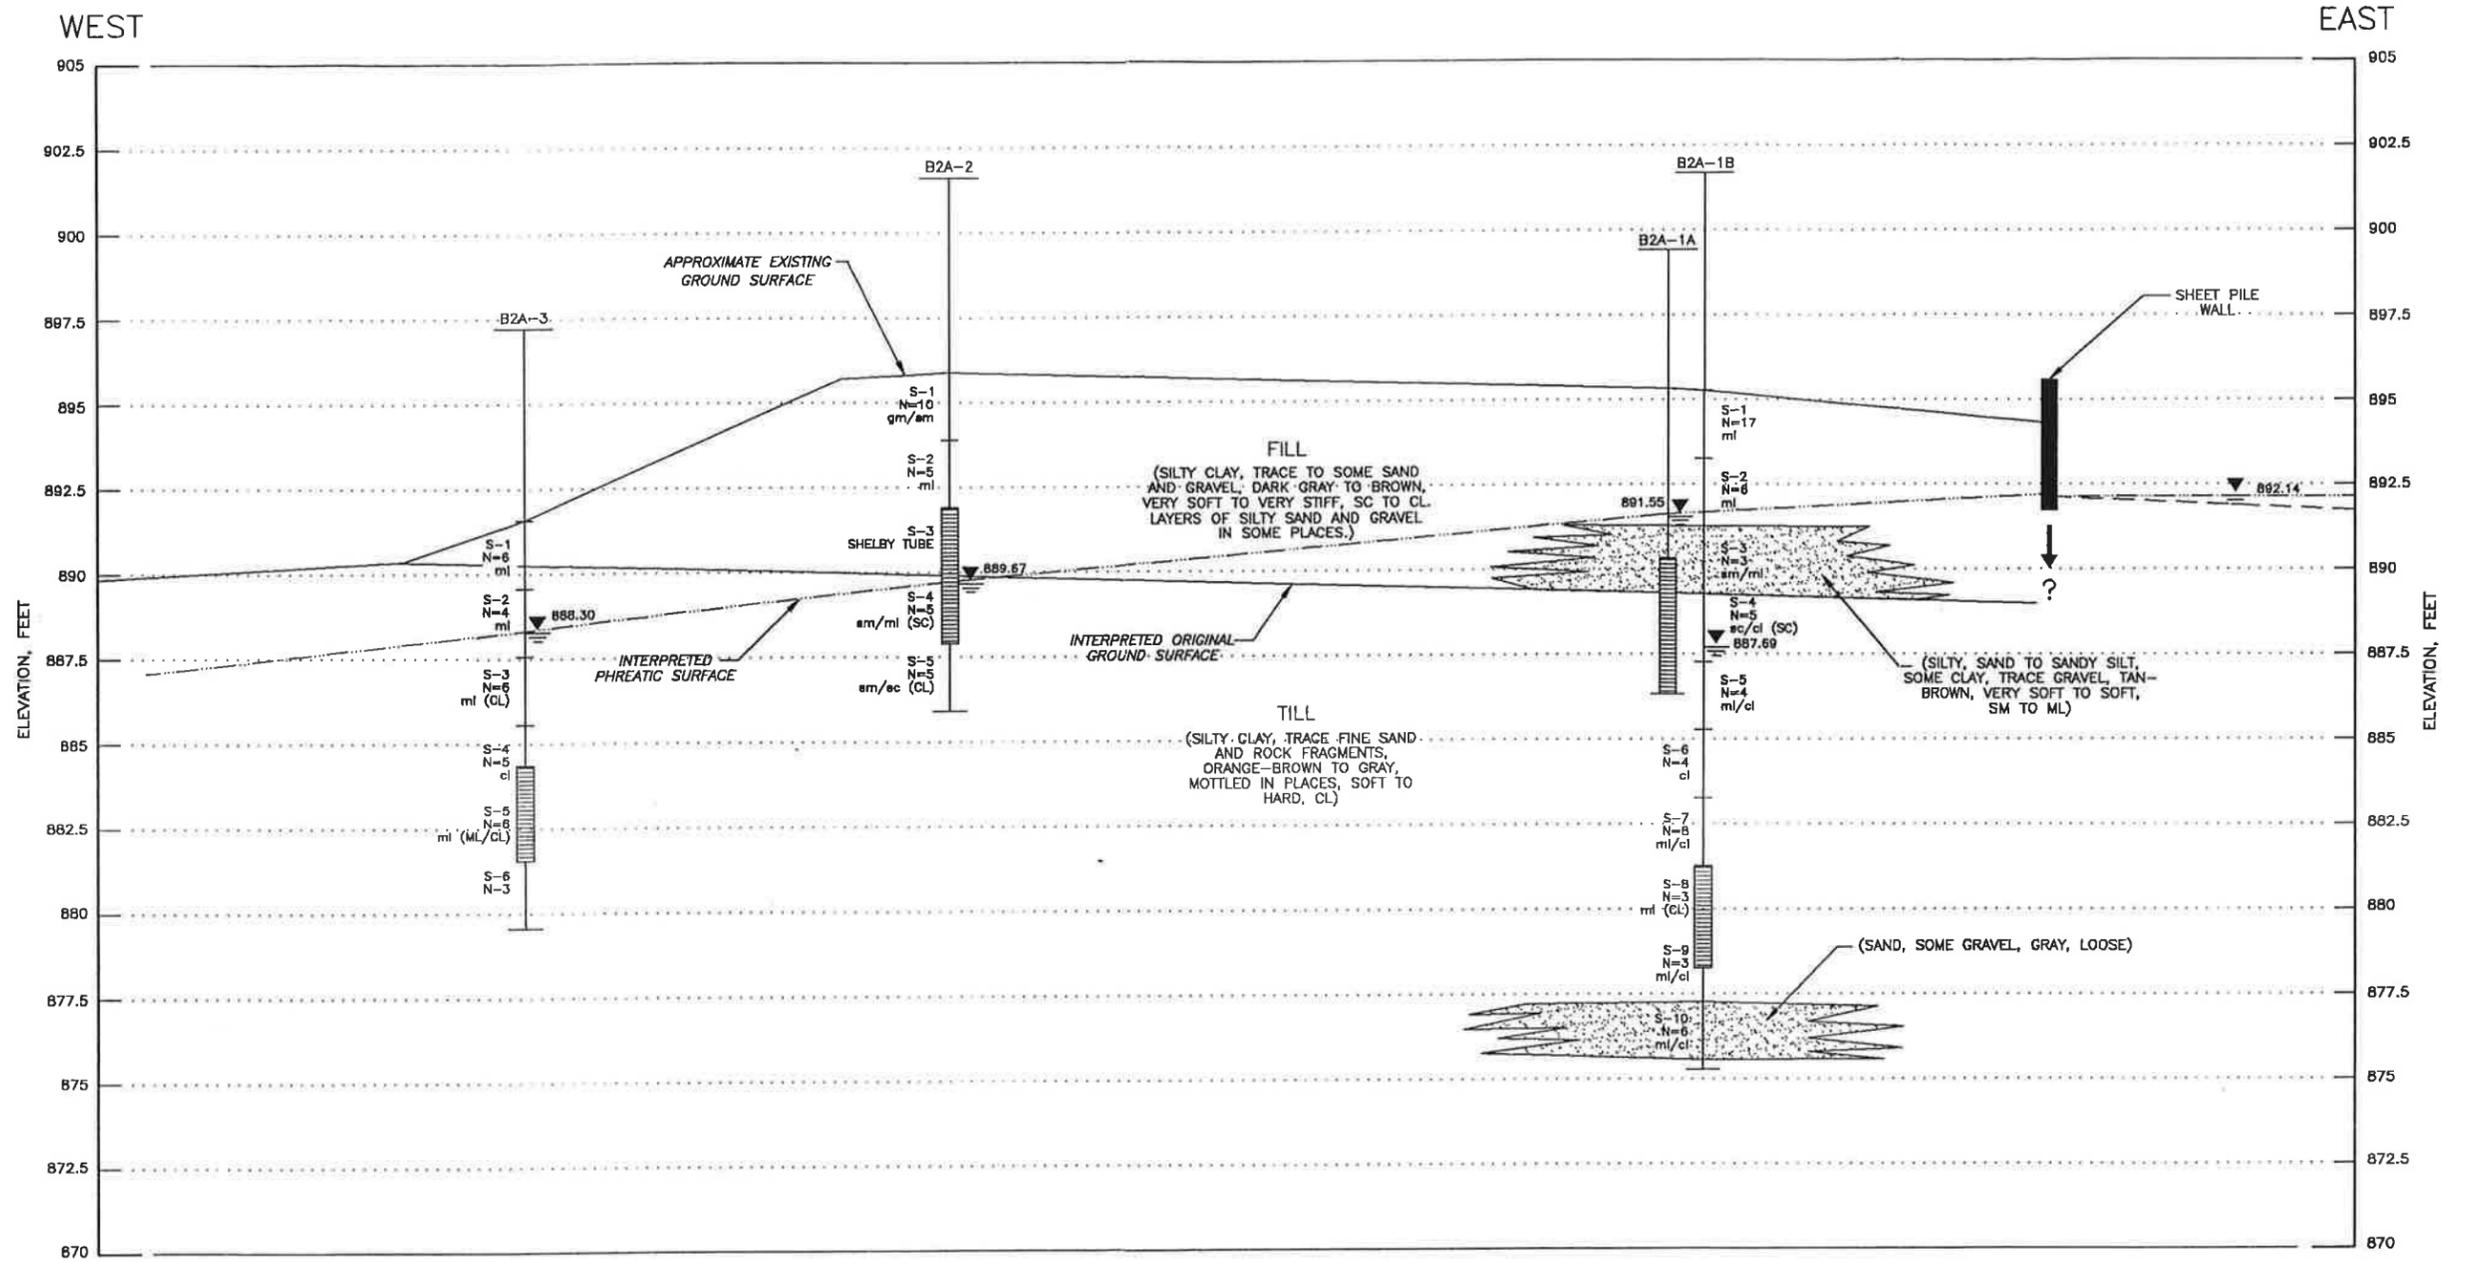
FIGURE 2-5

3.5 SECTION 2A SUBSURFACE CONDITIONS

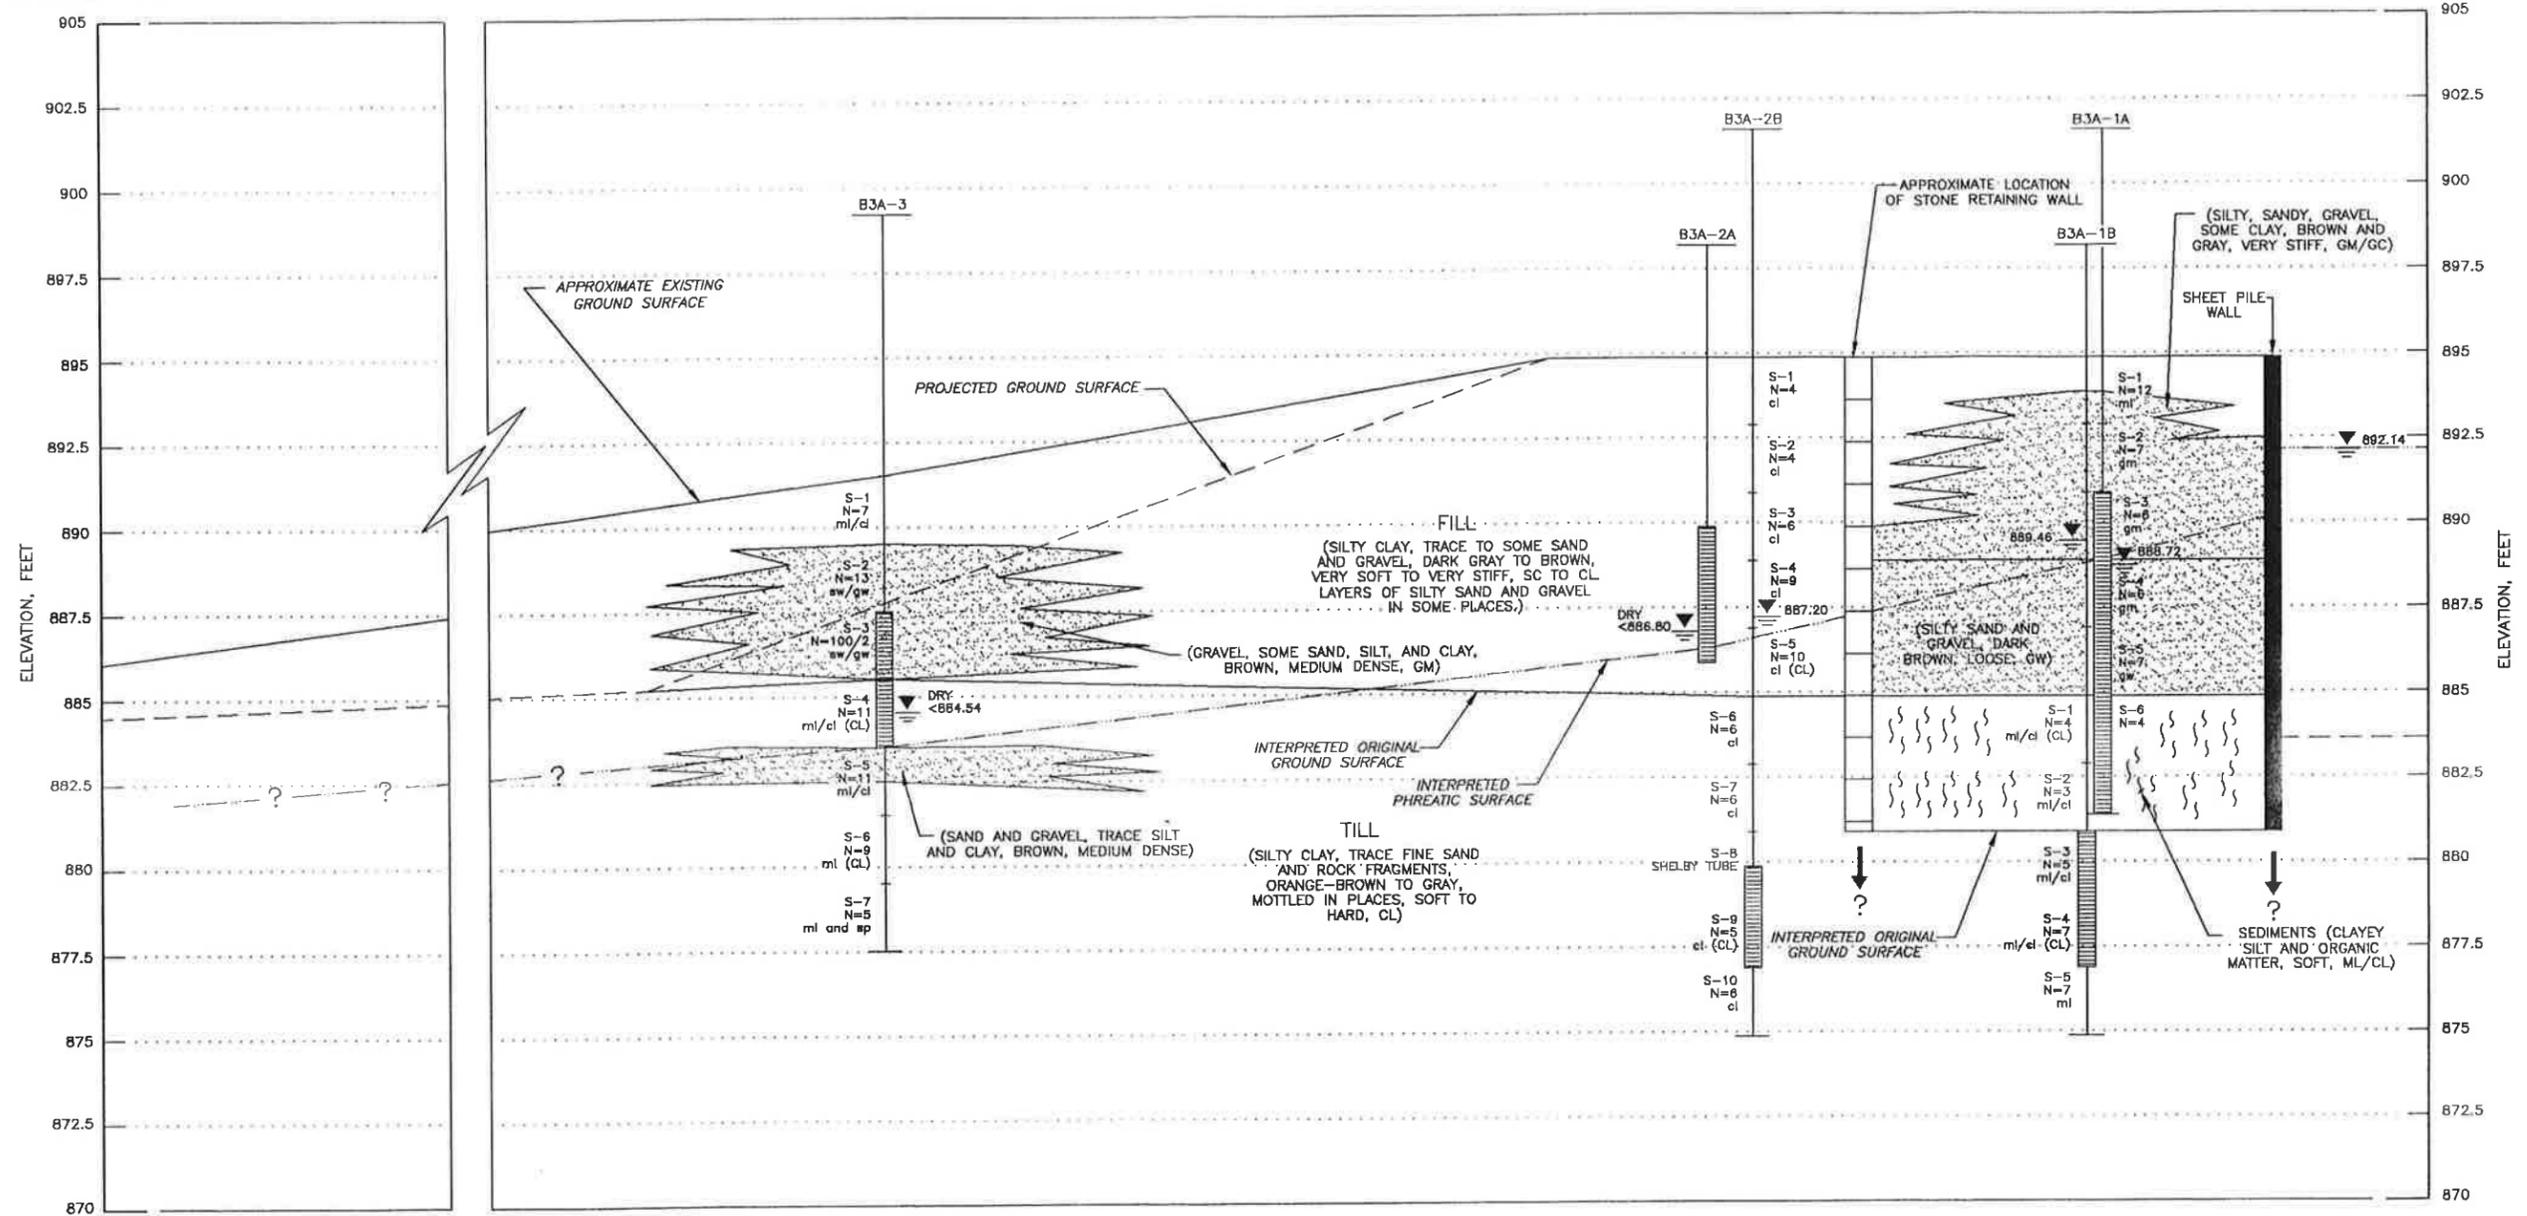
DAM CROSS SECTION 3A

3.6 SECTION 3A SUBSURFACE CONDITIONS

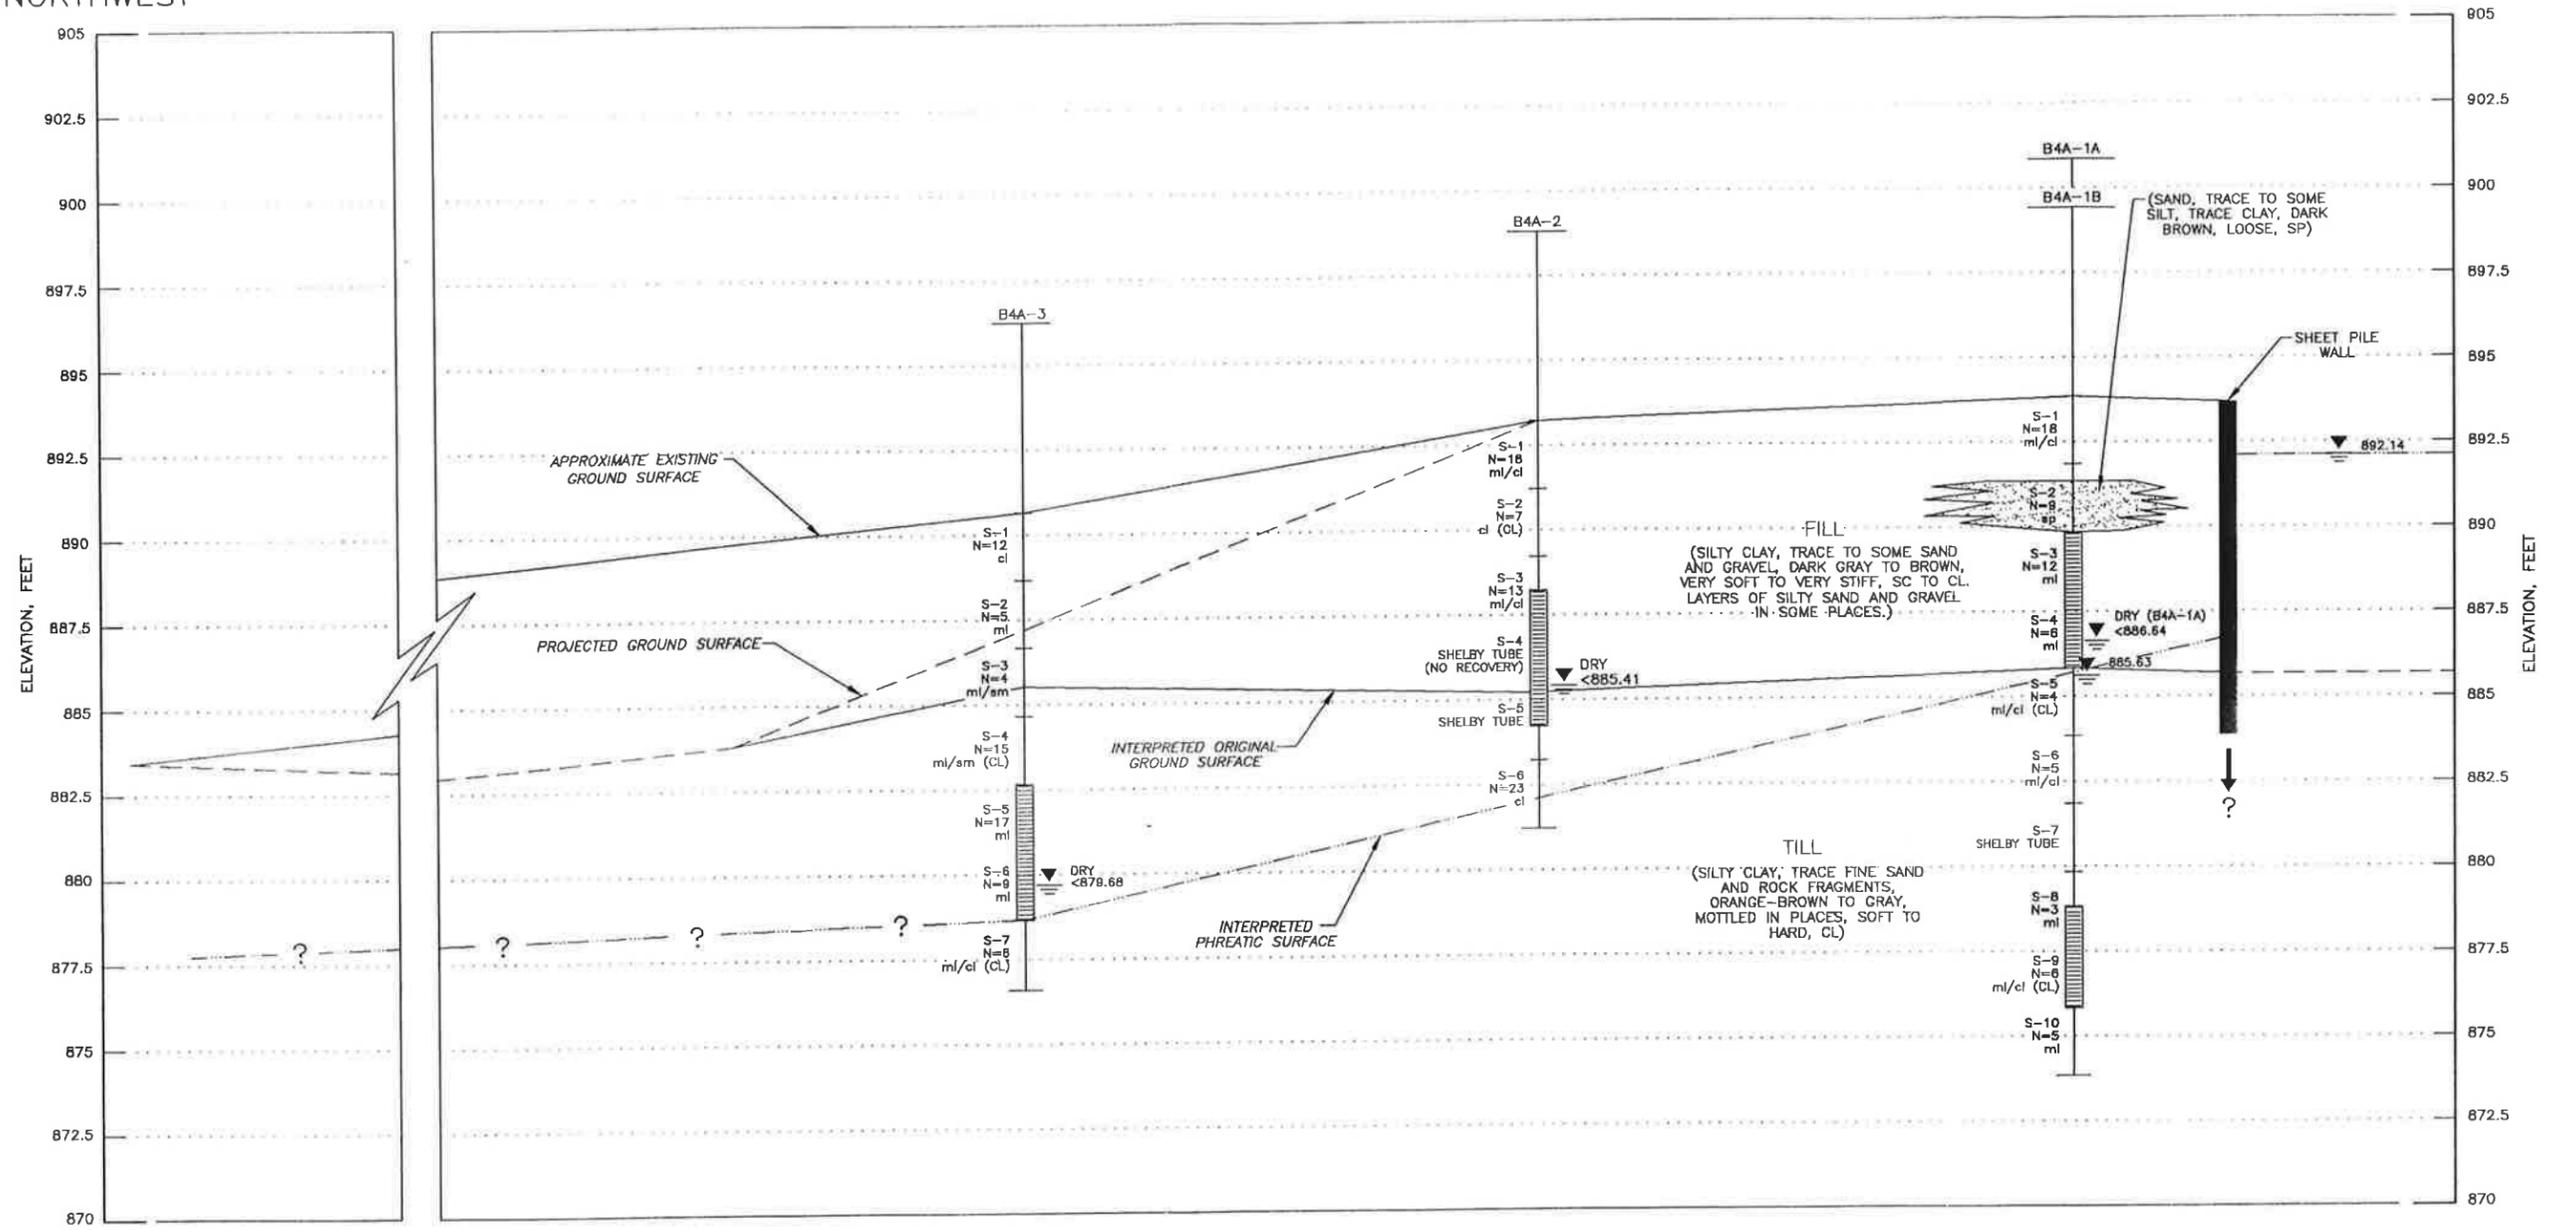
FIGURE 2-9

3.7 SECTION 4A SUBSURFACE CONDITIONS

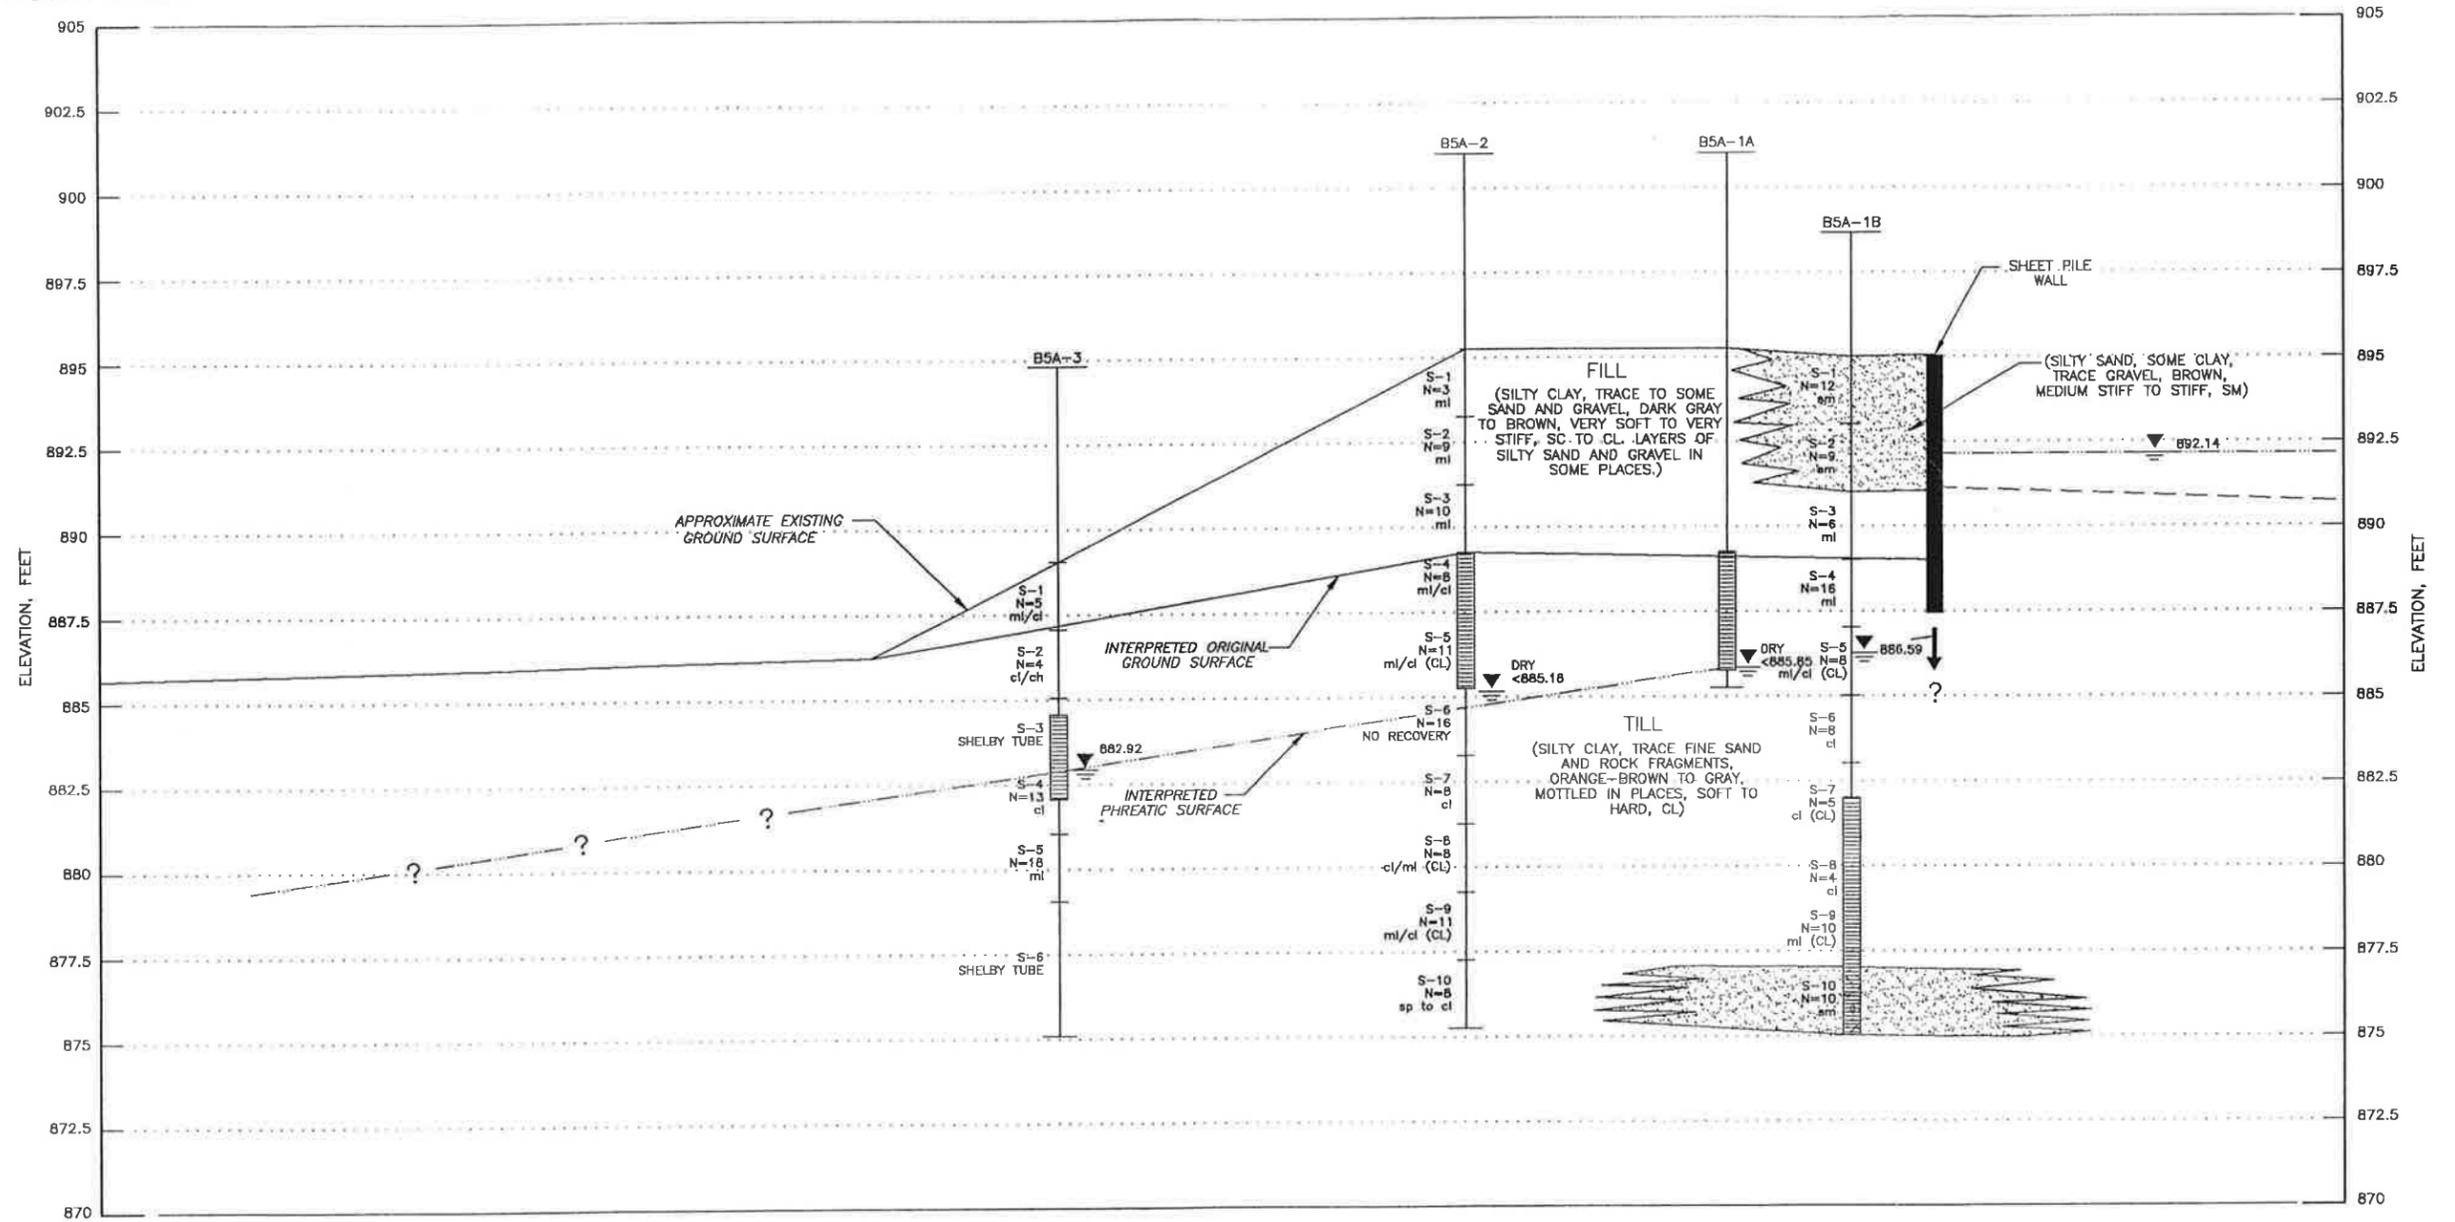
3.8 SECTION 5A SUBSURFACE CONDITIONS
