RE: Buckeye Lake Dam
Licking and Fairfield Counties
File Number: 9723-004

**DIVISION OF WATER
SITE VISIT MEMORANDUM
BUCKEYE LAKE DAM
FILE NUMBER: 9723-004**

**Buckeye Lake Dam
West Bank Inspection
April 14, 2000**

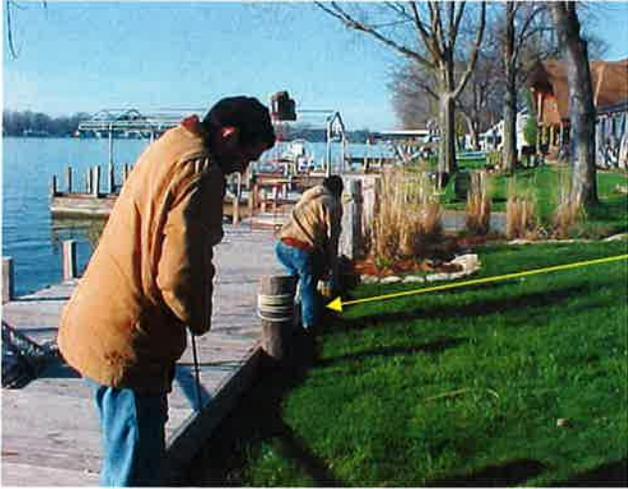
The tile probes could be pushed half their lengths along most of this section. Near the stone and masonry wall, at an approximate station of 62+10, the tile probe was completely pushed its full length into the upstream embankment. See digital photograph labeled number 1 for additional information. The possible existence of a second wall was detected by repeated probing approximately 1.0 foot below the present grade and 5 to 6 feet behind the stone and masonry wall.

PHOTO # 1
Station 62+25 to 61+00
- the tile probe was pushed
half its distance along the
stone and masonry wall.

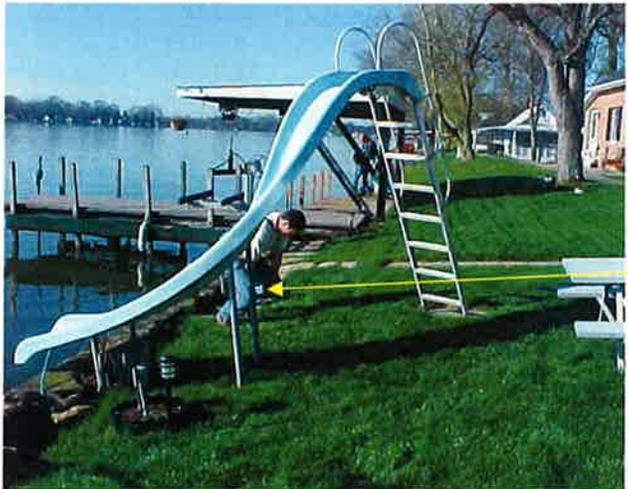
The upstream embankment contained a low area (0.5 foot deep) near the stone and masonry wall at an approximate station of 60+15. The tile probes were pushed their full lengths in this area. See digital photograph labeled number 2 for additional information.

PHOTO #2
Station 61+00 to 60+00
- The tile probe was pushed
its full distance along the
stone and masonry wall.

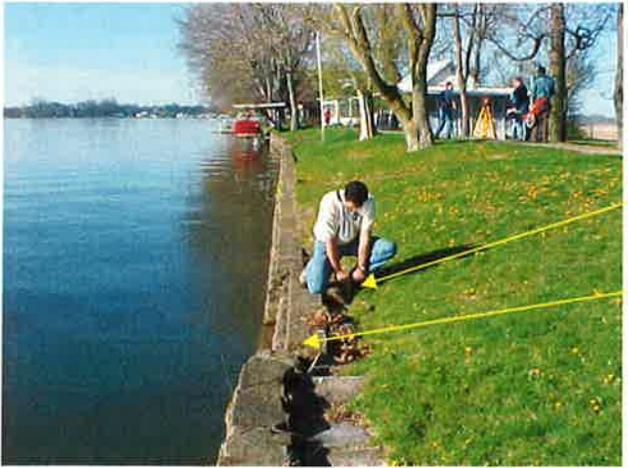
The upstream embankment contained low areas all along the stone and masonry wall. The tile probes were pushed their full length in this area. A section of the stone and masonry wall was broken and displaced near station 59+40. A sidewalk (station 59+10) that extended from the crest to the stone and masonry wall was broken and displaced. The area along the sidewalk could be probed half the distance of the tile probe. See digital photograph labeled number 3 for additional information.

PHOTO #3
Station 60+00 to 59+00
- The tile probe was pushed
its full distance along the
stone and masonry wall.
- Broken and displaced stone
and masonry wall.

1. Repair the stone and masonry wall along the entire West Bank from Mud Island to Leibs Island. Also, repair the noted sinkholes and low areas with compacted clay material and establish a dense grass cover. Remedial measures must be taken immediately to stabilize the largest hole observed at station 53+80.
2. Monitor the depressions (low areas) along the upstream embankment for additional signs of settlement until repairs can be made.
3. Remove the trees and root systems along the upstream embankment. Replace the voids in the embankment with compacted fill material and establish a dense grass cover.
4. Remove all landscaping and structures from the state-owned portion of the dam. This will facilitate proper inspection and maintenance of the earthfill embankment.

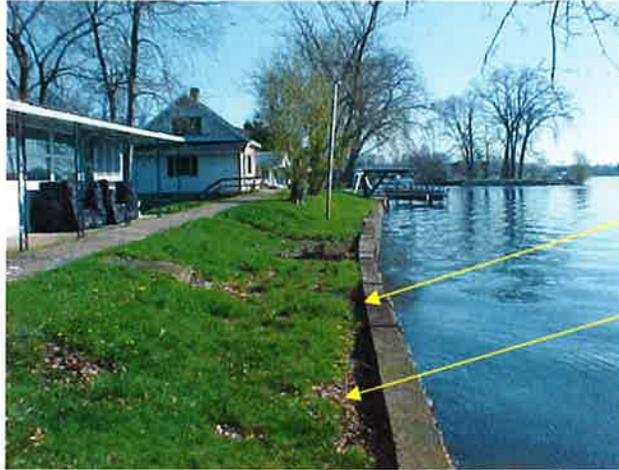
At an approximate station of 55+50, a depression of 0.5 foot deep was observed along the stone and masonry wall. The probe was pushed its full length in the area of the depression. See digital photograph labeled number 4 for additional information.

PHOTO #4
Station 56+00 to 55+00
- The tile probe was pushed its full distance along the stone and masonry wall.
- Depression behind the wall.

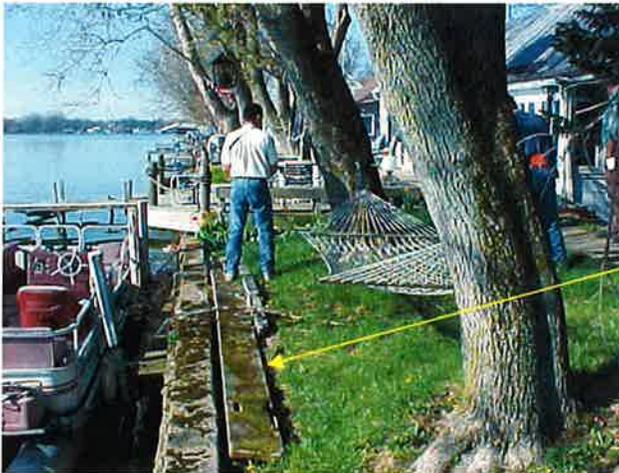
Near station 54+50, the stone and masonry wall was observed to be tilting towards the lake. Along this section of the upstream embankment, the tile probe was pushed its full length. See digital photograph labeled number 5 for additional information.

PHOTO #5
Station 55+00 to 54+00
- The tile probe was pushed its full distance along the wall.

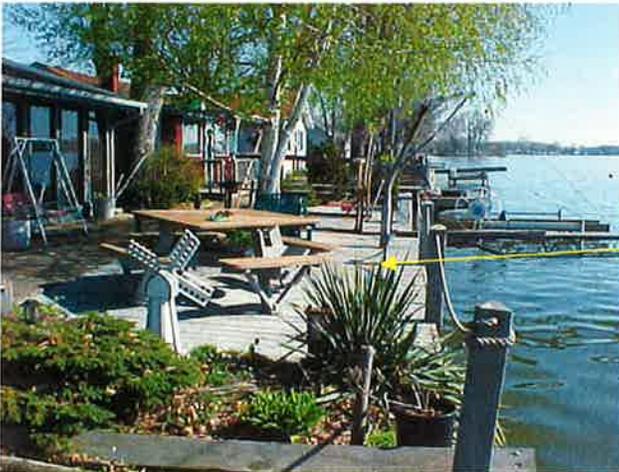
A deck covered a large portion of this area. A tile probe could not be used on this area of the upstream embankment. The tile probe was pushed half its length in the remainder of the section. See digital photograph labeled number 6 for additional information.

PHOTO #6
Station 50+00 to 49+00
- Decks covered a large portion of this section. A visual inspection was not possible on the embankment.

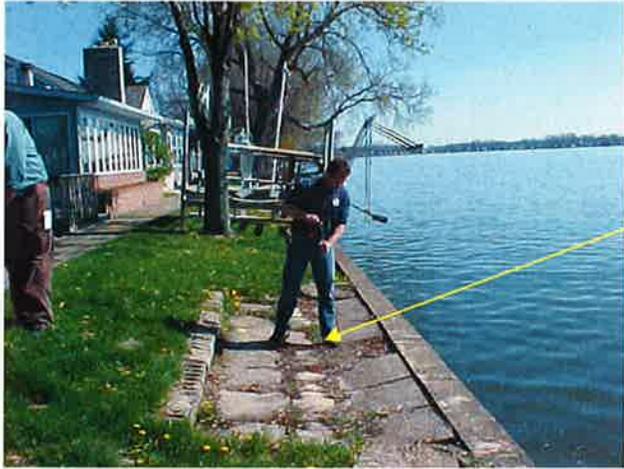
A low area, 18 inches deep, was noted along the stone and masonry wall. The tile probe was pushed its full length along the stone and masonry wall. See digital photograph labeled number 7 for additional information.

PHOTO #7
Station 45+00 to 44+00
- The tile probe was pushed its full length in this low area. The low area was 18 inches below the top of the wall.

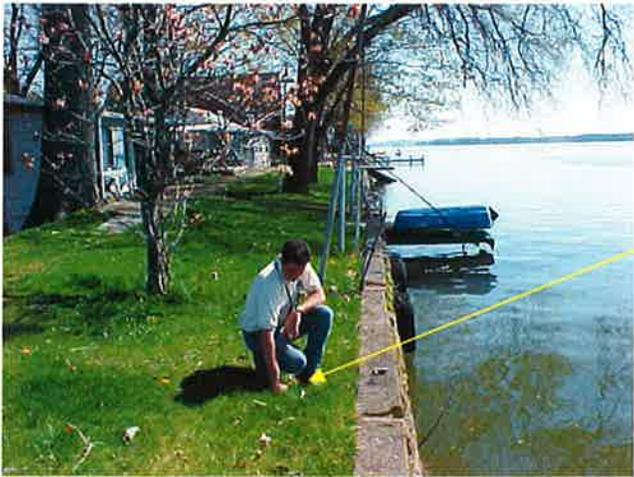
Sinkholes were observed near station 35+85, in the upstream embankment, adjacent to the stone and masonry wall. A full tile probe distance was obtained in the area around the sinkholes. At an approximate station 35+60, the elevation of the upstream embankment was a 0.5 feet below the top of the stone and masonry wall. The tile probe was pushed its full length and the tip of the tile probe was wet. See digital photograph labeled number 8 for additional information.

PHOTO #8
Station 36+00 to 35+00
- The tile probe was pushed its full distance along the stone and masonry wall.

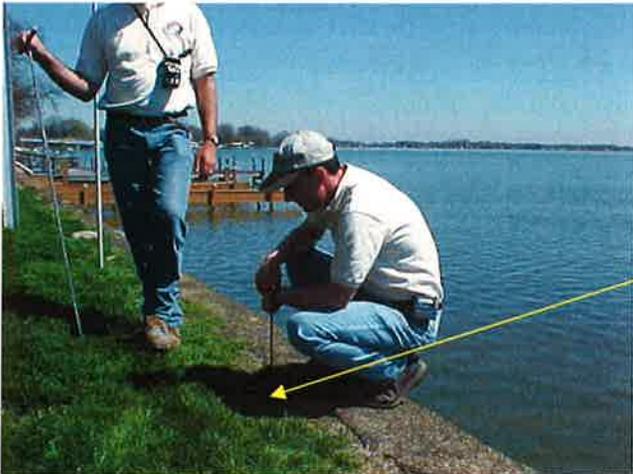
At station 20+50 (house number 126360), the resident stated that a lot of fill material had been placed in front of their house to raise the elevation of the upstream embankment. A tile probe was pushed its full length near station 20+25. The tile probe was pushed half its length in the remainder of the section. See digital photograph labeled number 9 for additional information.

PHOTO #9
Station 21+00 to 20+00
- The tile probe was pushed its full distance along the stone and masonry wall.

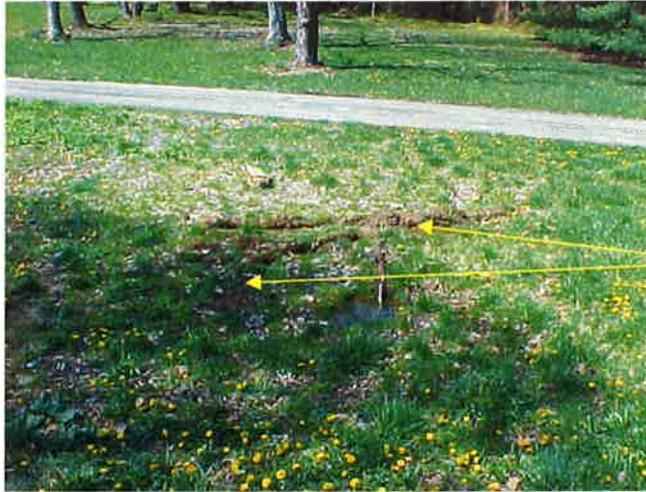
A wet area approximately 4-foot in diameter was observed 12 to 15 feet beyond the downstream toe near station 18+00. The tile probe was pushed its full length along the stone and masonry wall between station 17+55 to 17+45. See digital photograph labeled number 10 for additional information.

PHOTO #10
Station 18+00 to 17+00
- A wet area was observed
12 to 15 feet beyond the
downstream toe.

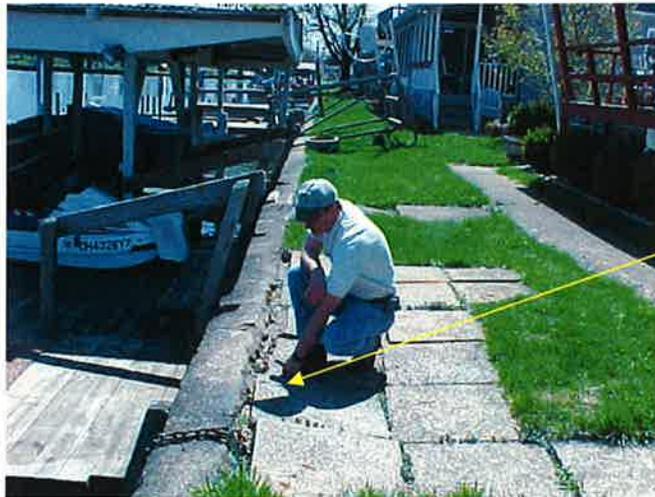
Near station 15+05 and adjacent to the stone and masonry wall, the tile probe was pushed the full length. The tile probe was pushed half its length in the remainder of this area. See digital photograph labeled number 11 for additional information.

PHOTO #11
Station 16+00 to 15+00
- The tile probe was
pushed its full distance
along the stone and
masonry wall.
