RE: Buckeye Lake Dam
Licking County
9723-004

MISCELLANEOUS SITE VISIT MEMORANDUM

Name of Dam: Buckeye Lake Dam **File Number:** 9723-004

County: Licking **Date of Inspection:** May 31, 2001 **Time:** 2:00 p.m.

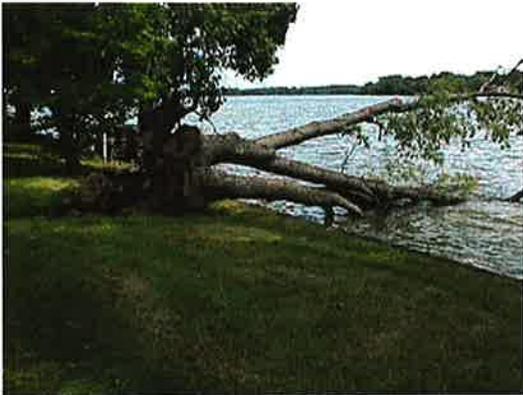
1. A 36 to 40-inch diameter tree located near the middle of the crest had been uprooted during a recent storm and fallen against the stone masonry wall. The fallen tree was located on the West Bank near station 35+50. The exposed root ball was approximately 7 to 8 feet in diameter and left a cavity in the embankment approximately 1 to 1.5 feet deep.
2. A damp/soft area at residential address 3733 was noted along the downstream toe of the North Bank. The damp/soft area was approximately 15 feet long by 10 feet wide. No standing water or boils were noted. The house at this location was recently removed and most of the area along the downstream slope and toe was unprotected fill material. Grass had started to germinate in this area.

View of an uprooted 36 to 40 inch diameter tree on the West Bank near station 35+50.

1. The large tree on the West Bank should be removed and the remainder of the exposed root system ground down 10 to 12 inches below the surface of the crest. Clay material should be compacted in the root cavity and followed by 4 to 6 inches of topsoil. A dense grass cover should then be established.

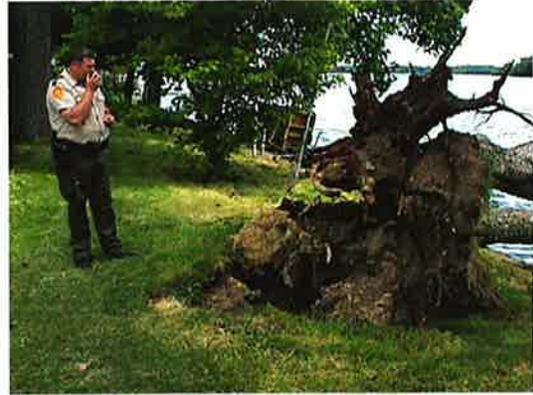
Close-up of root cluster that was approximately 7 to 8 feet in diameter.

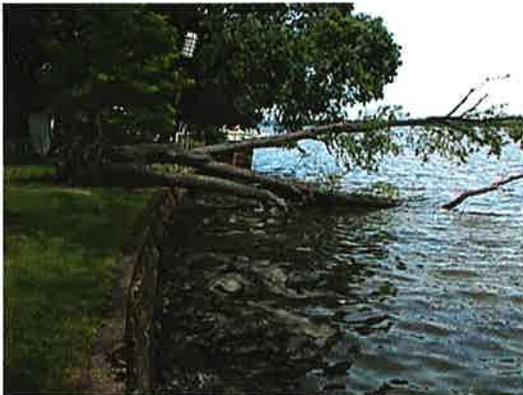
View of the close proximity of the fallen tree to stone masonry wall along the upstream slope.

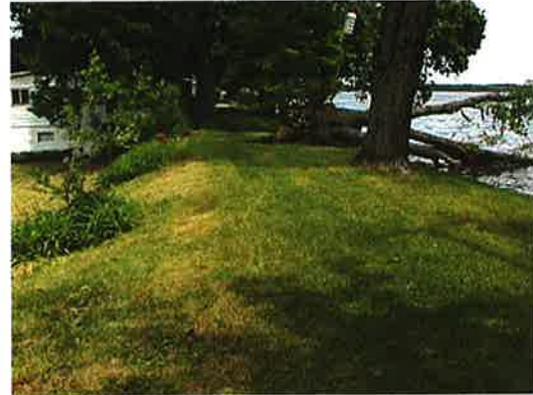
An overview of the cross-section of the West Embankment at station 35+50.

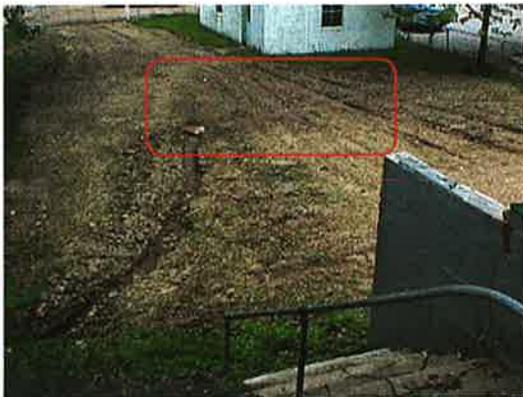
View of the wet area along the downstream toe at residential address 3733.

2. Monitor the damp area on the North Bank at residential address 3733 for changes in size, seepage flow, boils or depressions/low areas. The area should be graded to allow positive drainage away from the toe area and establish a dense grass cover to prevent erosion gullies.

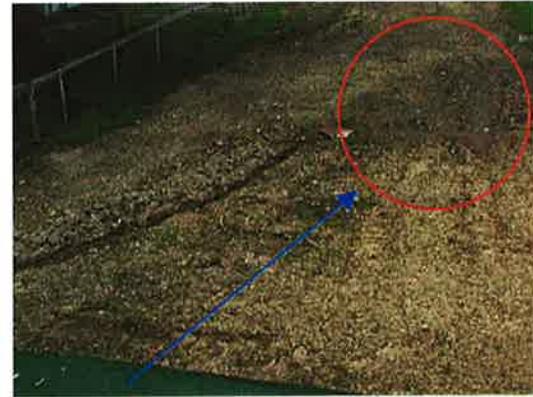
View of wet area from the crest. No flow was noted. The wet area measured to be approximately 15 feet x 10 feet.
