RE: Buckeye Lake Dam
Licking County
File Number: 9723-004

Enclosed you will find the report of the dam safety inspection that was completed on July 26, 2001, for the North Bank of Buckeye Lake Dam.

**DIVISION OF WATER
SITE VISIT MEMORANDUM
BUCKEYE LAKE DAM
FILE NUMBER: 9723-004**

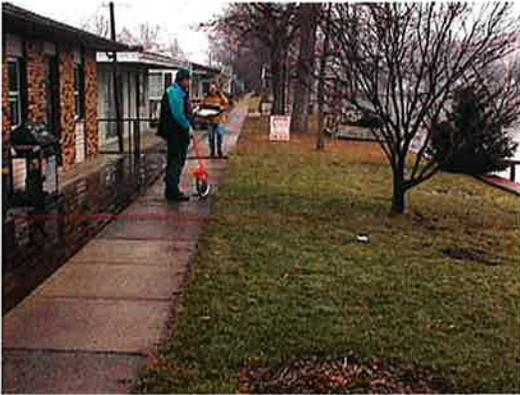
Station 69+00 to 70+00

Two large diameter trees and two new trees were noted along this section of the upstream slope. The fill material was nearly even with the sheet-pile retaining wall located along the upstream slope. A tile probe reading of $T < 1$ was noted along this section. A house is located in the downstream slope. A steel cap had been welded to the top of the sheet-pile retaining wall.

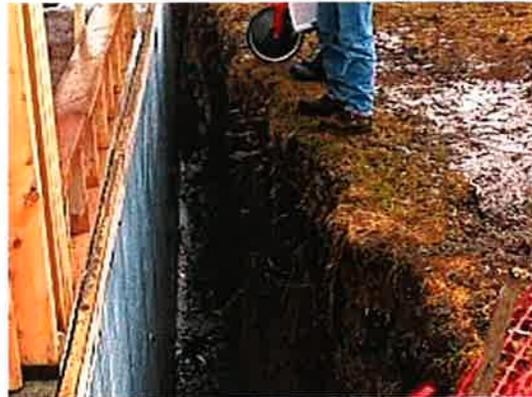
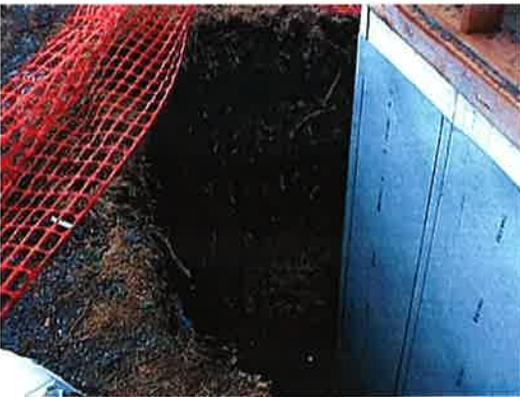
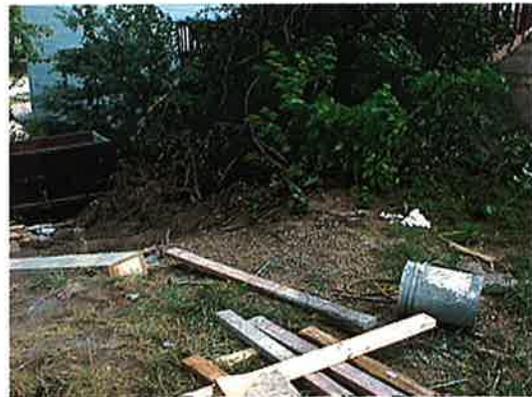
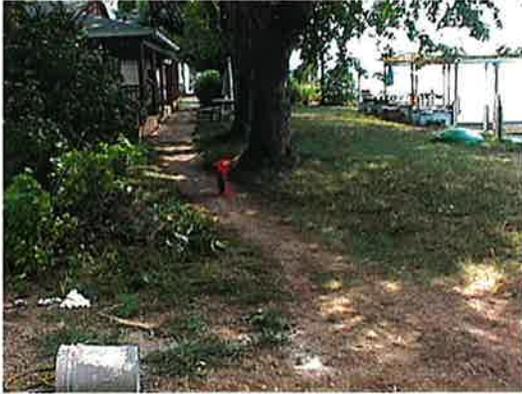
Station 97+00 to 98+00

Along the section the downstream slope had been removed and the basement for a new house had been constructed. The excavation was 9 to 10 feet below the top of the crest elevation. Two large trees were noted on the upstream slope and one tree was noted on the downstream slope. A low area near station 97+60 was noted that was approximately 6 feet in diameter, 3 to 4 inches deep and 12 feet from the sheet-pile retaining wall. The fill material was approximately 6 to 8 inches below the top of the sheet-pile wall. A tile probe reading of T<1 was noted along this section. See digital photos of this section on page 1 & 2. There was no sidewalk in this location.

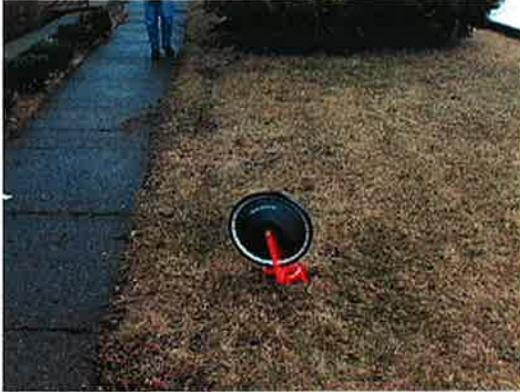
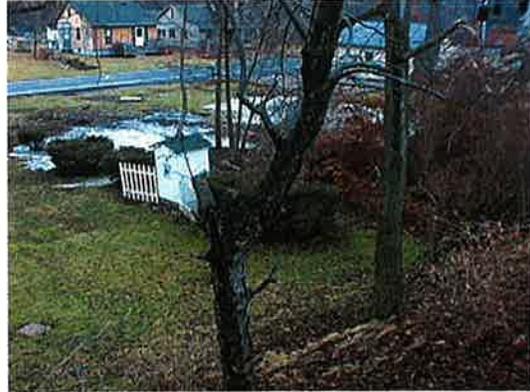
Station 127+00 to 128+00

A tree was noted on the upstream slope and six large trees were noted on the downstream slope. A sinkhole was noted near station 127+75, approximately 11 feet from the sheet-pile wall and measured 8 inches in diameter. See a digital photo of this section on page 3. A tile probe reading of T=3 was recorded along this section.
