**DIVISION OF WATER
DAM SAFETY INSPECTION REPORT
NORTH BANK OF BUCKEYE LAKE DAM
FILE NUMBER: 9723-004**

LOCATION: Fairfield County, Walnut Township &
Licking County, Union Township

DATE: Wednesday, May 4, 2005

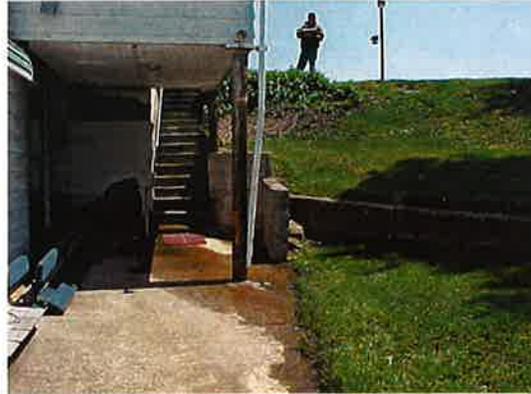
Station 152+00 to 153+00

A low area was noted near station 152+25 along the upstream slope that measured 3 feet by 3 feet and 4 inches deep. One tree was noted on the upstream slope and one tree on the downstream slope. The steel I-beam located on top of the sheet-pile retaining wall had been removed near station 153+00. Seepage on the downstream slope was estimated at less than 1 gallon per minute. A digital photo of seepage along the downstream slope was taken.

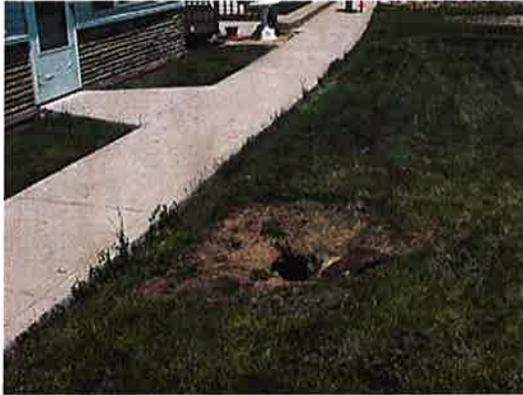
Station 163+00 to 164+00

A depression was noted near station 163+25 and 13.2 feet from the upstream sheet-pile retaining wall. The depression was 16 inches in diameter and 16 to 21 inches deep. One tree was noted on the upstream slope. Fill material was 4 inches below the sheet-pile retaining wall. A digital photo of this area was taken.
