RE: Buckeye Lake Dam
File Number: 9723-004
Licking and Fairfield Counties

DAM SAFETY INSPECTION REPORT

Buckeye Lake Dam – West Bank
File Number: 9723-004

Inspection Date: June 24, 2010

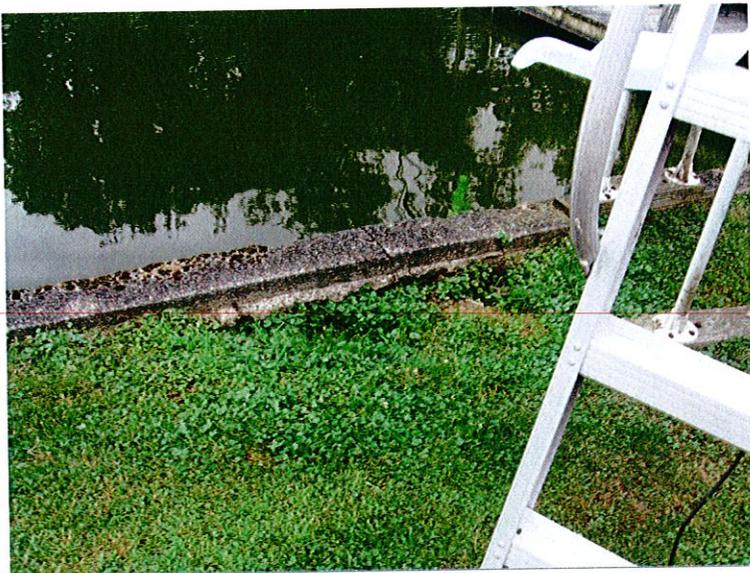
Photograph No. 1:

A large tree still existed near station 11+90. The upstream stone wall was leaning towards lakeside. A low area at station 11+28 was noted adjacent to the upstream stone-wall and measured 5 feet x 2 feet. *A digital photo was taken of this area and is included in this report.*

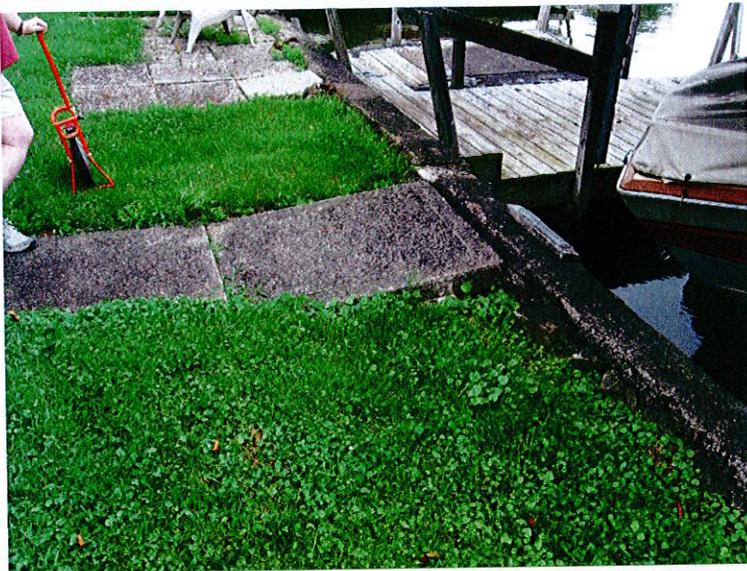
Photograph No. 2:

Near station 15+05, a 2-foot depression was noted next to the wall. Brick pavers were noted along the upstream slope. The embankment around the perimeter of the pavers was low. At house number 12530, a low area was noted adjacent to the wall. Sidewalk elevation is below top of wall elevation. *A digital photo of this area was taken and is included in this report.*

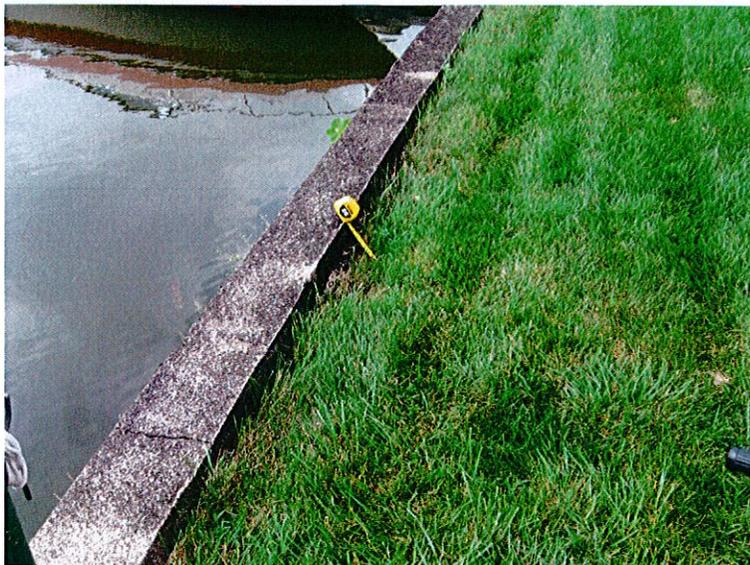
Photograph No. 5:

A wet area approximately 4 feet in diameter that had been observed 12 to 15 feet beyond the downstream toe near station 18+00 in 2005 was dry during this inspection. According to the plans, a tree had been located in this area. A low area was noted adjacent to the wall that measured 7-inches deep, 30-inches wide, and 10-feet long. *One digital photo was taken in this area and is included in this report.*

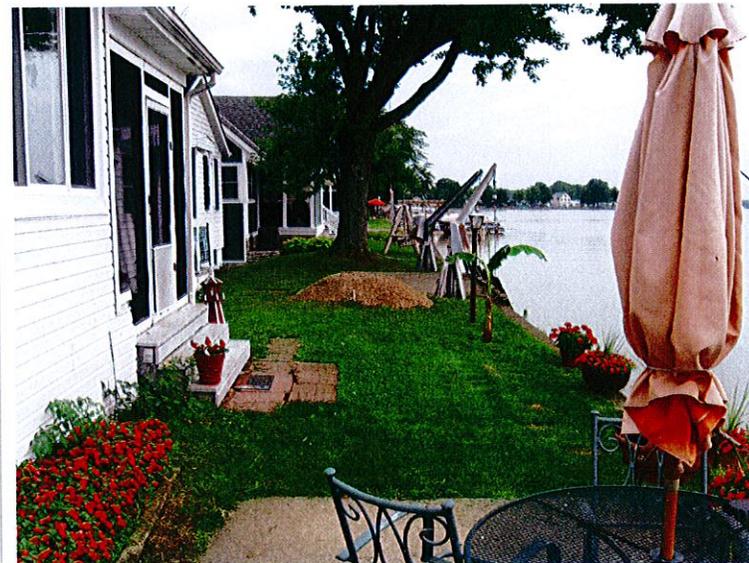
Photograph No. 9:

At station 20+50 (house number 12636), the resident stated that considerable fill material had been placed in front of their house to raise the elevation of the upstream portion of the slope in 2000. A tree had been removed near station 20+25 and the stump had been removed by the 2010 inspection. A 24-inch-diameter depression was observed near station 20+50. The downstream slope was dry. *A digital photo was taken of this area and is included in this report.*

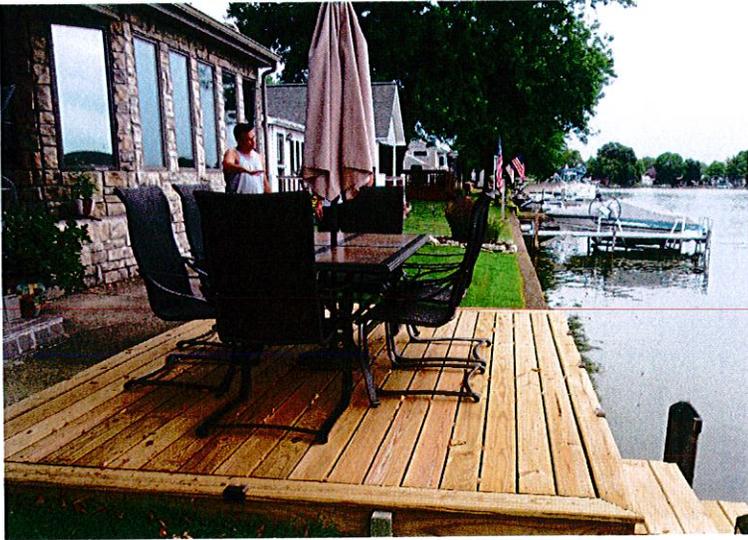
Photograph No. 10:

A tree was noted at station 22+90 during the 2005 inspection. During the 2010 inspection, the tree tag no.18 had been removed and the upstream slope had been covered with patio pavers. *A digital photo was taken of this area and is included in this report.*

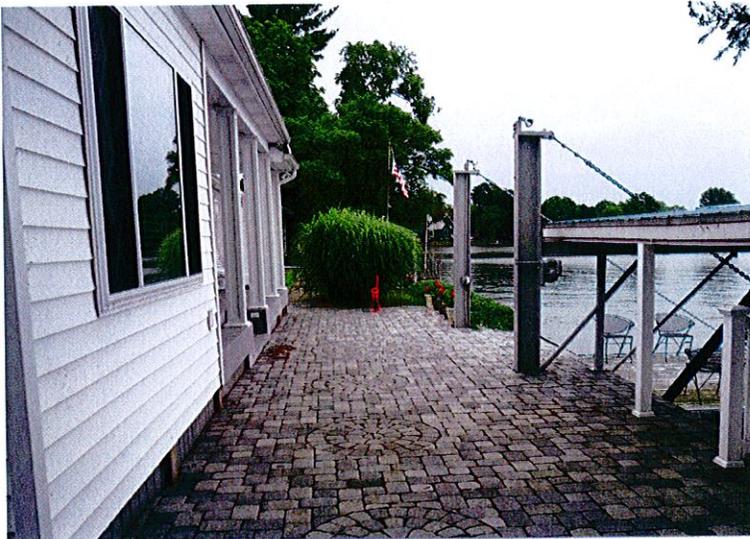
Photograph No. 12:

The upstream slope is covered with concrete pavers. We were unable to inspect the upstream slope. *A digital photo was taken of the pavers on the upstream slope.* No seepage was noted on the downstream slope

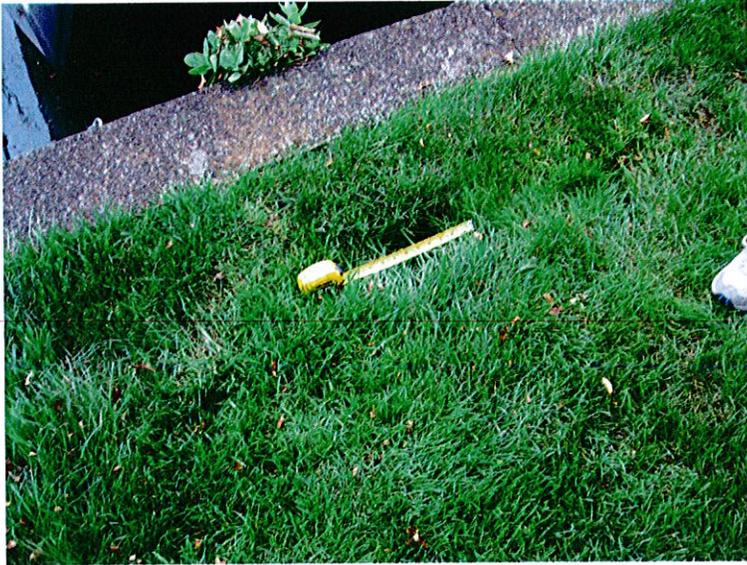
Photograph No. 13:

Near station 30+50, a low area was noted approximately 1 foot in diameter and 6 to 8 inches deep. Another low area, noted at station 30+75, was 7 feet from the upstream wall, approximately 3 feet in diameter, and 14 inches deep. *A digital photo was taken of this area and is included in this report.*

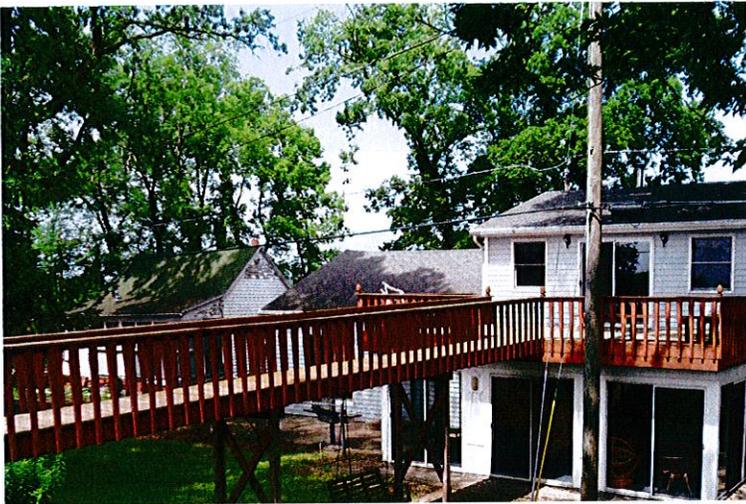
Photograph No. 26:

A depression 0.5 foot deep was observed along the stone wall at station 50+25. A tree had been removed near station 50+50. Two survey monuments were observed on the downstream slope near station 50+80. Trees tag nos. 77 & 78 were noted in this section. There is no house located on the downstream slope. *A digital photo was taken of this area and is included in this report.*

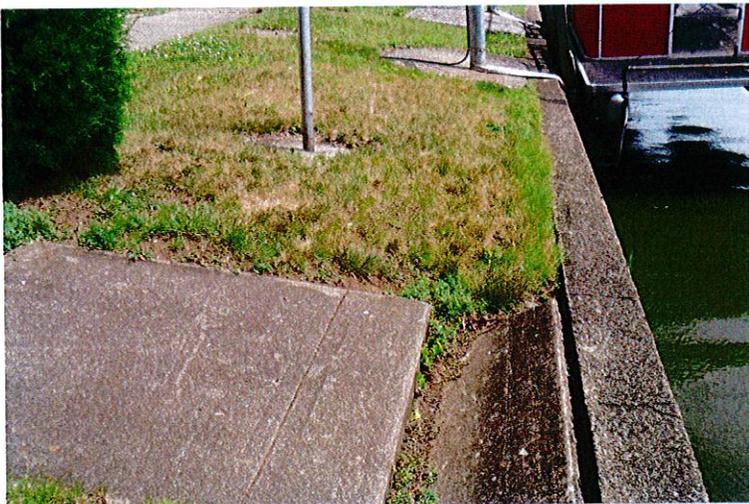
Photograph No. 27:

A recently constructed sidewalk was observed. The older portion of the sidewalk that leads to the stone wall had collapsed. A large tree tag no. 79 was noted in this section. Near station 51+50 on the downstream slope a large tree was noted. *A digital photo was taken of this area and is included.*

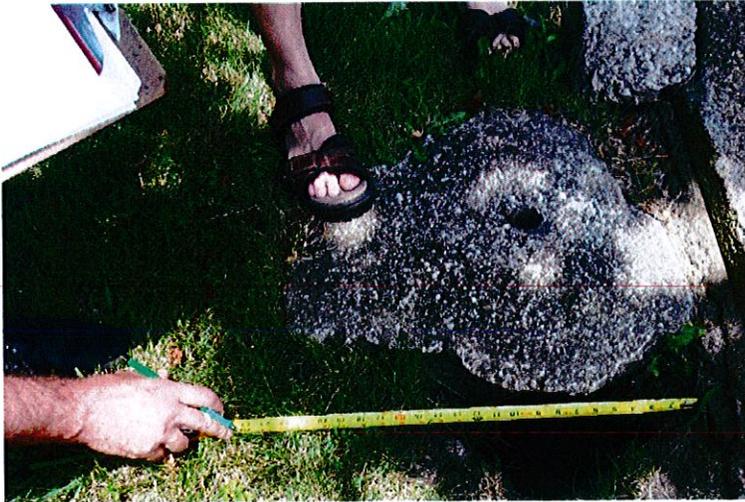
Photograph No. 28:

Fill was 6 inches below the top of the stone wall. A large tree tag no. 95 was noted in this section. A sinkhole near station 58+68, that was 13-inches in diameter and 3-feet deep was observed adjacent to the upstream stone wall. *A digital photo was taken of this sinkhole and has been included in this report.*

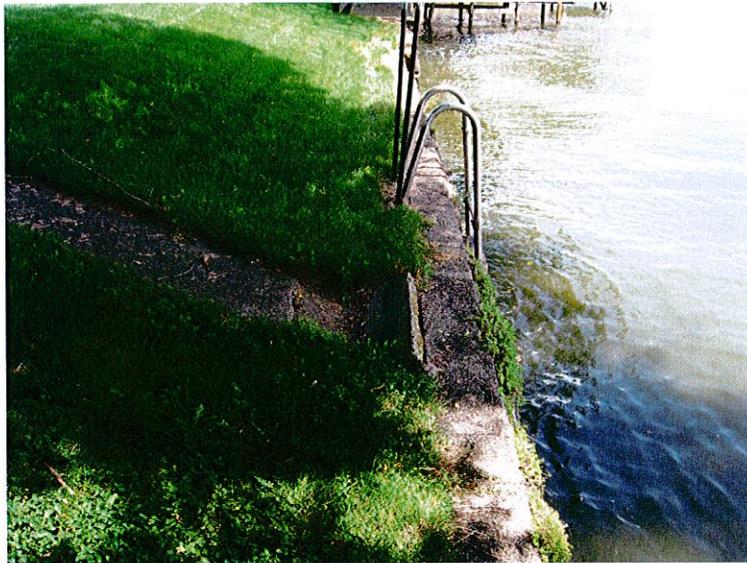
Photograph No. 32:

Three trees tag nos. 98, 99, and 100 were noted on the upstream slope. The upstream embankment contained a low area (0.5 foot deep) near the stone wall at an approximate station of 60+15. *A digital photo was taken of this area and is included in this report.*

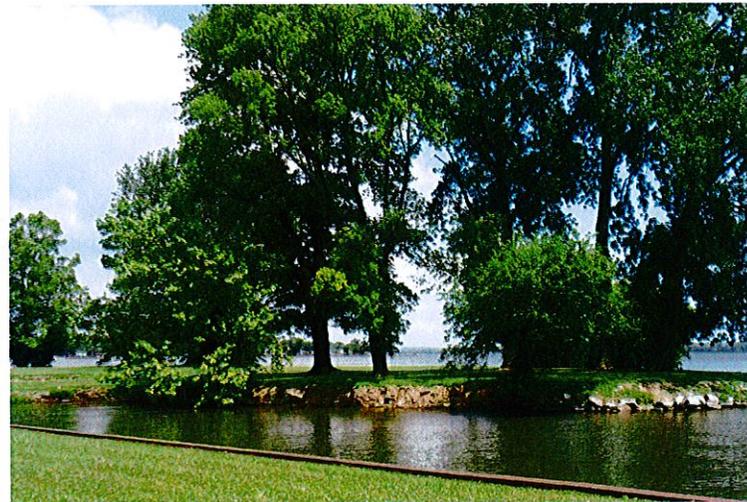
Photograph No. 33:

No problems were noted. New sheet piling had been installed along the upstream slope. *A digital photo was taken at this station and included in the report.*
