**OVERVIEW**  
**BUCKEYE LAKE DAM**  
**ODNR PHASE III**

**BUCKEYE LAKE DAM  
REVIEW OF EMBANKMENT STABILITY**

**BUCKEYE LAKE DAM  
REVIEW OF EMBANKMENT STABILITY****INTRODUCTION**

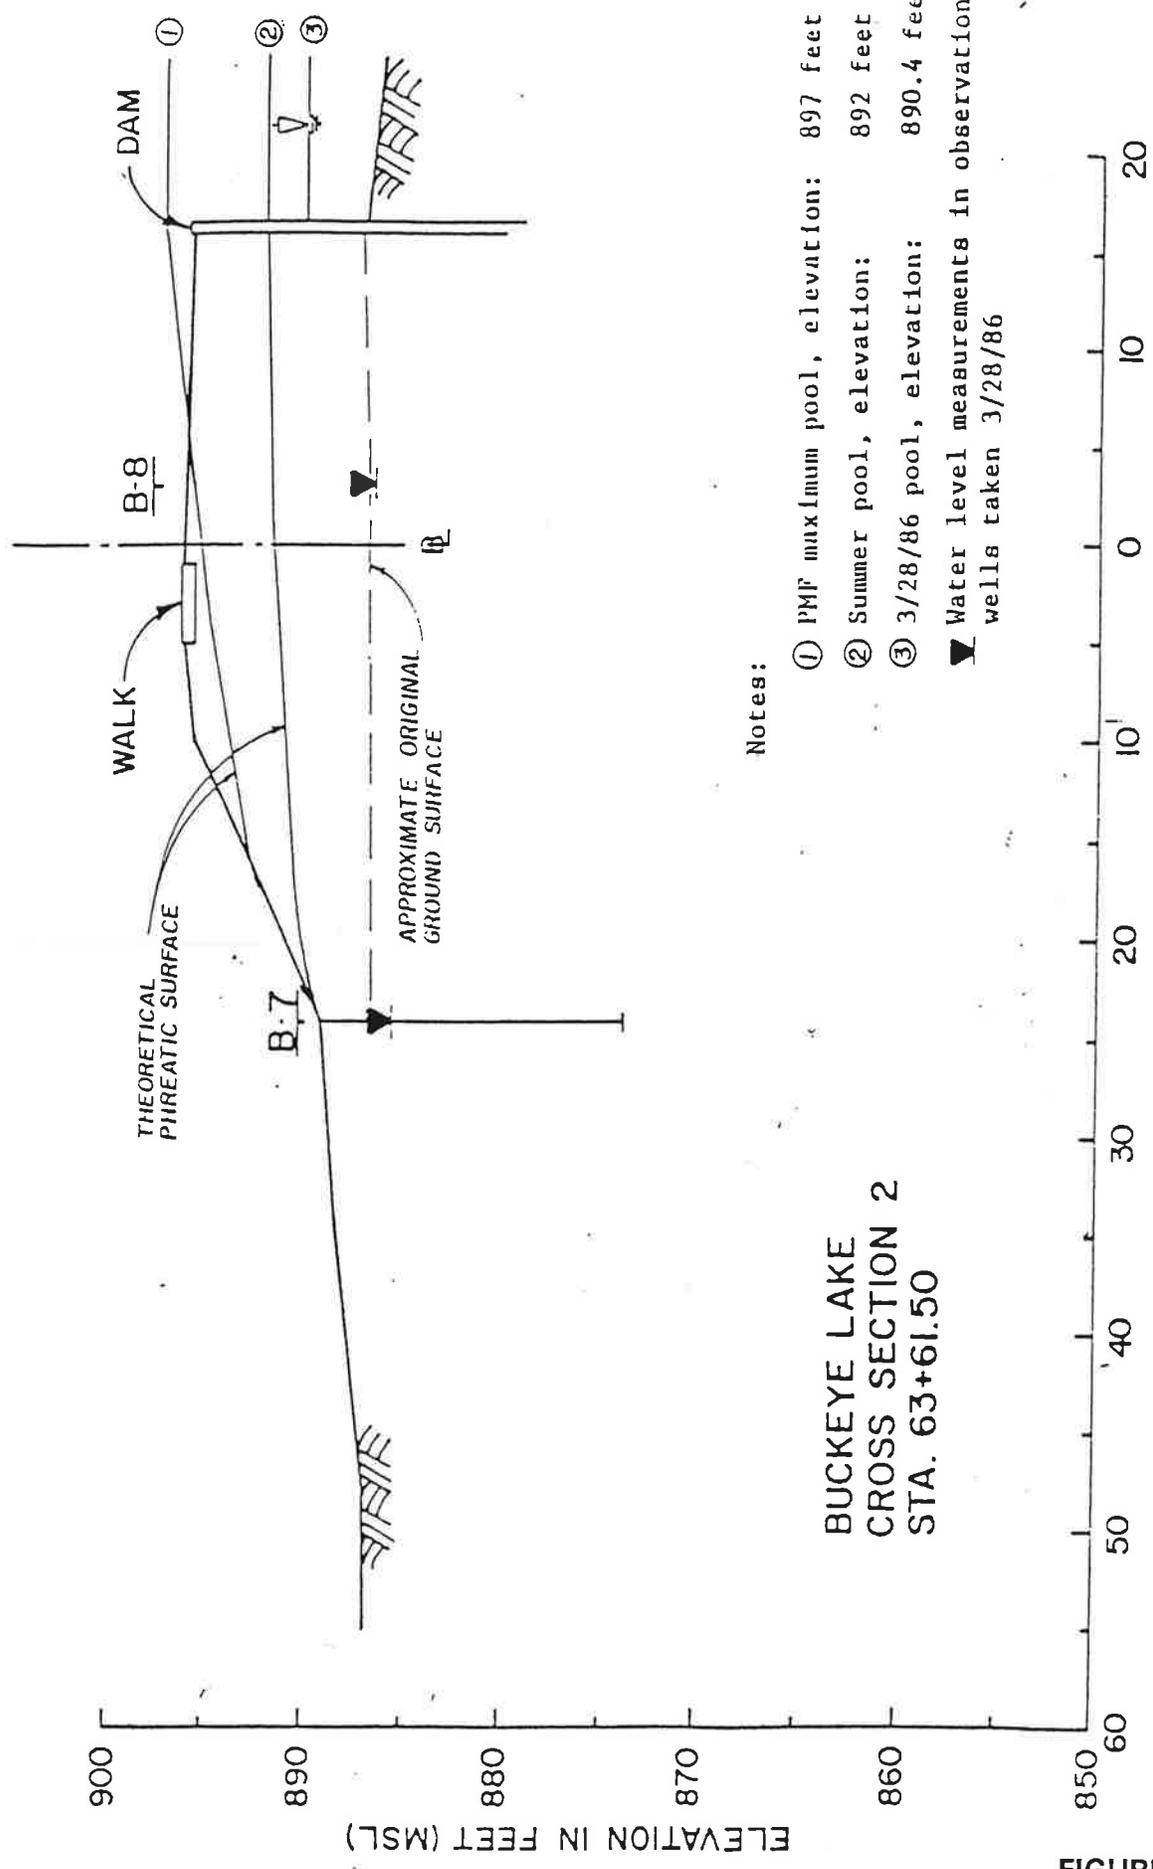
FIGURE 1

In summary, sand and/or silt partings and seams were encountered in the embankment and foundation of the dam, primarily at Cross Sections 2 and 3. In addition, Boring 2A of Cross Section 3 reported significant seepage through the sand seams within the embankment. In Cross Section 4, water seepage was encountered in all of the borings at various depths with the exception of Boring 4A. The seepage was encountered in the foundation soils below the embankment soils at a depth of 6.2 ft. below the dam crest. It is also noted that the current phreatic surface is lower than the summer average.

BUCKEYE LAKE  
 CROSS SECTION 2  
 STA. 63+61.50

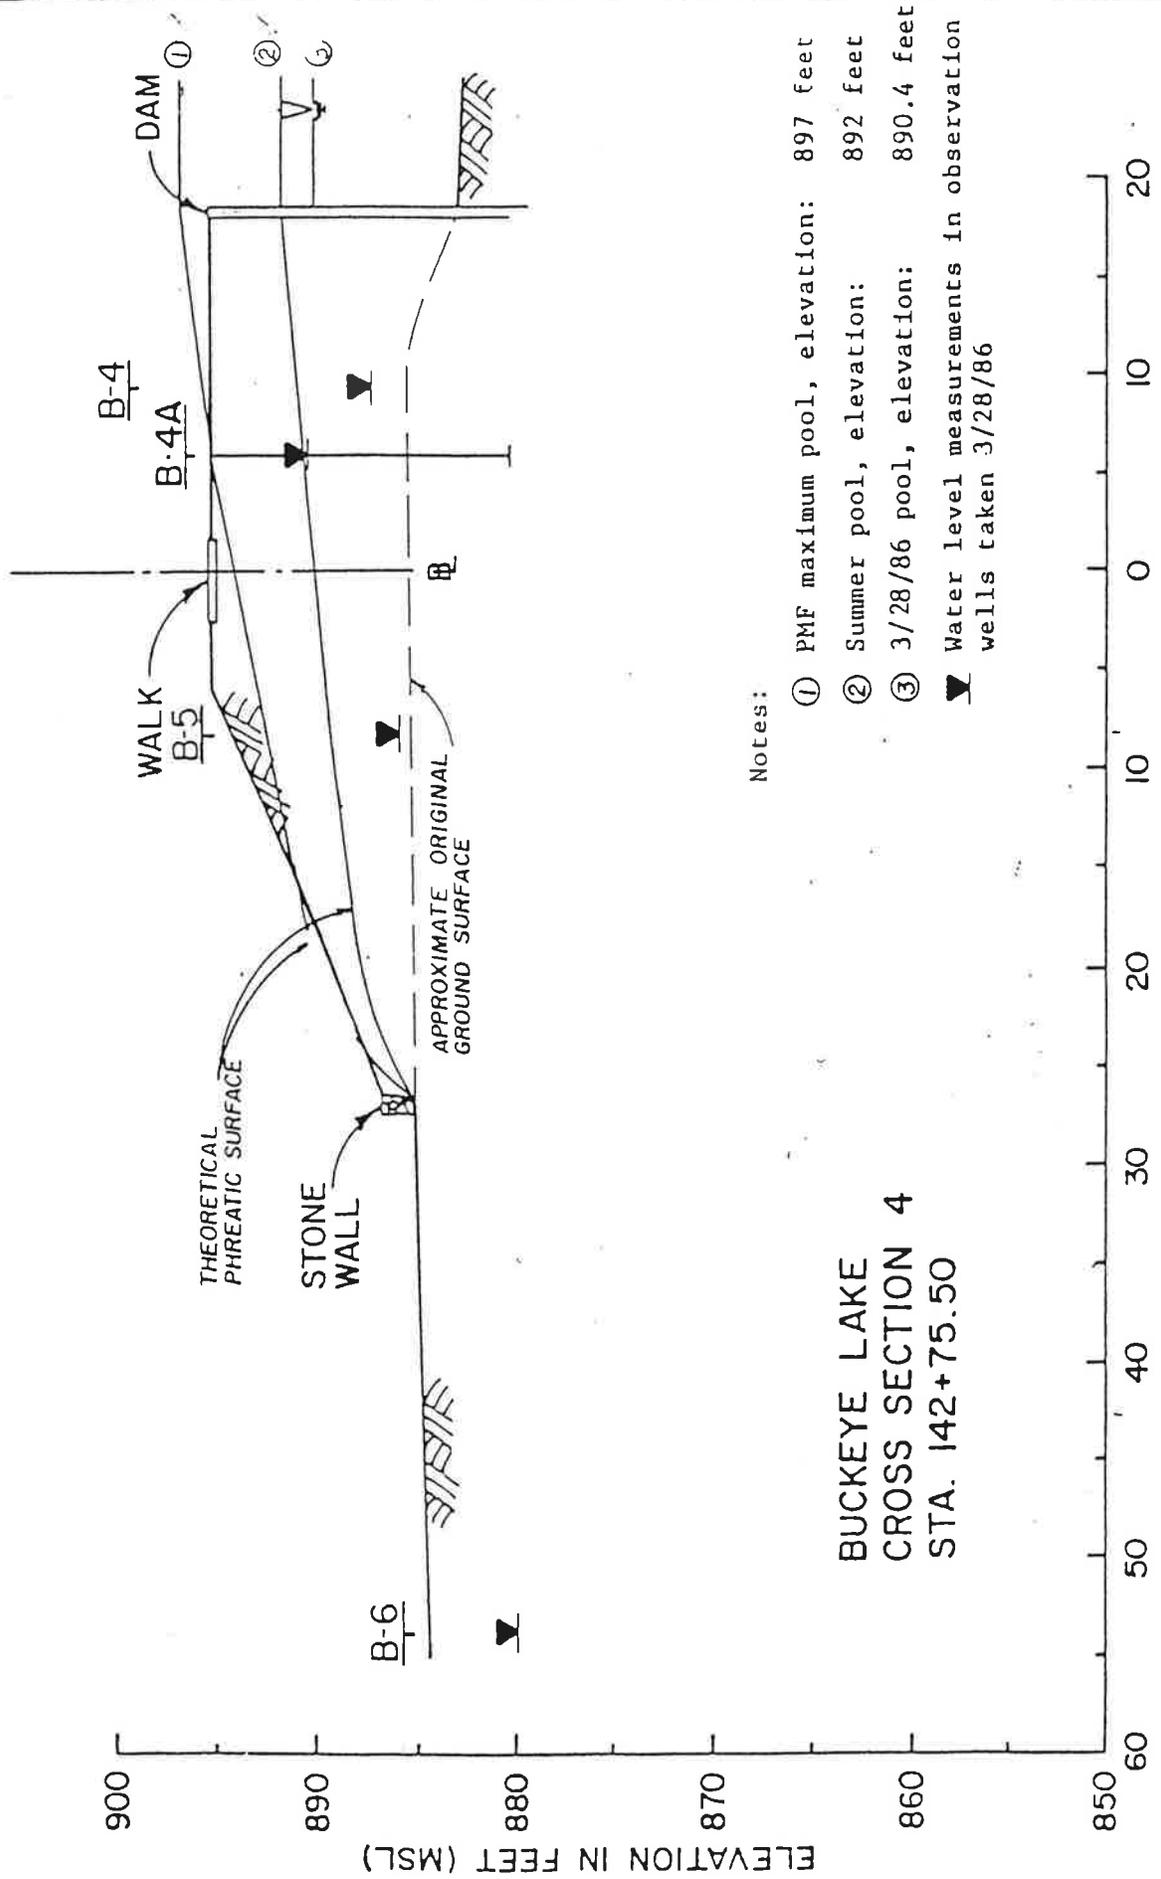
**FIGURE 3**

**BUCKEYE LAKE  
CROSS SECTION 4  
STA. 142+75.50**

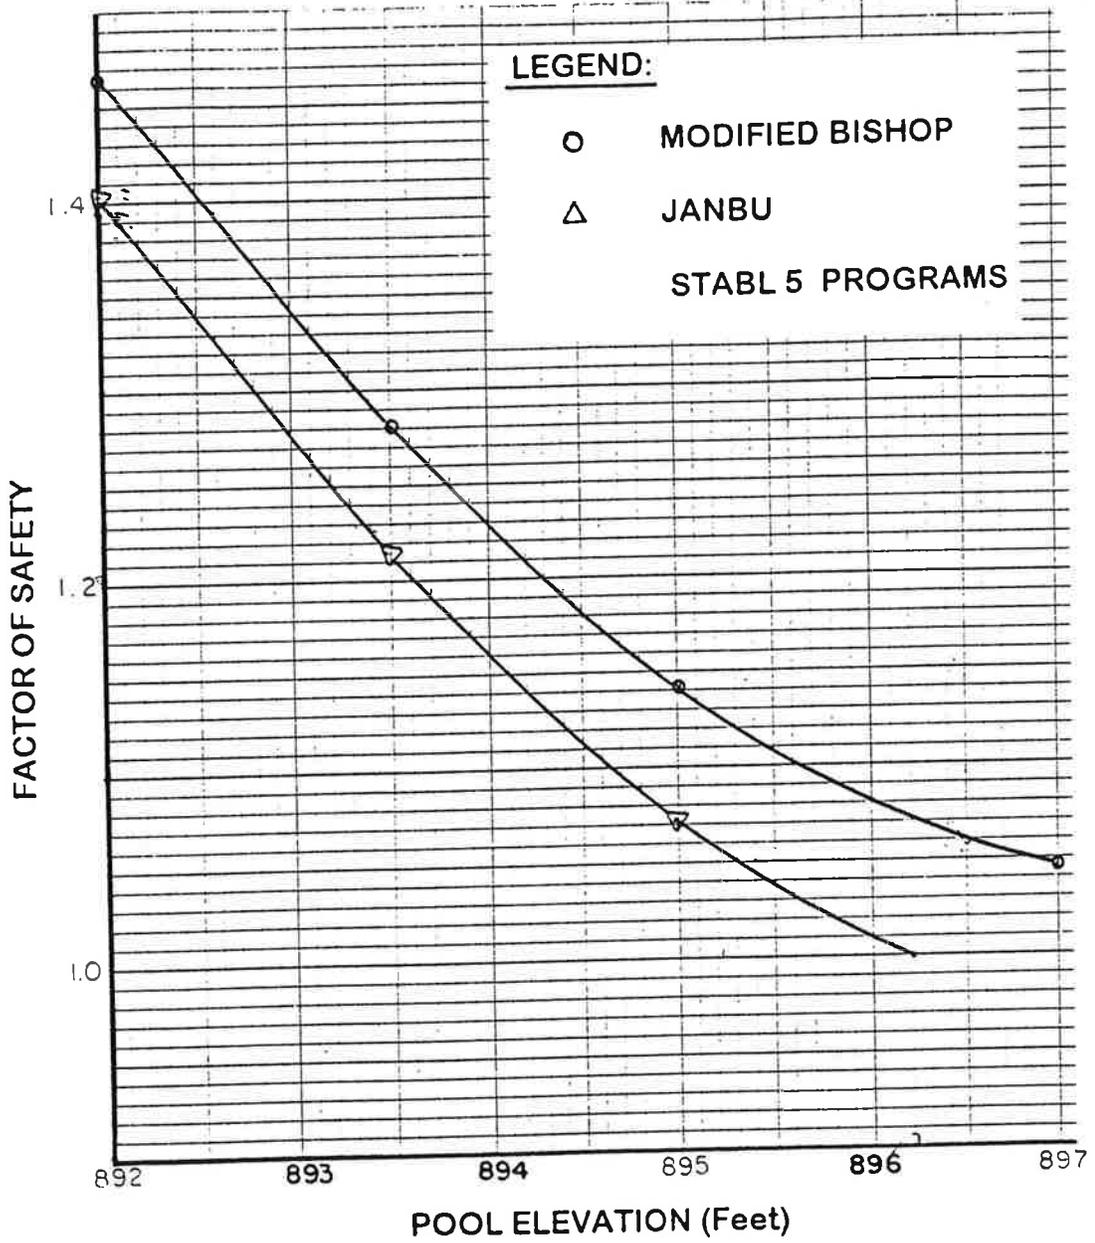
**CROSS SECTION 2  
FACTOR OF SAFETY vs POOL ELEVATION**

Based on the STABL 5 slope stability programs, Figure 4 provides safety factors as a function of the pool elevations of the dam. Thus, safety factors for a variety of pool elevations can be determined for both the Modified Bishop and Janbu slope stability analyses.

Based on the results of the independent stability analyses, it is concluded that the DLA study has been reasonably conservative in predicting safety factors for the Buckeye Lake Dam. The most significant findings are the low safety factors found in Cross Section 2, whereas the safety factors of Cross Sections 3 and 4 have significantly larger safety factors. As shown in Table 3, the safety factor is marginal with a pool at and above elevation 895. This is indicated by a safety factor of essentially 1.0. In addition, there are other factors that further increase the risk of failure. These include seismicity effects and the probability that there will be less stable embankment zones within the dam which have not been investigated.

In summary, analysis of Buckeye Lake Dam indicates that the embankment is unsafe at pool elevations much above 892. At this elevation, the factor of safety against failure is essentially 1.5 which meets conventional safety standards, and is strongly recommended. It is also prudent to provide the dam a freeboard of at least 3 ft. (to elevation 895) and is also a recommended safety provision. The plan by ODNR to construct a parapet wall around the dam to accommodate the PMF is unsafe as a temporary raise in the pool elevation to 896.5 would most likely induce an embankment failure. Consequently, it is recommended that the PMF be accommodated by other means, such as adding an additional spillway.

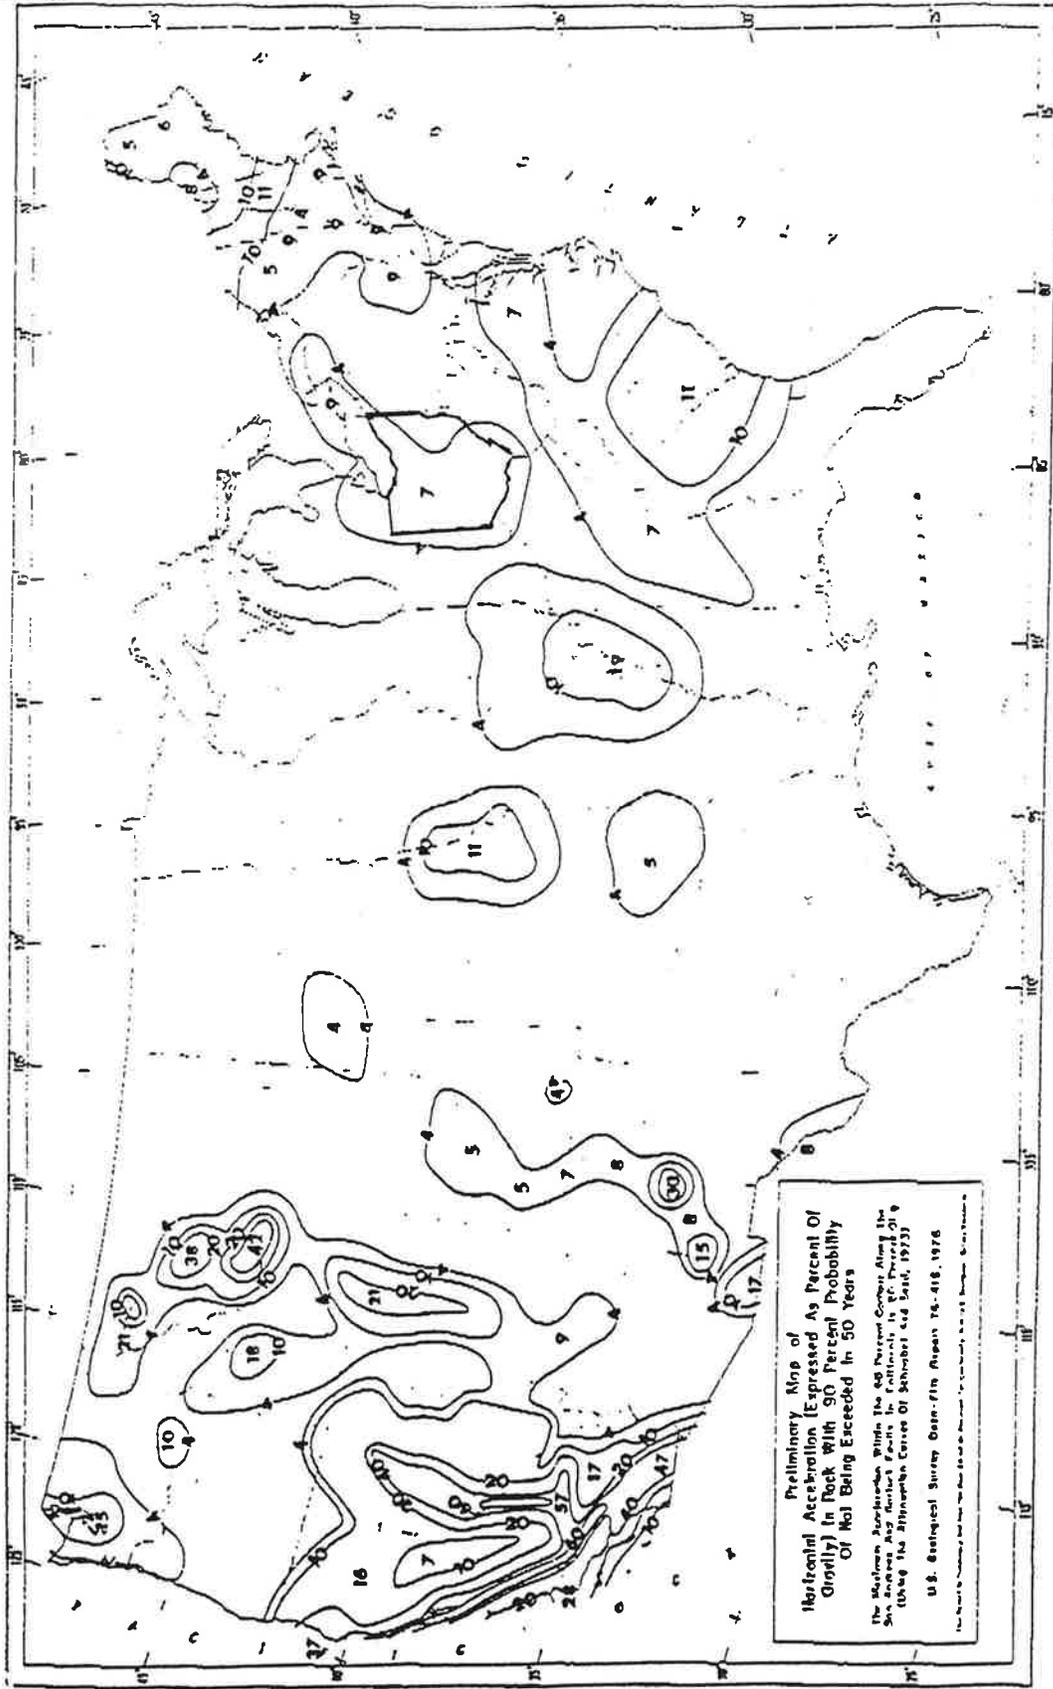
FIGURE 5  
HORIZONTAL ACCELERATIONS FOR  
500-YEAR RETURN PERIOD

Seismic occurrence relatively near Buckeye Lake significantly reduces the stability of the earth dam. In this regard, two concentrations of earthquakes are evident in Ohio. Based on the Earthquake History of the United States (1970), the largest of these is located in the northwestern part of the State near the town of Sidney. The largest shock in this area was recorded as an MM VII-VIII<sup>1</sup> (7.5) earthquake, the largest of the historical record. The other concentration of earthquakes is in southeastern Ohio and are most active in the vicinity of Meigs County and its environs. The largest earthquake in this area occurred in 1926 at Zanesville which is about 21 miles from the Buckeye Lake Dam. This earthquake had an intensity of MM VI-VII (6.5).

Conservatively assuming an earthquake similar to the Zanesville shock, the maximum horizontal acceleration near the dam site is 0.10 g, where g is the acceleration due to gravity. Seismic risk studies have been conducted throughout the U.S. by a number of investigators. In this regard, Algermissen and Perkins (1976) provide contours of horizontal acceleration for a return period of 500 years (see Figure 5). Using the risk level for the State of Ohio, the maximum horizontal acceleration near the site is interpreted as 0.06 g.

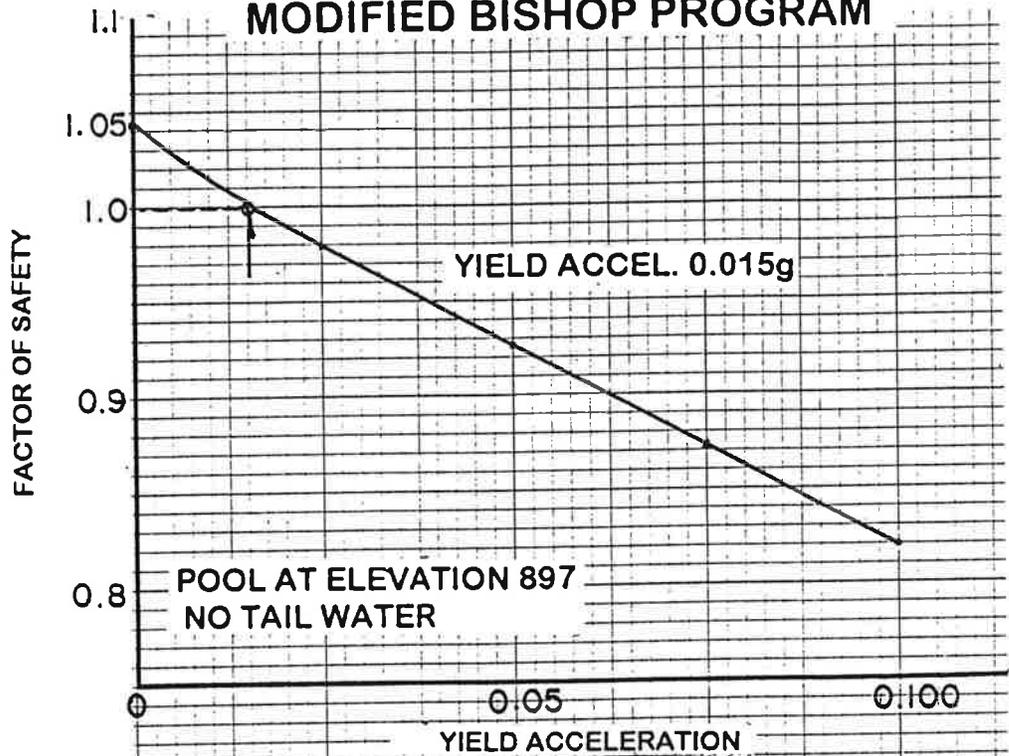
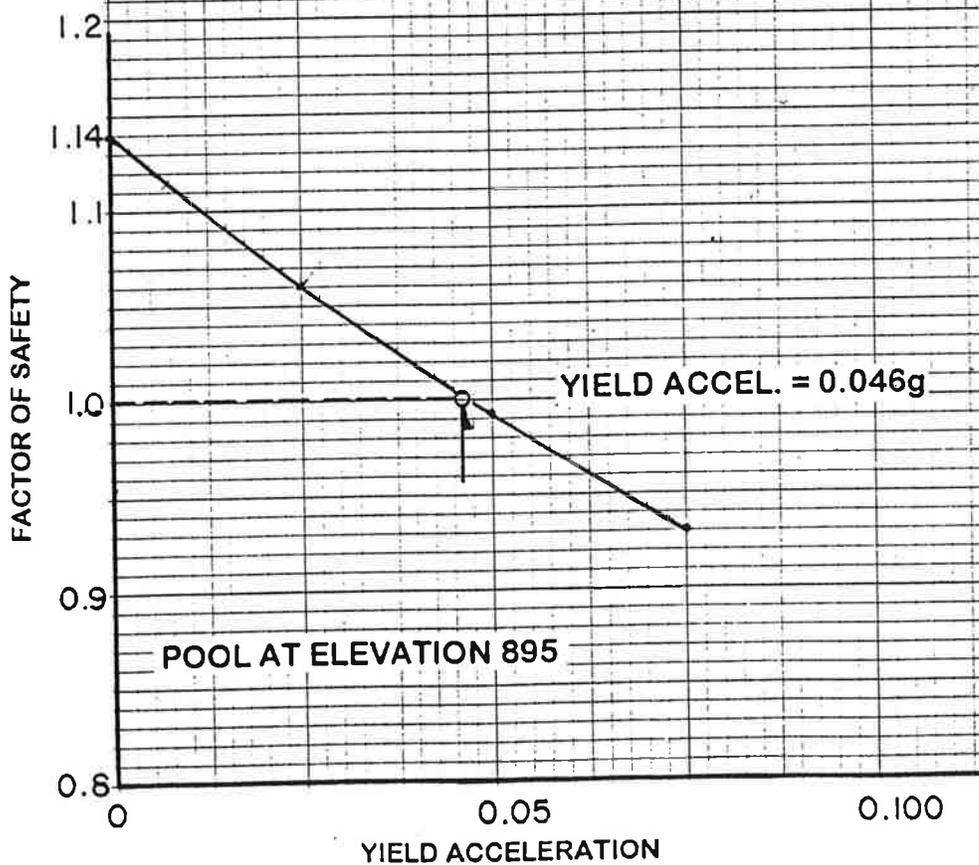
FIGURE 6

To evaluate the effect of seismicity in the dam vicinity, pseudo-static analyses were conducted to investigate the yield accelerations of the embankment, i.e. the acceleration required to produce a safety factor of 1.0. The yield accelerations, ( $k_y$ ) plotted are shown by Figures 6 and 7. With one exception, these analyses have been conducted using the Modified Bishop program. The yield acceleration for the elevation 895 pool was also calculated, using the Janbu slope stability analysis for comparison with the Modified Bishop analysis. As indicated, the yield accelerations range from 0.015 g to 0.138 g which correspond to pool elevations of 897 and 892, respectively. It is noted that the yield acceleration at elevation 892 (0.138 g) is greater than the maximum acceleration for southeastern Ohio (0.06 g) and, therefore, does not fail. This is consistent with the calculated Safety Factor of 1.46.

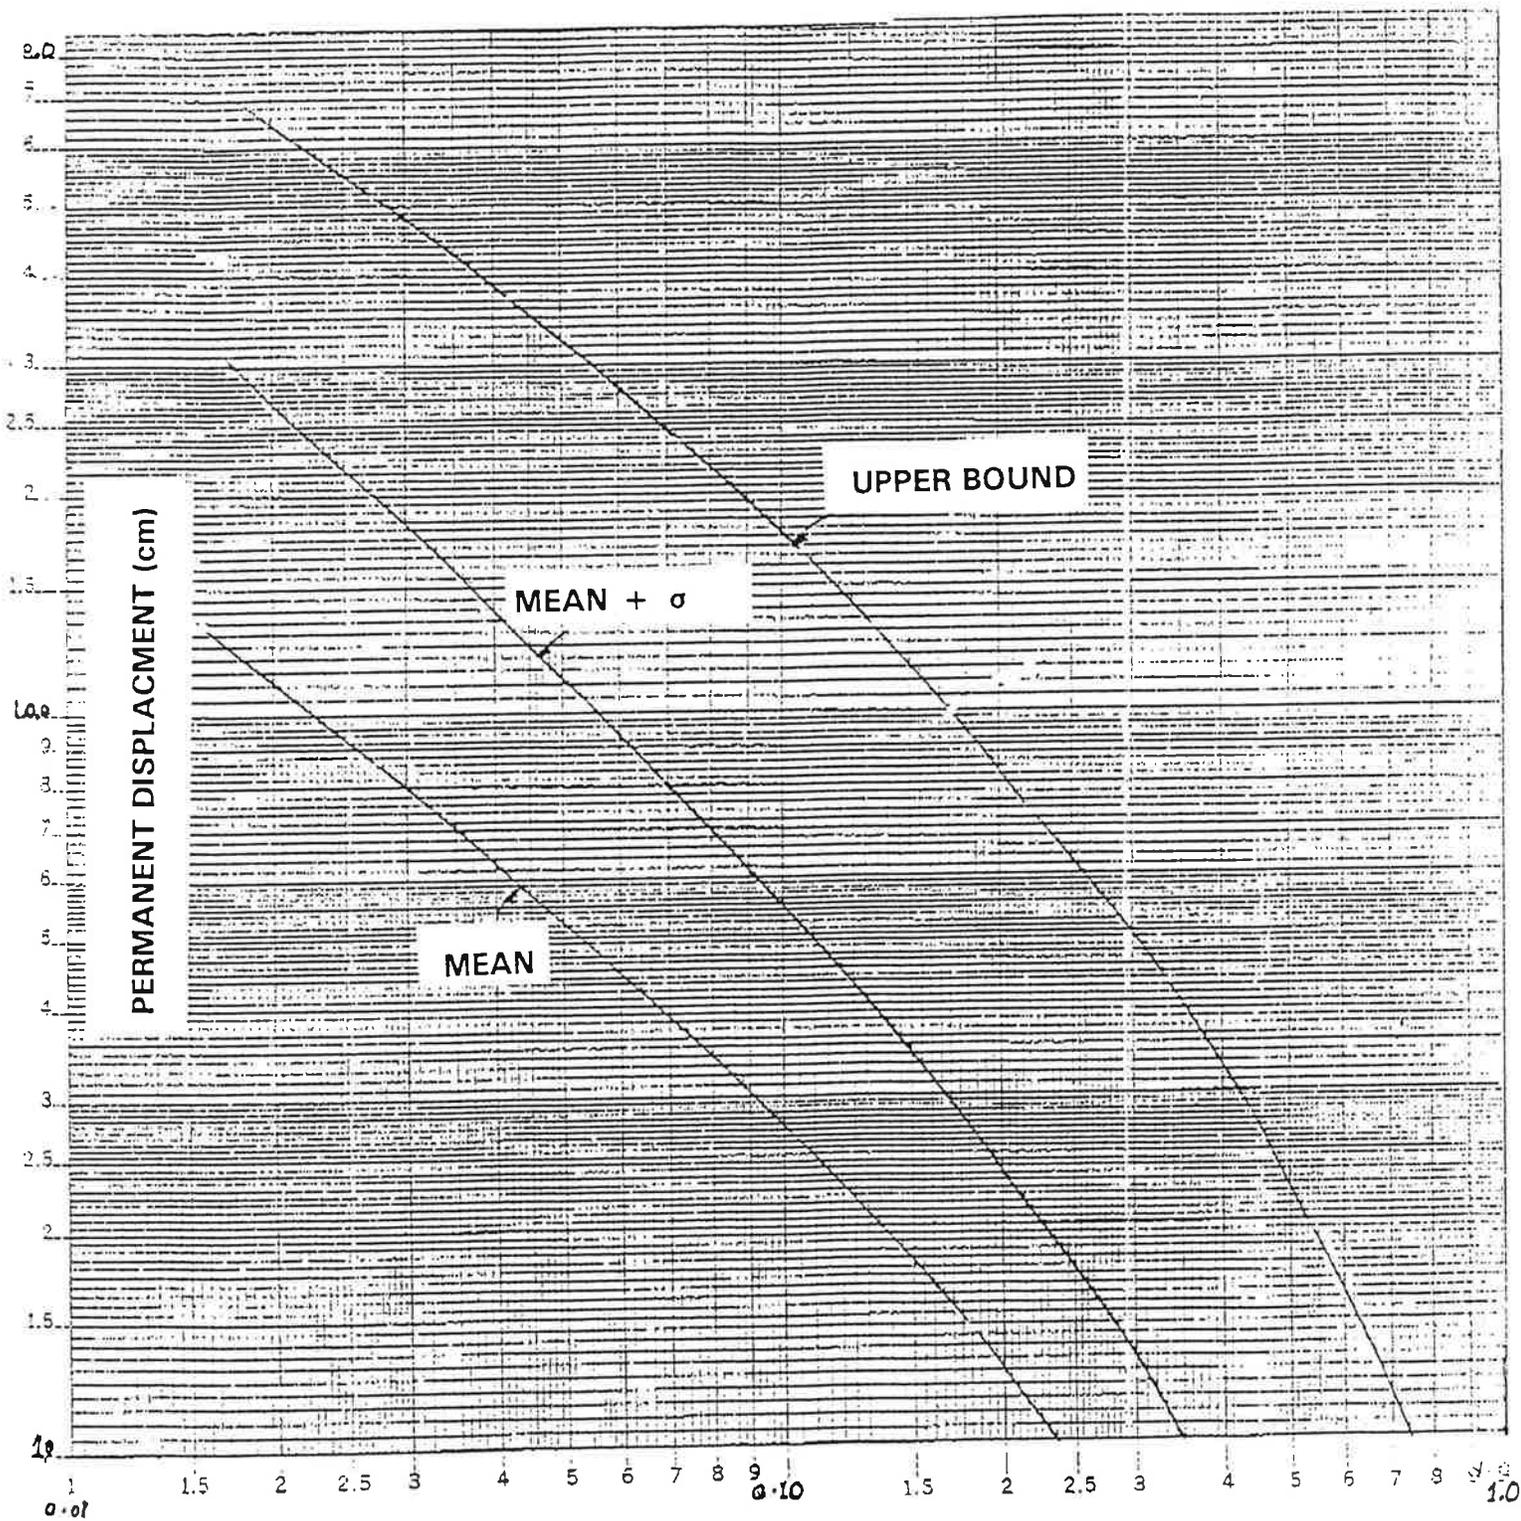
FIGURE 8

Earth dams subject to seismicity may cause significant horizontal displacements of the embankment which may lead to a dam breach. The amount of displacement depends on the yield acceleration ( $k_y$ ) and the maximum horizontal acceleration ( $A_{max}$ ) of the earthquake. Following Hynes and Franklin (1984), the data required for the displacement analysis is the maximum horizontal acceleration (0.10 g) and the yield accelerations calculated previously. The displacement relationship, given by Figure 8, conservatively utilizes the mean +  $\sigma$  of the curve. The results of the displacement calculations are included in Table 4. As anticipated, the largest permanent embankment displacement is 34 cm which will likely fail the dam when the pool elevation is 896.5. A 21 cm displacement of the embankment with the pool at 895 would also likely be sufficient to fail the dam. With the pool at an elevation of 892, the embankment is stable and there is no displacement during the maximum earthquake.

DISPLACEMENT OF EMBANKMENT  
AFTER HYNES & FRANKLIN (1984)
