DLA'S RESPONSES TO GARDNER AND ASSOCIATES' REPORT

The purpose of this letter report is to address several issues presented in a report prepared by W.S. Gardner and Associates (WSGA) entitled Review of the Embankment Stability at Buckeye Lake Dam. WSGA's review was performed on a 1987 report of the Buckeye Lake Project prepared by Dodson-Lindblom Associates (DLA) for the Ohio Department of Natural Resources. The issues addressed below concern the presence of sand seams within the embankment, the potential for piping, the results of stability analyses, and the potential for embankment saturation occurring at higher pool levels.

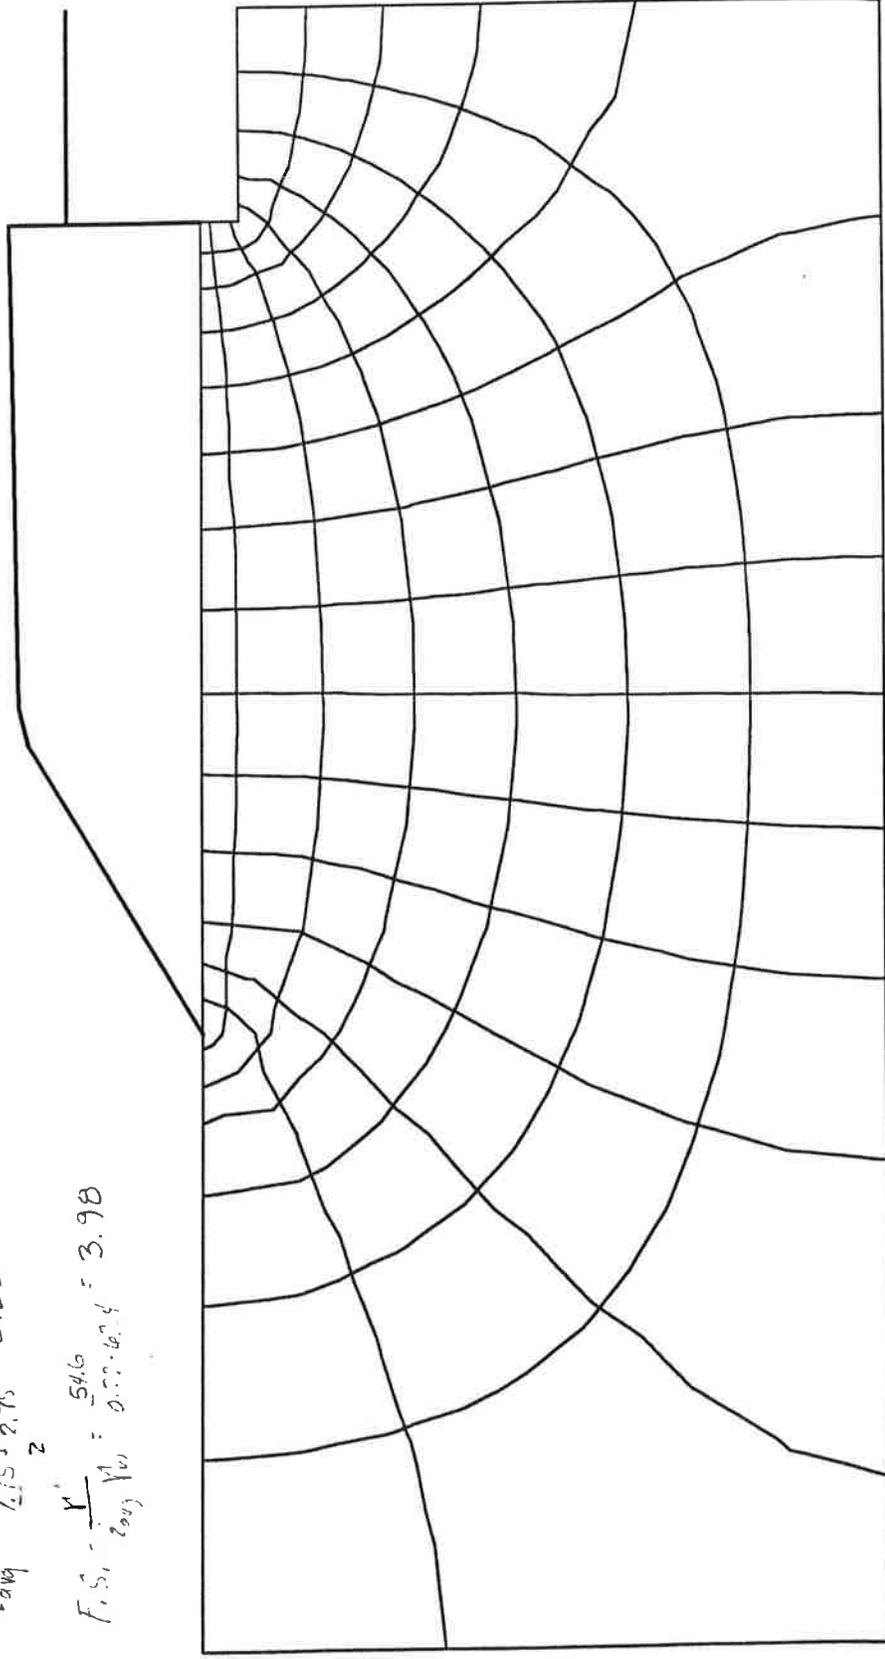
Section 3 - No sheet piling
Pool - 892'

Section 3 was analyzed since it was considered most critical, i.e., largest head and shortest seepage path length. The embankment was assumed to be impervious and seepage was confined to the foundation soils. This section was analyzed both with and without the existing sheetpile wall in place assuming the pool at the spillway crest elevation of 892. Even without the sheetpile wall, the exit gradient was 0.22,

which results in a safety factor of 4.0 against piping. With the sheetpile added to the section, the seepage path length increases, and, obviously, results in an even higher safety factor against piping. We would generally consider a minimum safety factor of 3.0 to be adequate.

$$z_{avg} = \frac{0.5'}{1.75' + 2.75'} = 0.122$$

$$F.S. = \frac{M}{z_{avg} W} = \frac{5416}{0.55 \cdot 67.4} = 3.98$$
