REPORT
BUCKEYE LAKE DAM STABILITY STUDY
BUCKEYE LAKE STATE PARK
FAIRFIELD, LICKING, AND PERRY COUNTIES, OHIO
DNR 736 730-96-034

PROJECT No. 95-1590
MAY 1997

PREPARED FOR:
OHIO DEPARTMENT OF NATURAL RESOURCES
COLUMBUS, OHIO

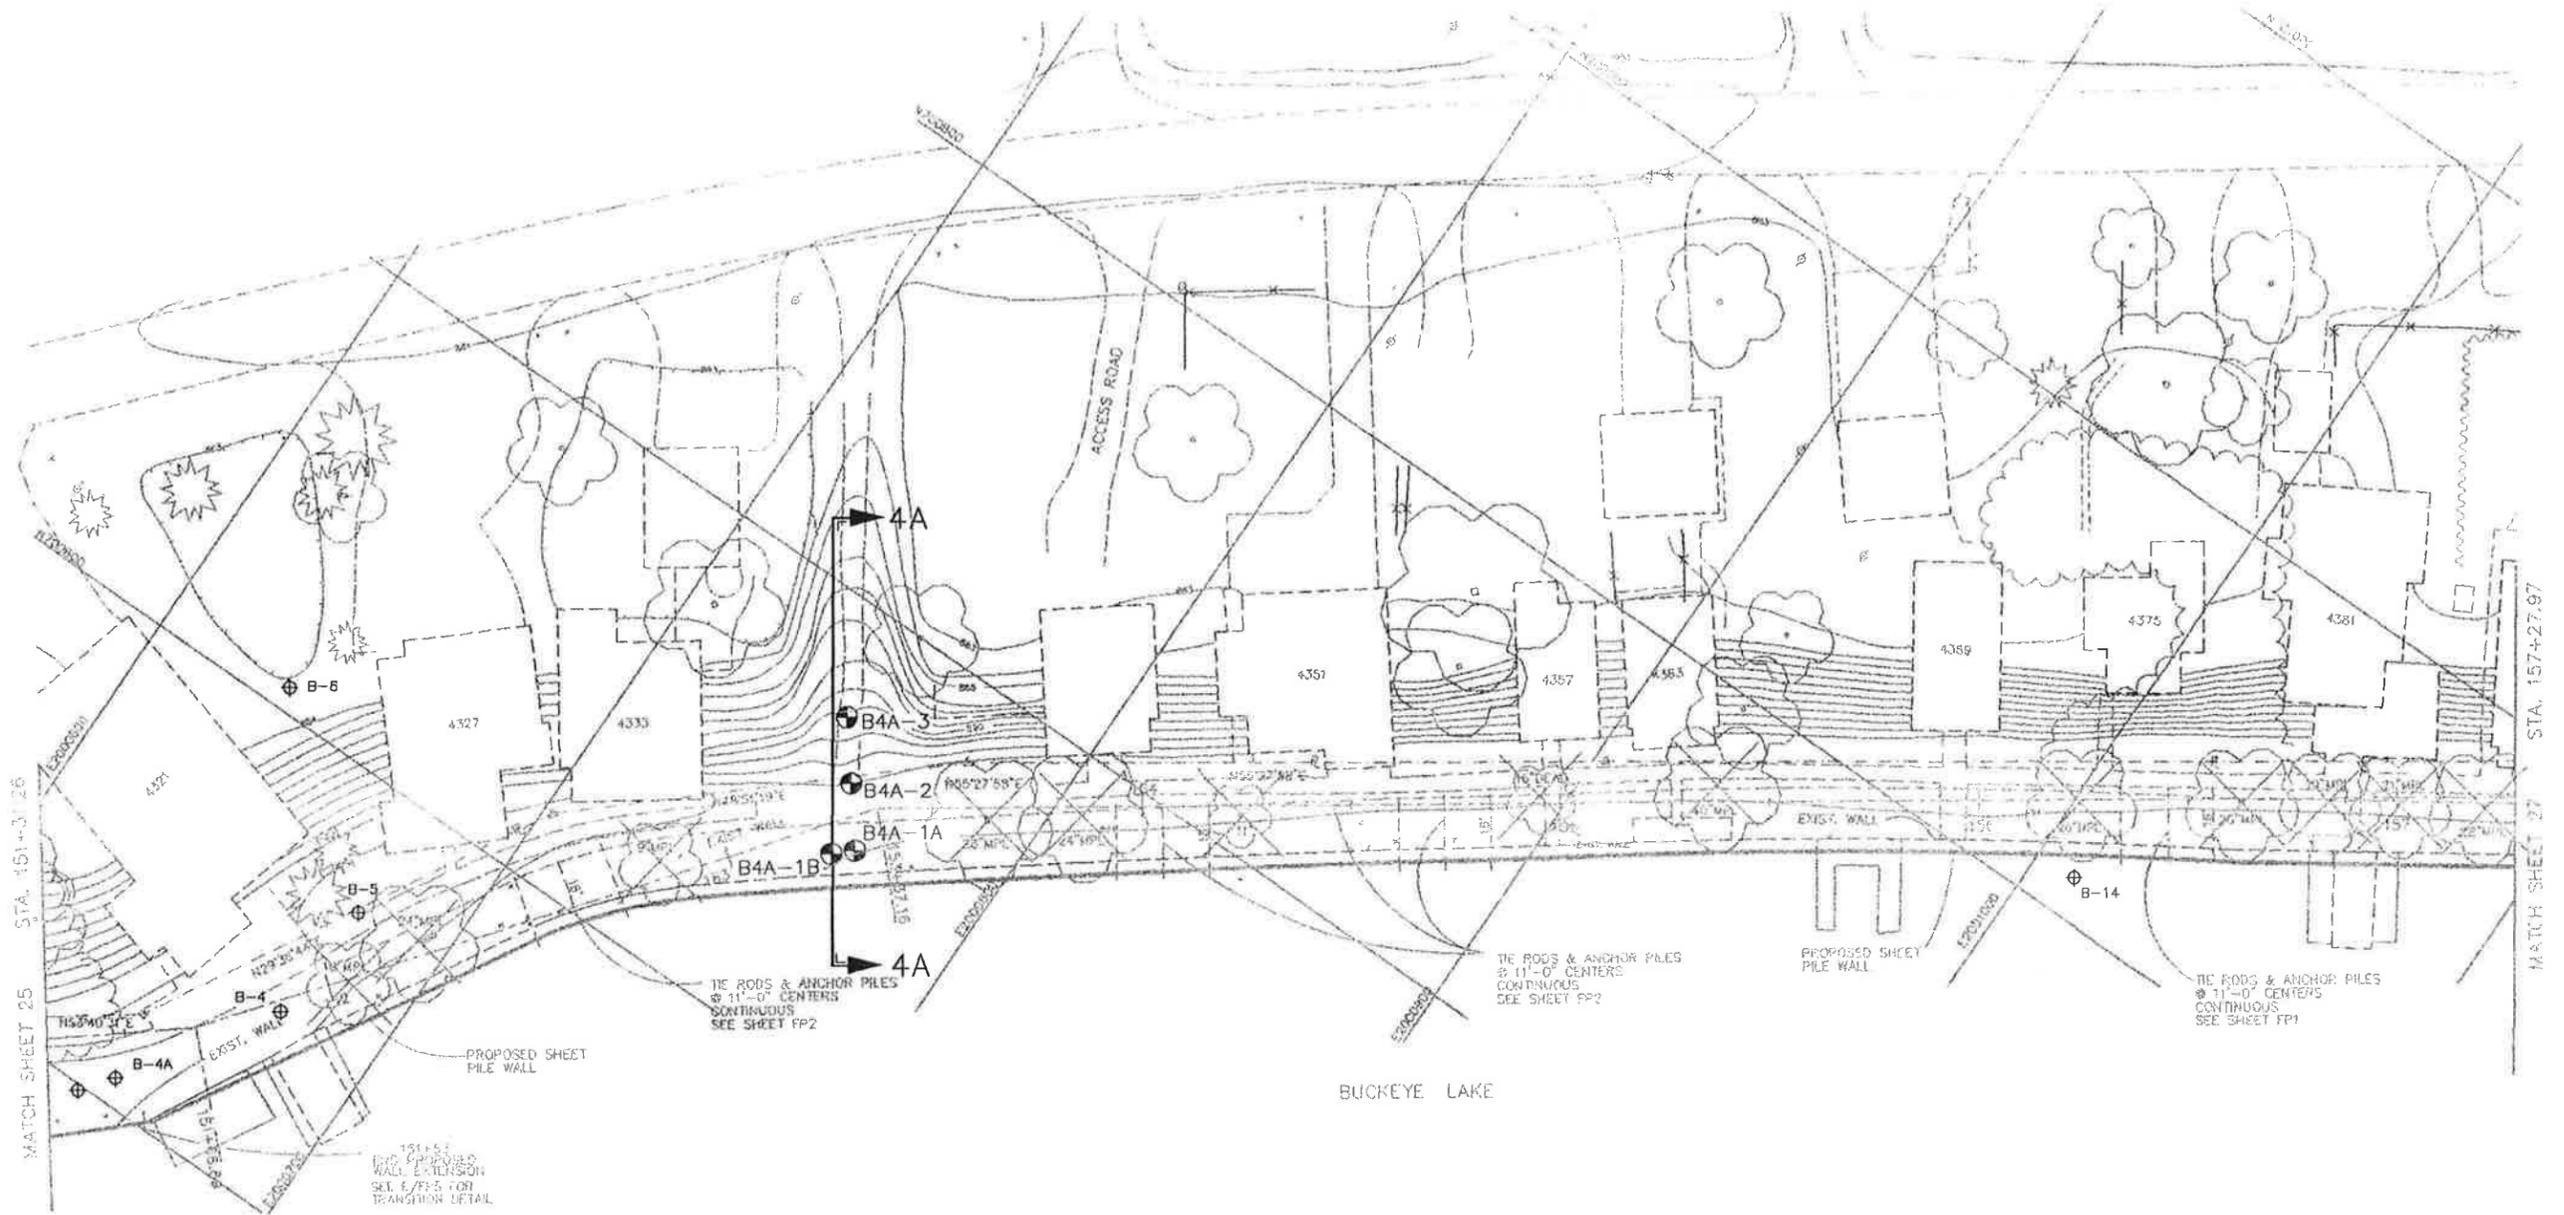
FIGURE 2-9

Section 4A shown on Figure 2-9 is located on the North Bank of the Dam as shown on Figures 2-1 and 2-8. The B4A-series Borings were also drilled along a state-owned fire lane built on the downstream side of the Dam. The typical ground surface was surveyed adjacent to the fire lane ramp and is shown on Section 4A as the projected ground surface.

Three of the four Piezometers at this section are dry causing the interpretation of the position of the phreatic surface shown on Figure 2-9 to be somewhat complicated. The dry Piezometers indicate that the Fill and upper portion of the foundation soils at this location are unsaturated, which is important information for the stability analysis. Otherwise, a significant head drop is seen from the Lake level to the Embankment Fill as indicated by the dry Piezometer at B4A-1A. It is likely that an upward vertical gradient exists between the 1A (shallow) and 1B (deep) nested Piezometers, indicating flow around the sheetpiling from below.

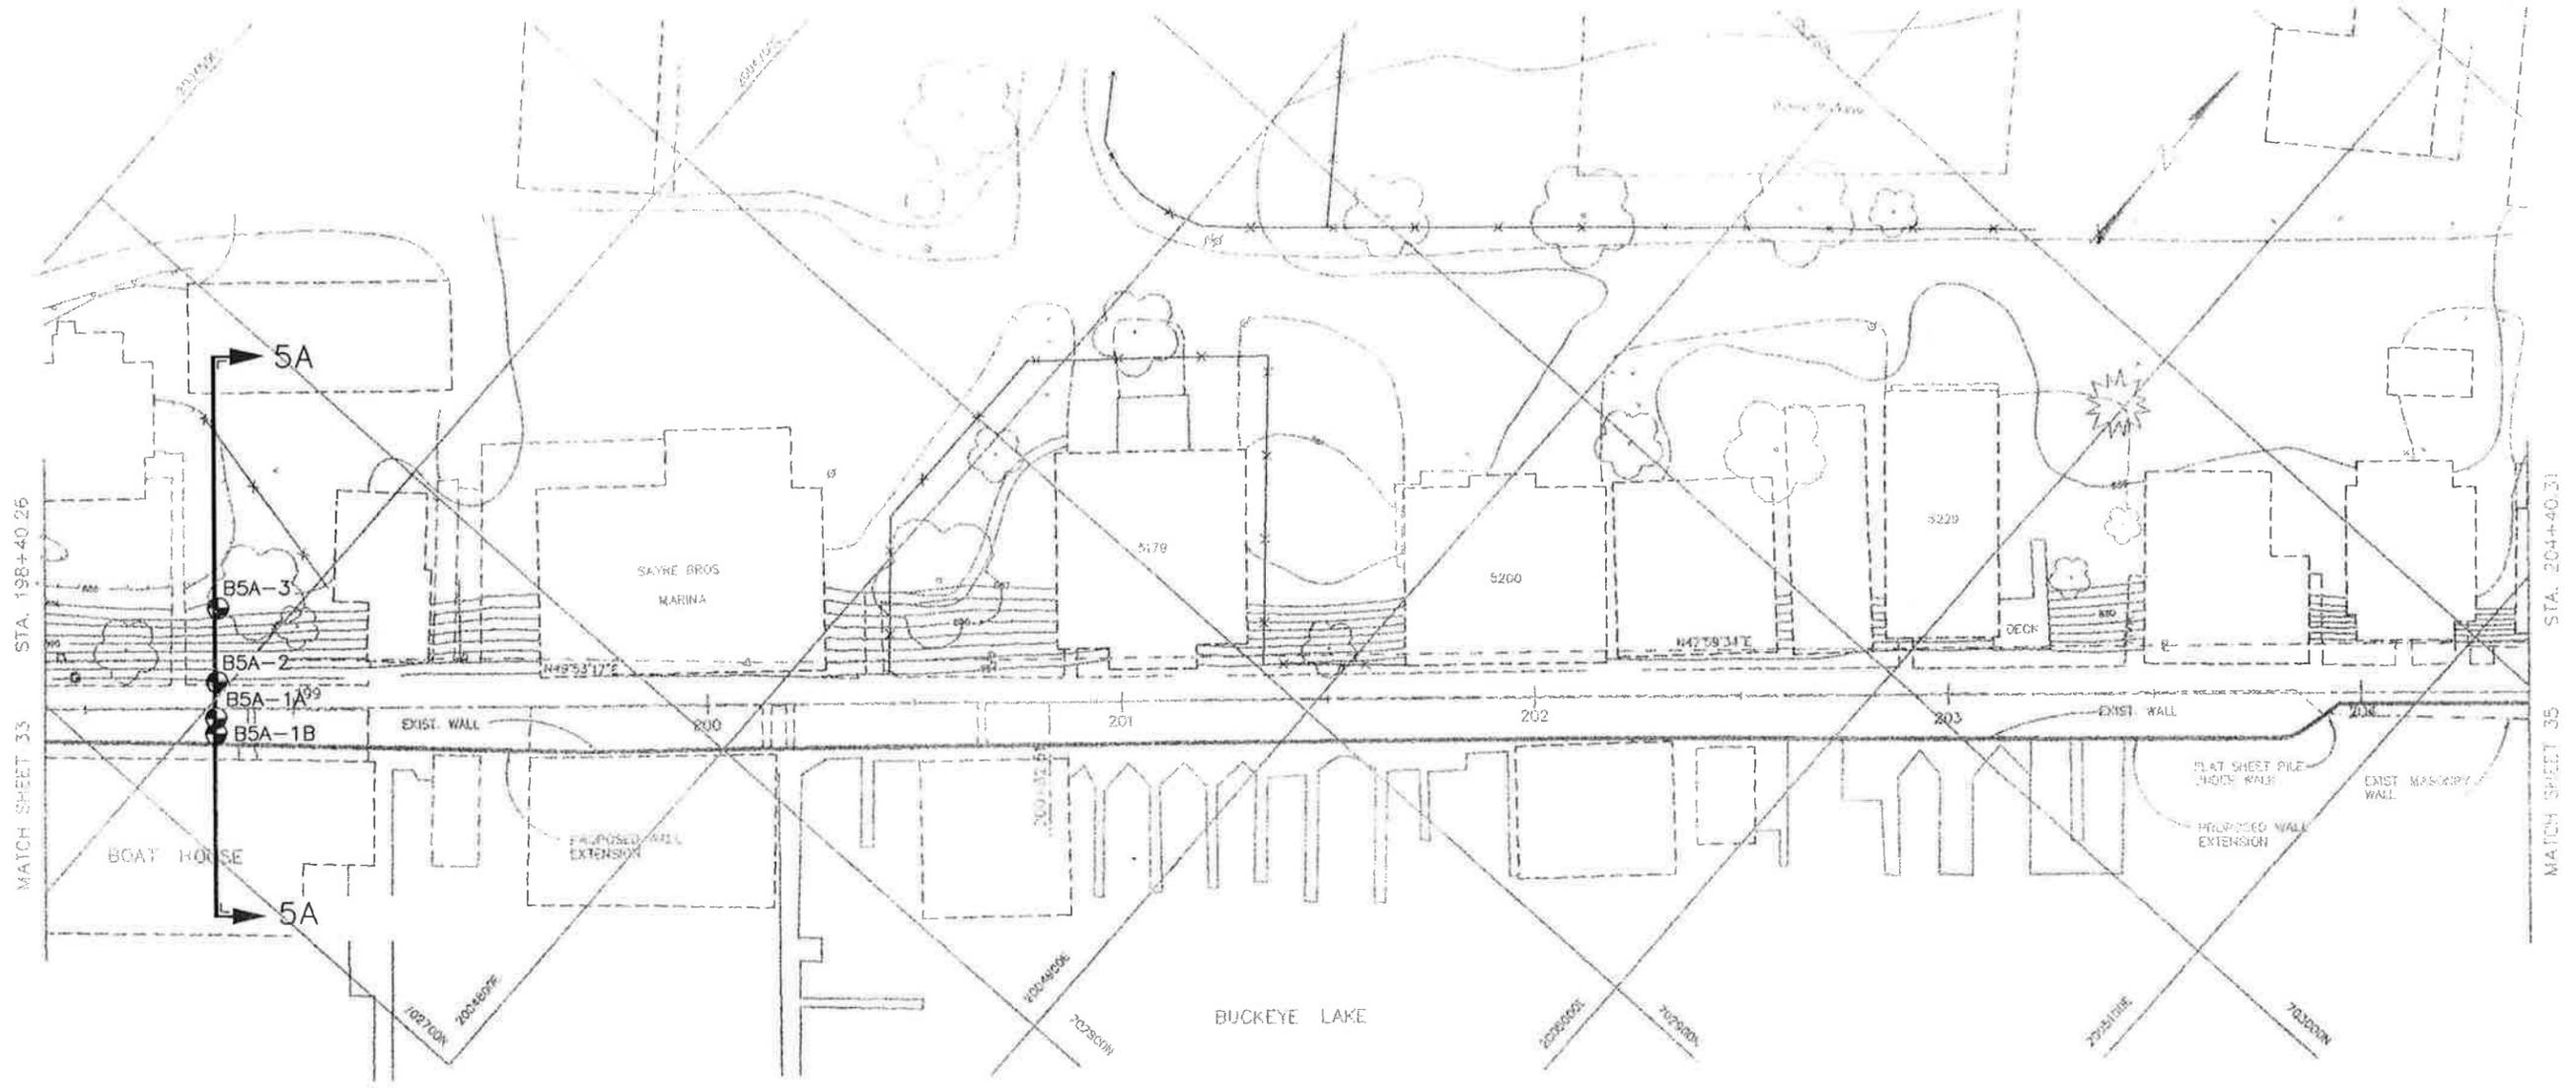
FIGURE 2-11

Section 5A shown on Figure 2-11 is located on the North Bank of the Dam as shown on Figures 2-1 and 2-10. The Embankment Fill materials along this section line have an approximate maximum thickness of 6.0 feet and consist of silty clay to clayey silt, with a trace to some sand, a trace of gravel, and very soft to stiff. A four foot thick sand and gravel deposit was encountered to a depth of approximately four feet at Boring B5A-1B. This coarse grained deposit does not appear to be saturated and is discontinuous.

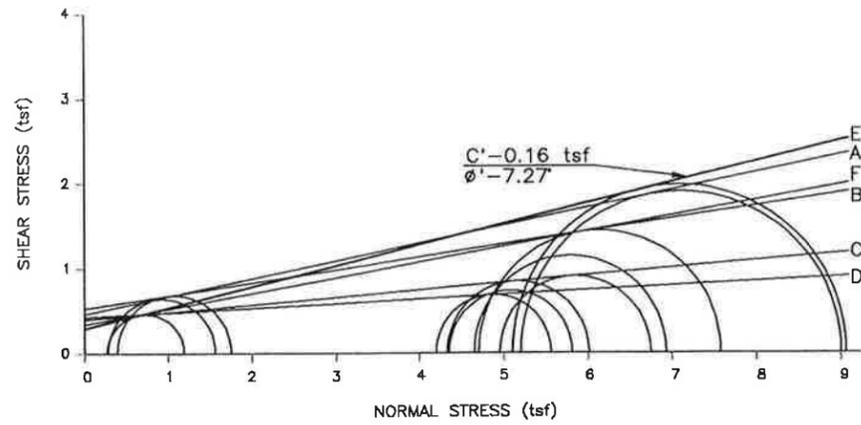
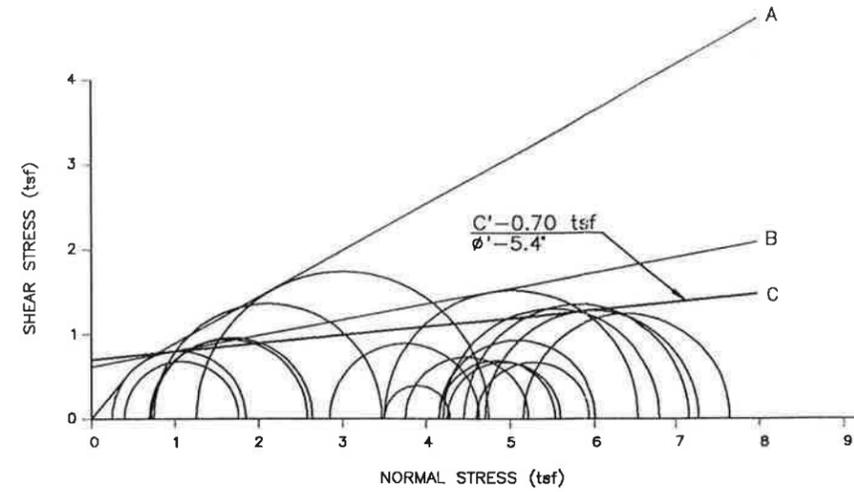
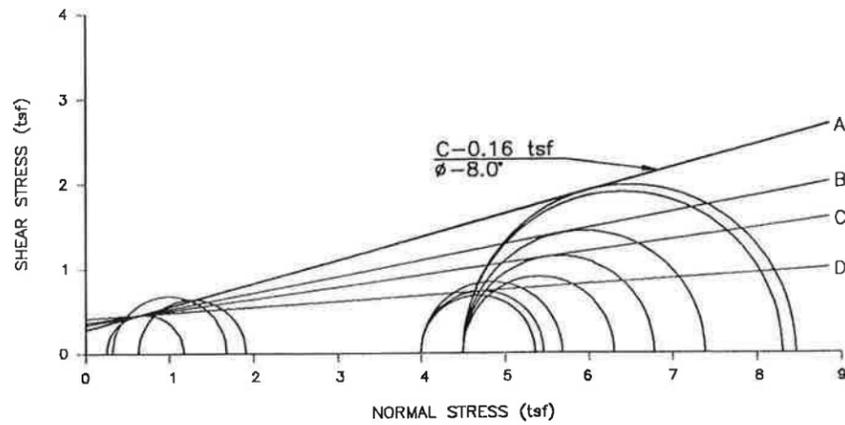
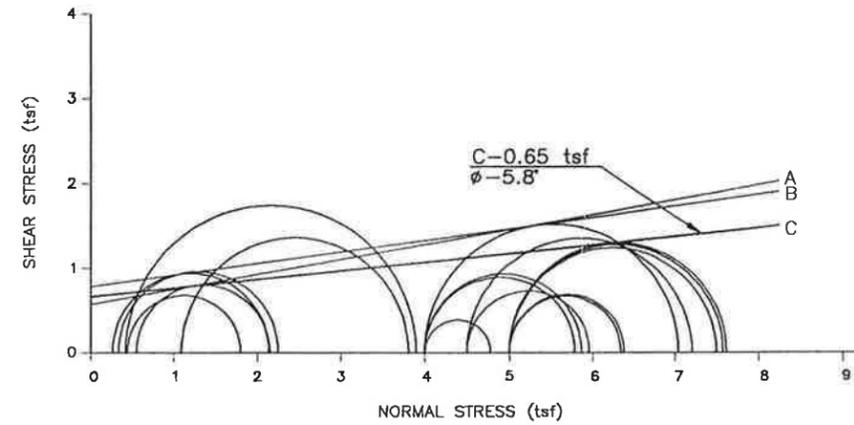
FIGURE 4-1

Several lines, denoted as A, B, C, etc., on Figure 4-1, tangent to and connecting the Mohr Circles, were drawn to represent several cases of cohesion and the angle of internal friction for the Embankment Fill and Foundation Till materials. Circles judged to be outliers or inconsistent with the bulk of the data are reported for completeness. We considered all the strength data, plus the Standard Penetration Test blow counts, the pocket penetrometer tests, the Atterberg Limits, the grain size variation and the moisture content, in arriving at a set of parameters that we judge to conservatively represent the available shear strength in the Embankment Fill and the Foundation Till, taking into account the scatter in the data, the presence of soft zones and/or organic pockets and likely variation across the 4.2 miles of Dam Embankment. An enveloping failure line, consistent with the Mohr Coulomb theory, chosen to be the most representative of the Embankment Fill and Foundation Till, was used to determine the cohesion and angle of internal friction. The effective stress cohesion and angle of internal friction and the total stress cohesion and angle of internal friction selected for stability analysis are presented on Table 4-3.

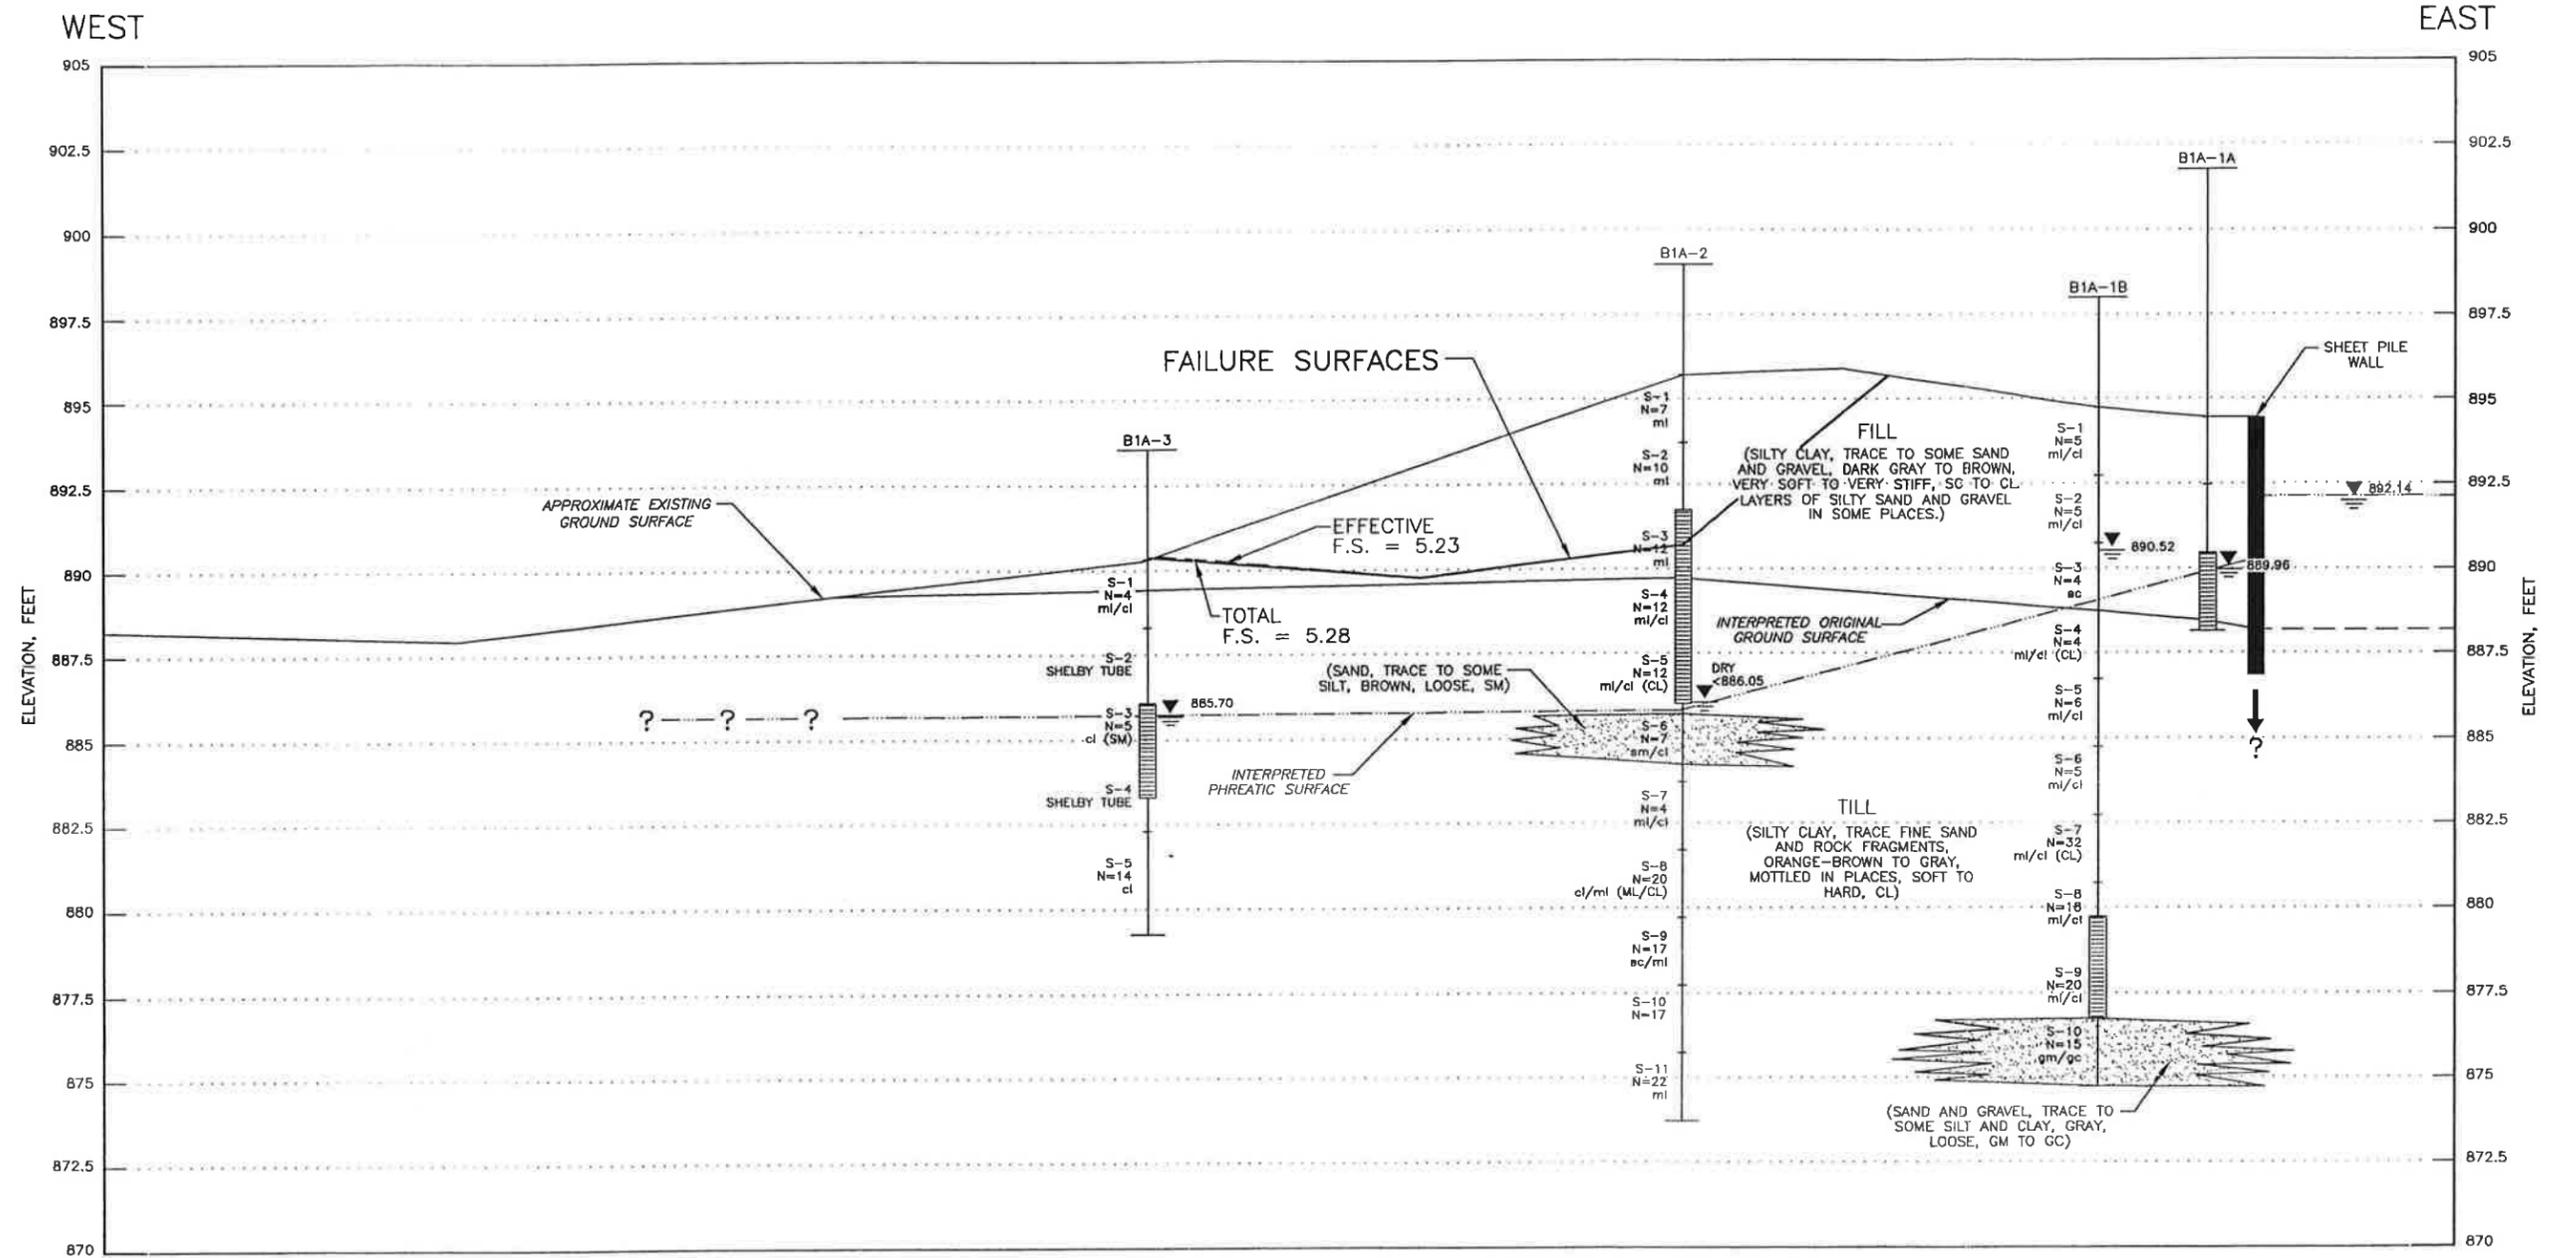
FIGURE 4-2

When compared to the slope stability analysis results of the other four cross sections, Section 1A is not the critical section and therefore, no additional cases were performed for Section 1A. The failure surfaces associated with the lowest factors of safety calculated for Section 1A are presented on Figures 4-2 and 4-3.

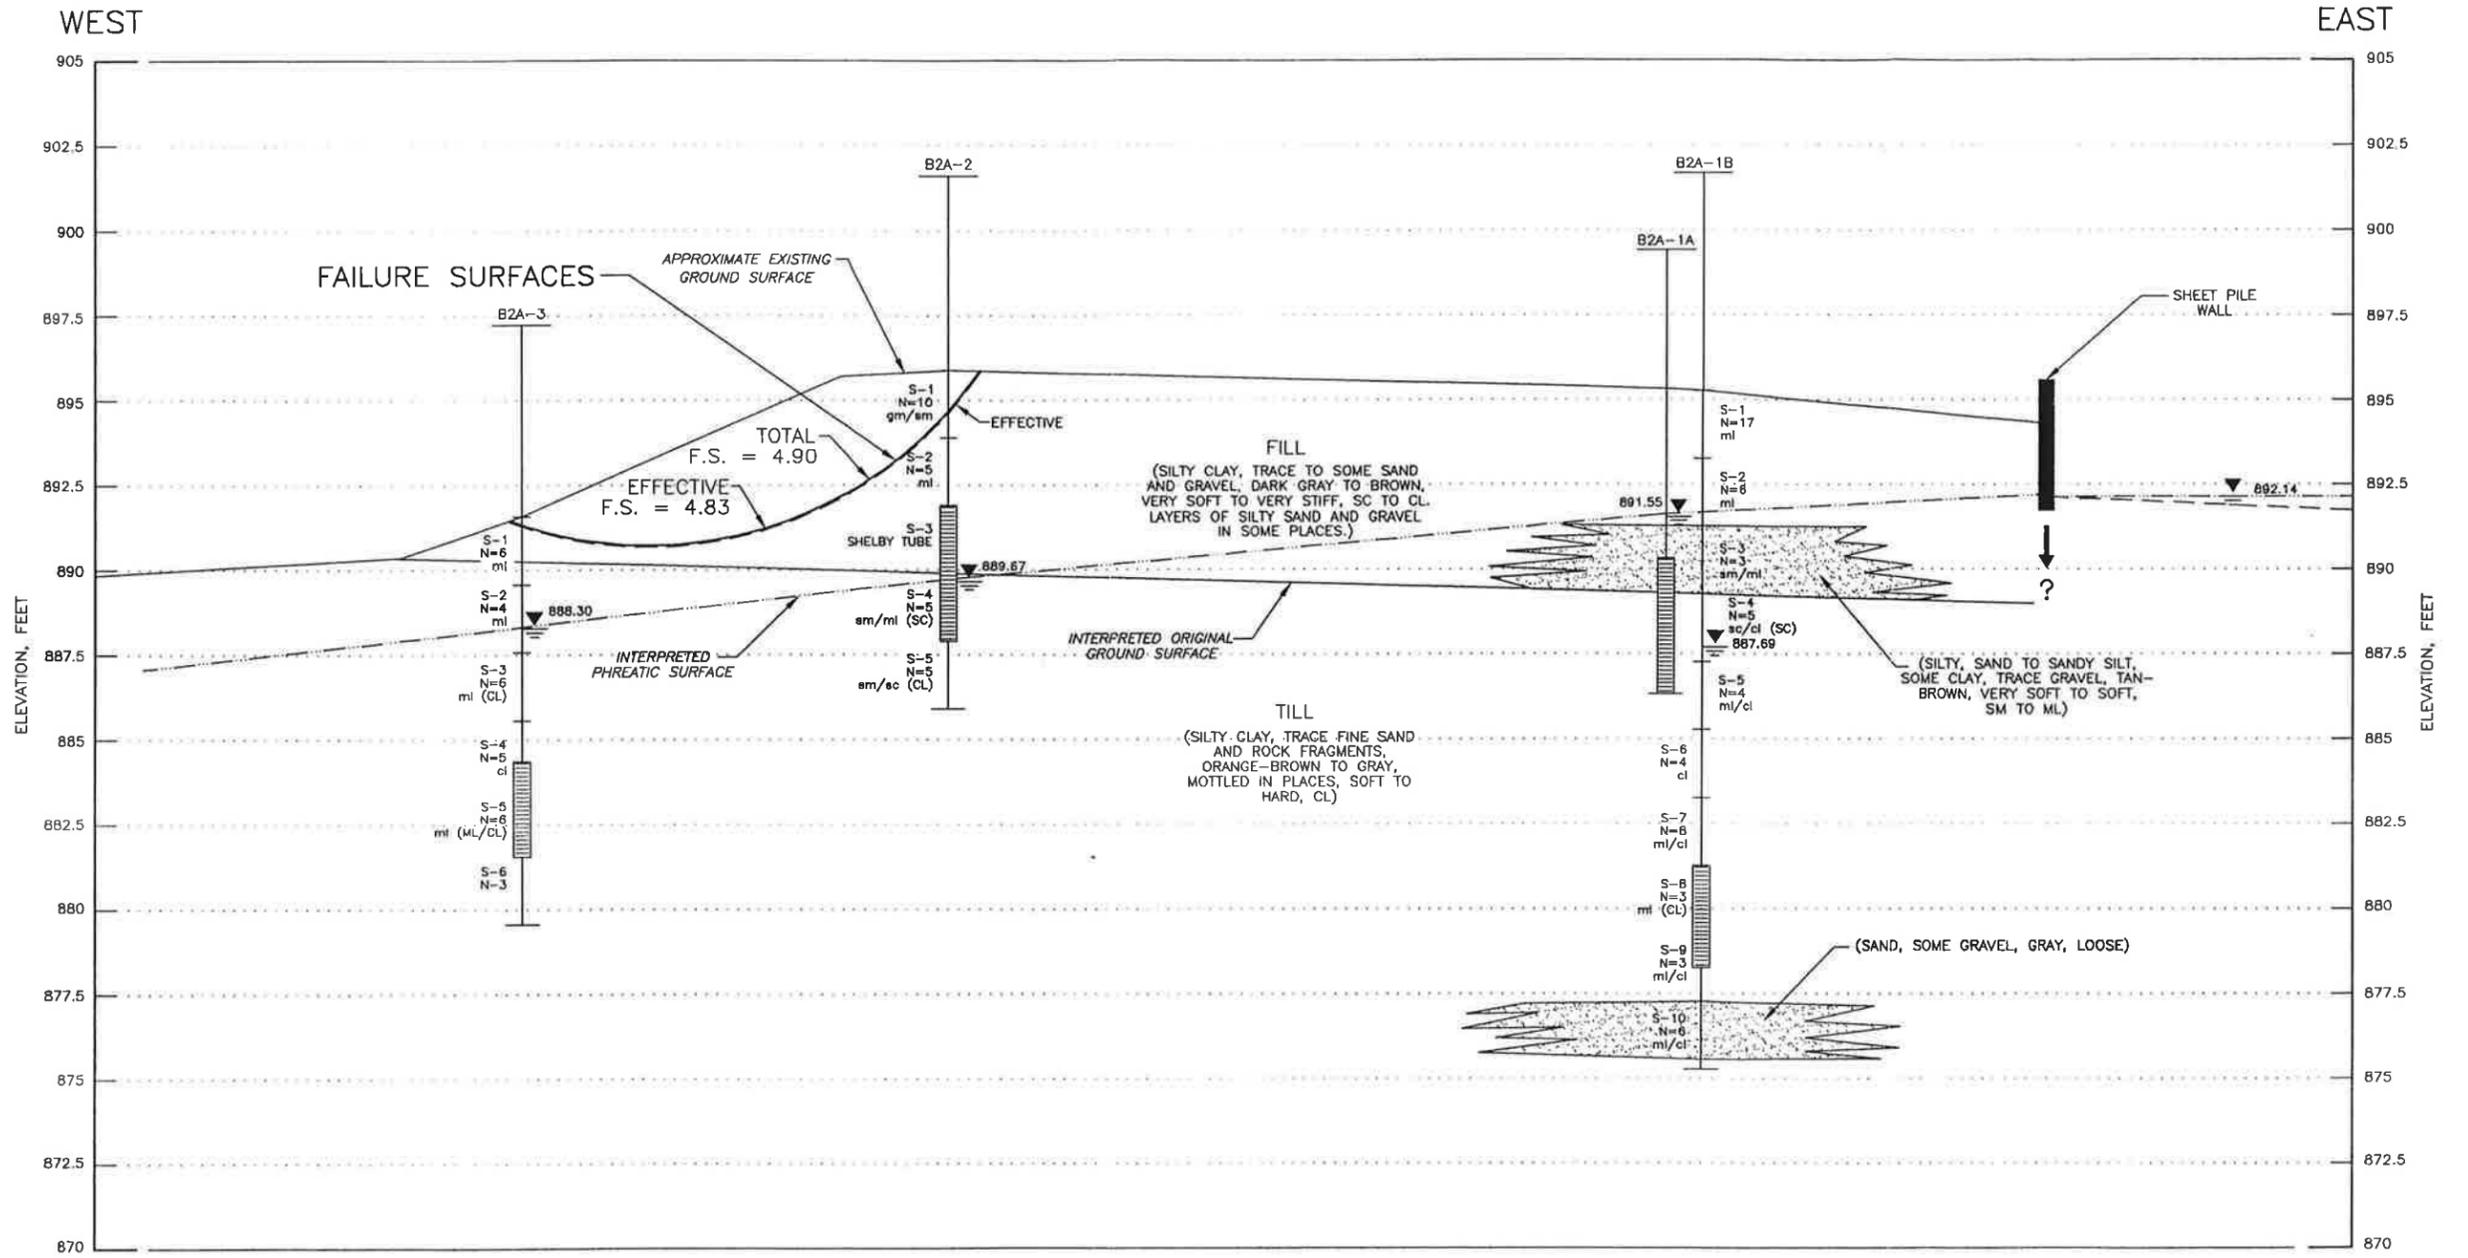
FIGURE 4-4

When compared to the slope stability analysis results of the other four cross sections, Section 2A is not the critical section and therefore, no additional cases were performed for Section 2A. The failure surfaces associated with the lowest factors of safety calculated for Section 2A are presented on Figures 4-4 and 4-5.
