**DIVISION OF WATER
DAM SAFETY INSPECTION REPORT
NORTH BANK OF BUCKEYE LAKE DAM
FILE NUMBER: 9723-004**

LOCATION: Fairfield County, Walnut Township &
Licking County, Union Township

DATE: Wednesday, May 4, 2005

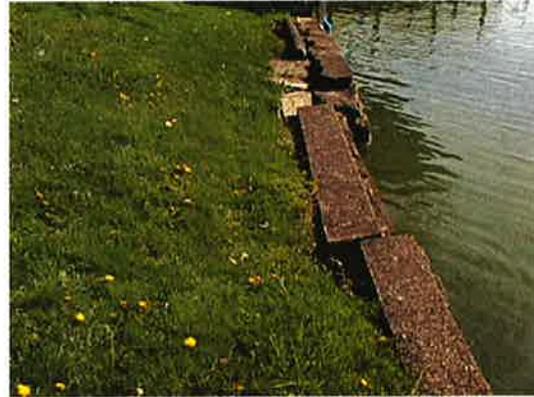
Station 59+00 to 60+00

Three trees were noted on the upstream slope. The upstream embankment contained a low area (0.5 foot deep) near the stone wall at an approximate station of 60+15.

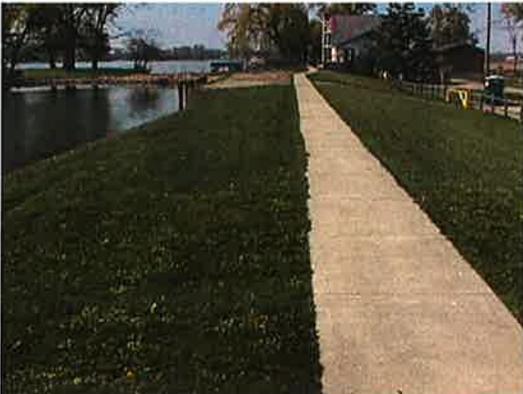
Station 68+00 to 67+00

No problems were noted. New sheet piling had been installed along the upstream slope. A digital photo taken at station 68+00 shows this section.
