RE: Buckeye Lake Dam
File Number: 9723-004
Licking and Fairfield Counties

DAM SAFETY INSPECTION REPORT

Buckeye Lake Dam – West Bank
File Number: 9723-004

Inspection Date: June 24, 2010

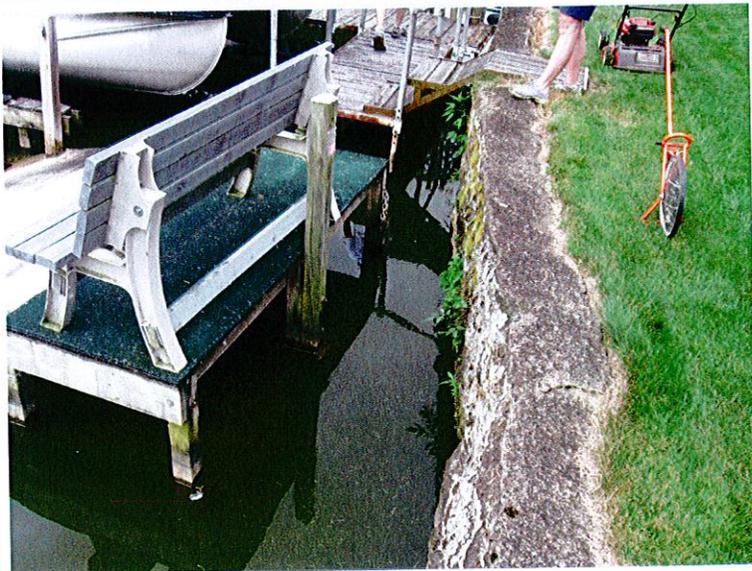
Photograph No. 3:

A new house had been constructed on the downstream slope. One digital photo was taken along the downstream slope. Upstream wall is leaning towards lake and 18 inches of undermining was noted at the waterline. *Two digital photos were taken and are included in this report.*

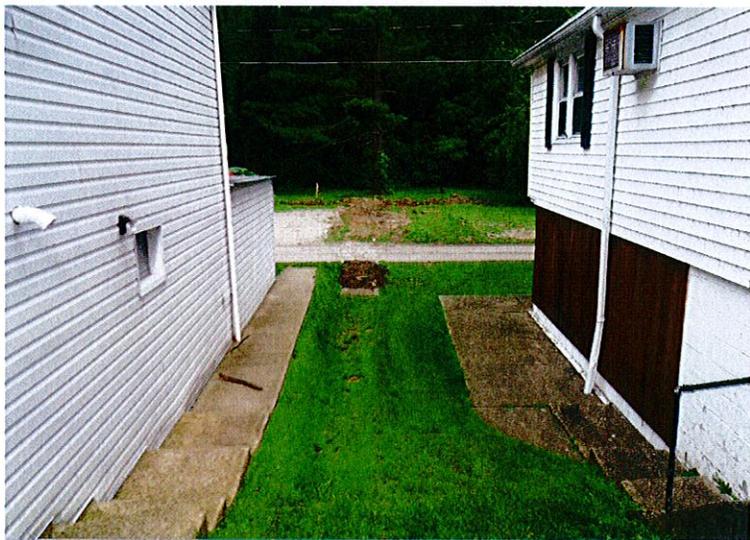
Photograph No. 5:

A wet area approximately 4 feet in diameter that had been observed 12 to 15 feet beyond the downstream toe near station 18+00 in 2005 was dry during this inspection. According to the plans, a tree had been located in this area. A low area was noted adjacent to the wall that measured 7-inches deep, 30-inches wide, and 10-feet long. *One digital photo was taken in this area and is included in this report.*

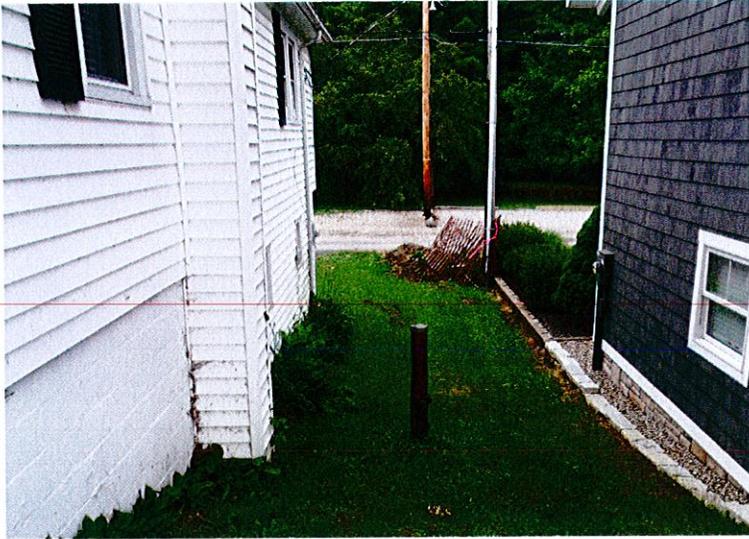
Photograph No. 6:

A 4-inch-diameter water well was noted on the downstream slope. Iron deposits were noted on the well casing. During the 2010 inspection, the outside of the well casing was wet. A tree had been removed at station 19+25. A drain had been added on the downstream slope. Slope appeared dry. *Three digital photos were taken along the downstream slope during this inspection.*

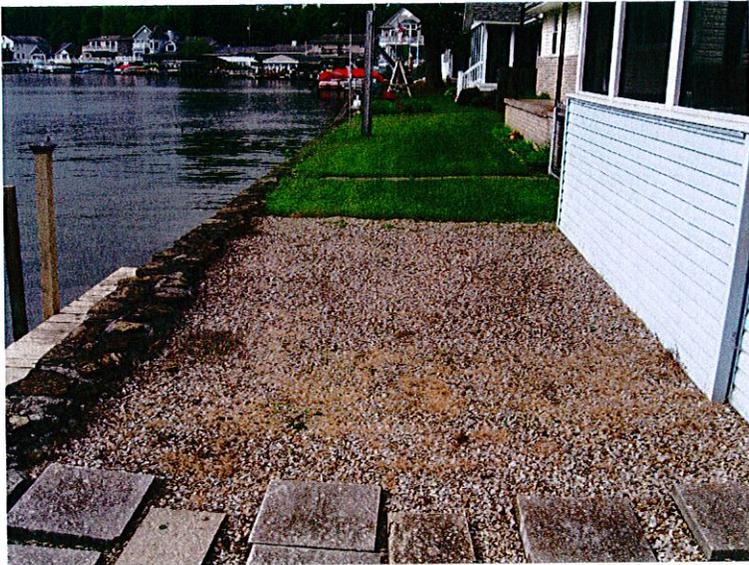
Photograph No. 10:

A tree was noted at station 22+90 during the 2005 inspection. During the 2010 inspection, the tree tag no.18 had been removed and the upstream slope had been covered with patio pavers. *A digital photo was taken of this area and is included in this report.*

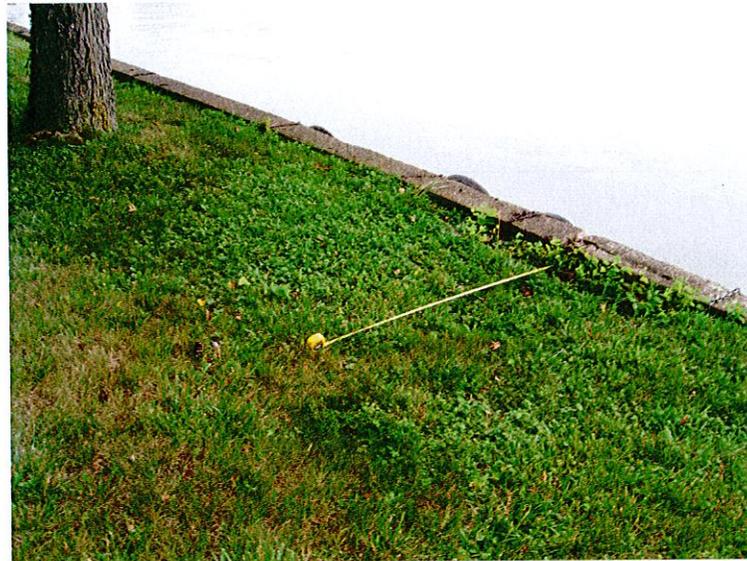
Photograph No. 13:

Near station 30+50, a low area was noted approximately 1 foot in diameter and 6 to 8 inches deep. Another low area, noted at station 30+75, was 7 feet from the upstream wall, approximately 3 feet in diameter, and 14 inches deep. *A digital photo was taken of this area and is included in this report.*
