South Fork Licking River
Watershed Initiative
Project # DNR 736 736-98-011

Project Memorandum

FINAL
50% PMF Analysis of the
Buckeye Lake Dam

Prepared for:
Ohio Department of Natural Resources
Division of Engineering
Columbus, Ohio

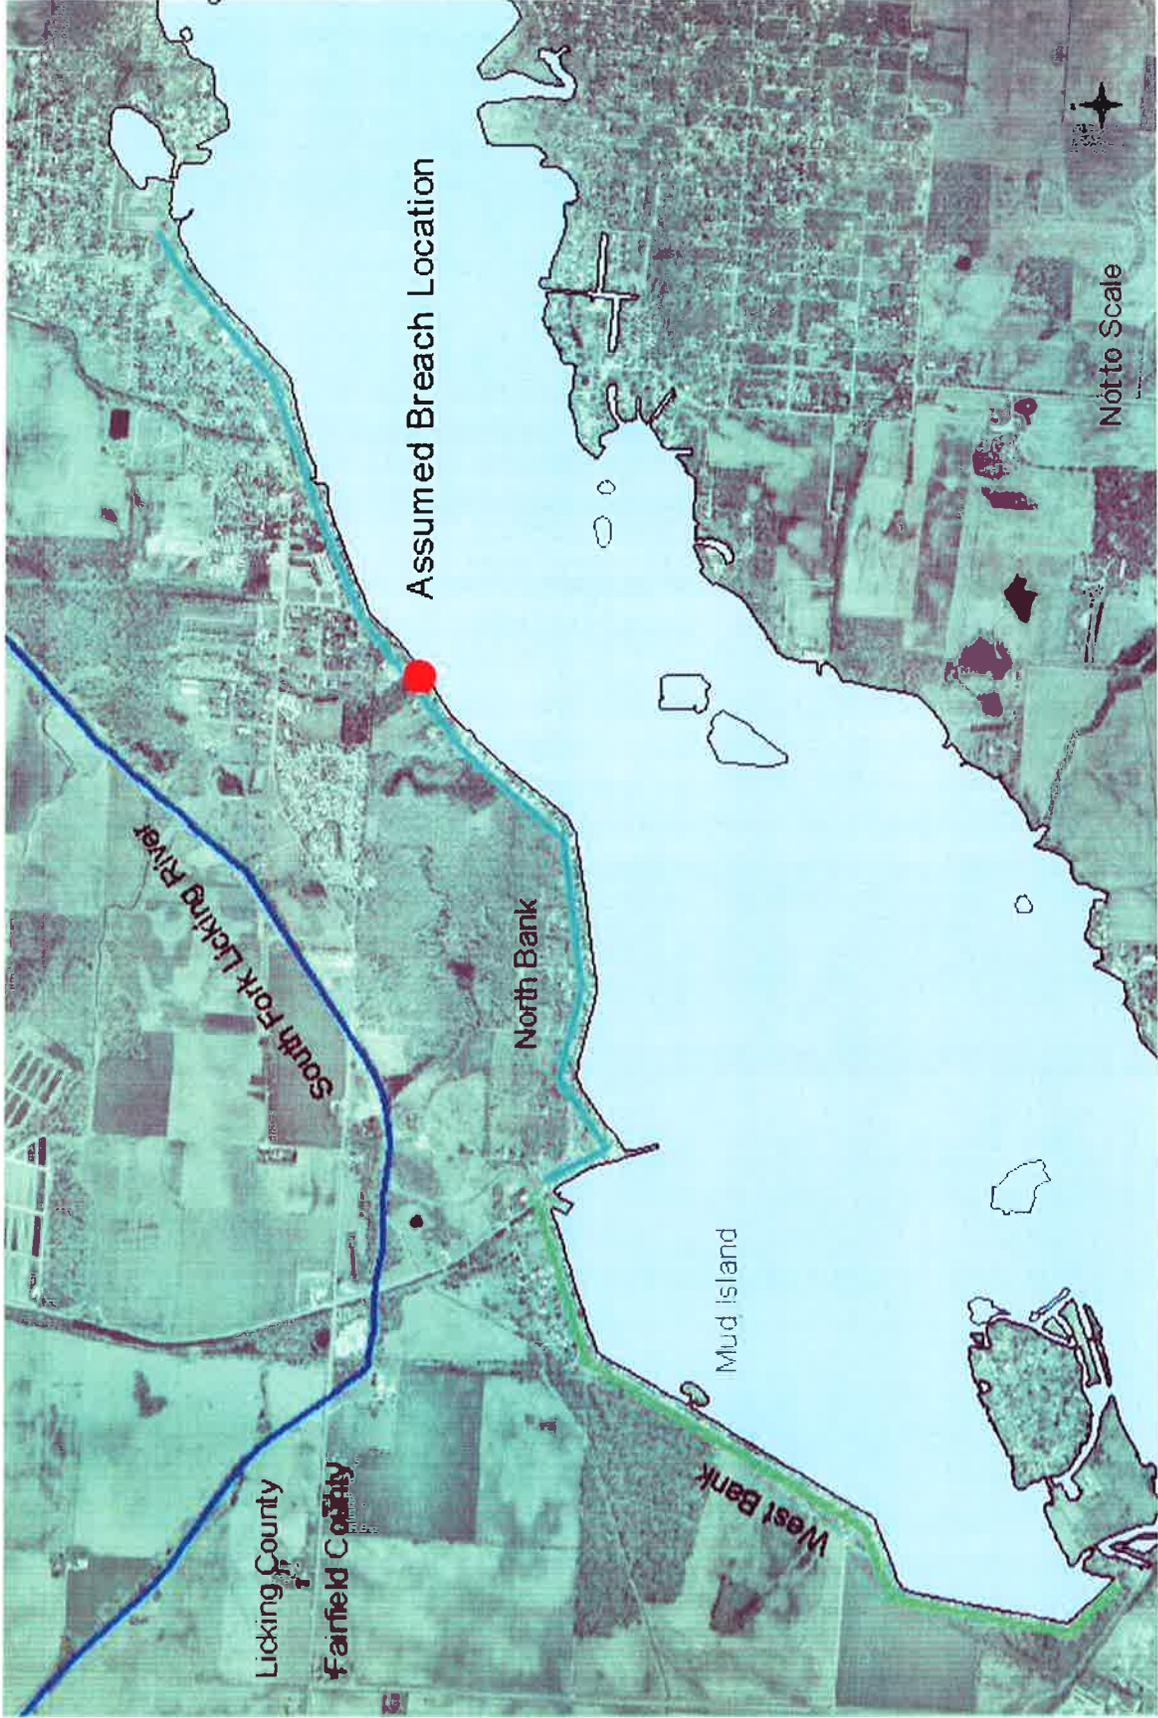
Figure 1. Buckeye Lake Dam: Assumed Breach Location.

The first screen for siting the assumed breach was that it be located where dam overtopping flow would first occur. There are five areas (total of 600 LF) with a dam crest of 894.5+’ (the minimum height of the dam according to the ODNR Dam Safety Information Sheet). Of these, the location with the greatest dam height (13.5 feet) was selected as the site of the assumed breach. A breach at this point is expected to have the greatest rate of discharge because the height of the dam is greatest. The breach location, approximately 600 LF south of the Licking County – Fairfield County line, is indicated in Figure 1, on the following page.

The development downstream of the assumed breach includes individual houses (on the dam and 200 feet distant), a trailer park (900+ feet downstream) and residential and commercial development of the Village of Buckeye Lake (1000+ feet laterally downstream). Flows from the breach will cross 2,700 feet of floodplain before they reach the SFLR channel. The development downstream of the assumed breach location can also be seen in Figure 1.

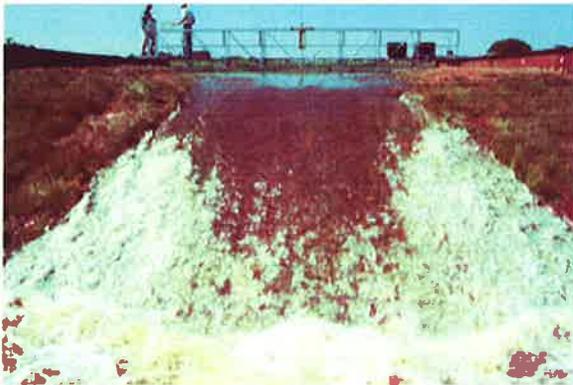
Figure 3. Initial Overflow and Energy Dissipation at Toe of Slope.

Figures 3 and 4 are pictures of a field embankment breaching experiment at the U.S. Department of Agriculture Agricultural Research Service (ARS) facility in Stillwater, Oklahoma. The pictures present two of the three major processes in the failure of an embankment by overtopping:

1. The development of the initial cut at the base of the embankment (where the energy of the overtopping water is dissipated) (Figure 3); and
2. The progression of the headcut towards the upstream edge of the embankment crest (Figure 4).

Application of ARS Field Research Results. ARS staff have published numerous papers on their field-scale experiments on overtopping failure of earthen embankments. Figures 3 and 4 were pictures from an overtopping experiment with 6-foot high embankments.⁵ Figure 5, from the ARS field research shown in Figures 3 and 4, presents the rate of headcut advance through a 6 foot high embankment composed of 63% sand, 31% silt and 6% clay with a 3:1 side slope. The vertical profiles drawn on the embankment profile are the location of the headcut as it advances upstream. For these experiments, a head of 1.5 feet was maintained on the crest of the embankment. Figure 5 (on the following page) illustrates that the headcut reached the upstream edge of the crest after about 5 hours for this experiment. A similar test embankment composed of 25% sand, 49% silt and 26% clay did not breach after 20 hours of testing.

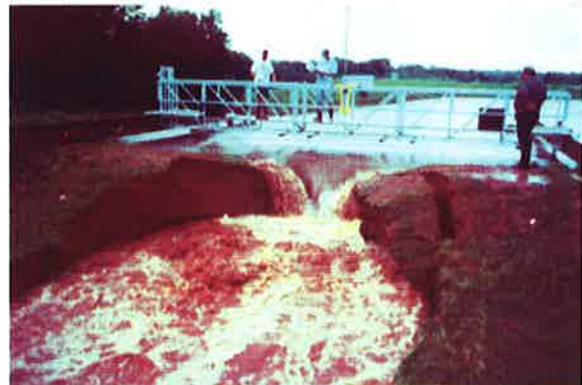
Figure 4. Headcut Progression to almost Full Breach.

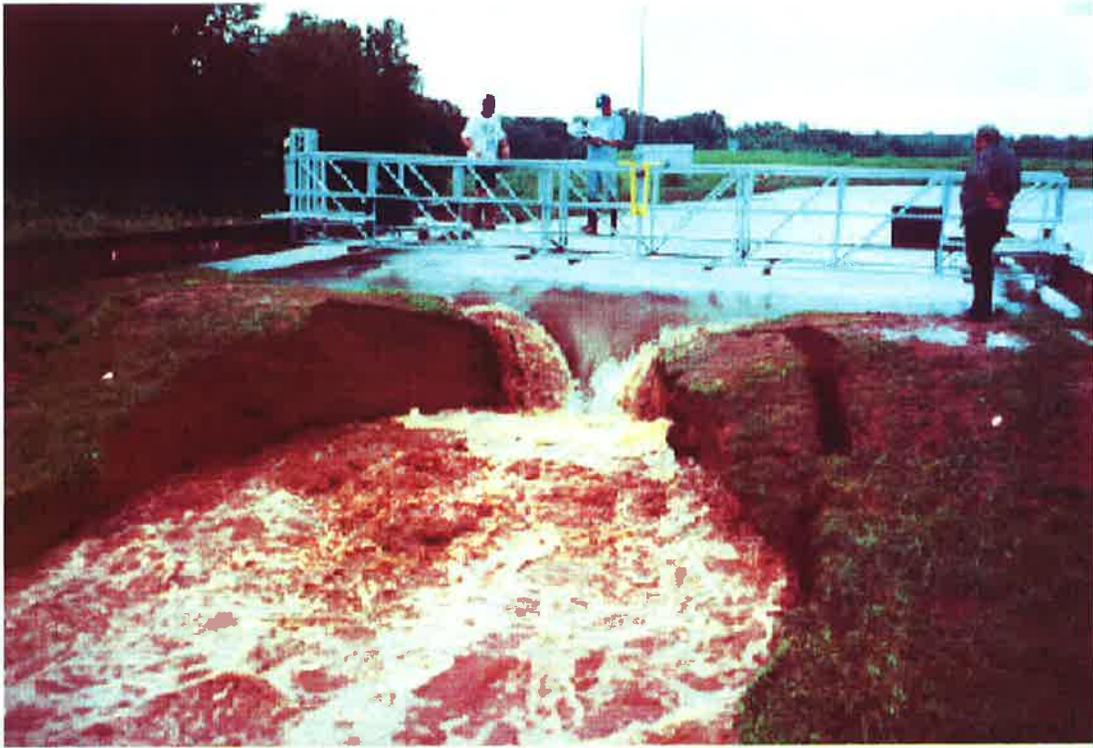
Figure 3. Overhead carriage used to take point gage readings of erosion profiles.

Chart recorders were utilized to record inflow and outflow hydrographs. A 10-m wide overhead rolling carriage with attached point gage was utilized to obtain bed profiles, cross sections, and water surface elevations during testing (Figure 2). Inflow to the reservoir during testing was supplied by a canal and measured at the test site with a modified Parshall flume. The reservoir upstream of the test embankments was filled in advance of testing to a depth of 1.2 m and 1.0 m for the 2.3 m and 1.5 m high embankments respectively. On the day of testing, the reservoir was completely filled and the embankment test section overtopped. Maximum overtopping head attained prior to breach was 0.46 m and 0.30 m for the 2.3 and 1.5-m high embankments respectively. The inflow discharge stabilized quickly during each test, and was then maintained at a relatively constant flow of about 1 m³/s and 0.3 m³/s for the 2.3 m and 1.5 m high embankment respectively. This relates to a unit discharge of approximately 0.1 and 0.06 m³/s/m for the 2.3 and 1.5 m high embankment respectively. Flow was measured both as it entered the reservoir and at a point downstream. The downstream measuring device had a maximum measuring capacity of 1.7 m³/s. This was not adequate capacity for all flows during the breaching process. Therefore, reservoir elevation and storage records were an essential part of evaluating the breach outflow. The storage outflow was determined by three means: (1) downstream V-notch weir; (2) a downstream H-flume; and (3) the change in storage measurements.
