BUCKEYE LAKE STATE PARK
WEST BANK DAM IMPROVEMENTS
VALUE ENGINEERING STUDY

Prepared for the
Ohio Department of Natural Resources

Final Report
March 2004

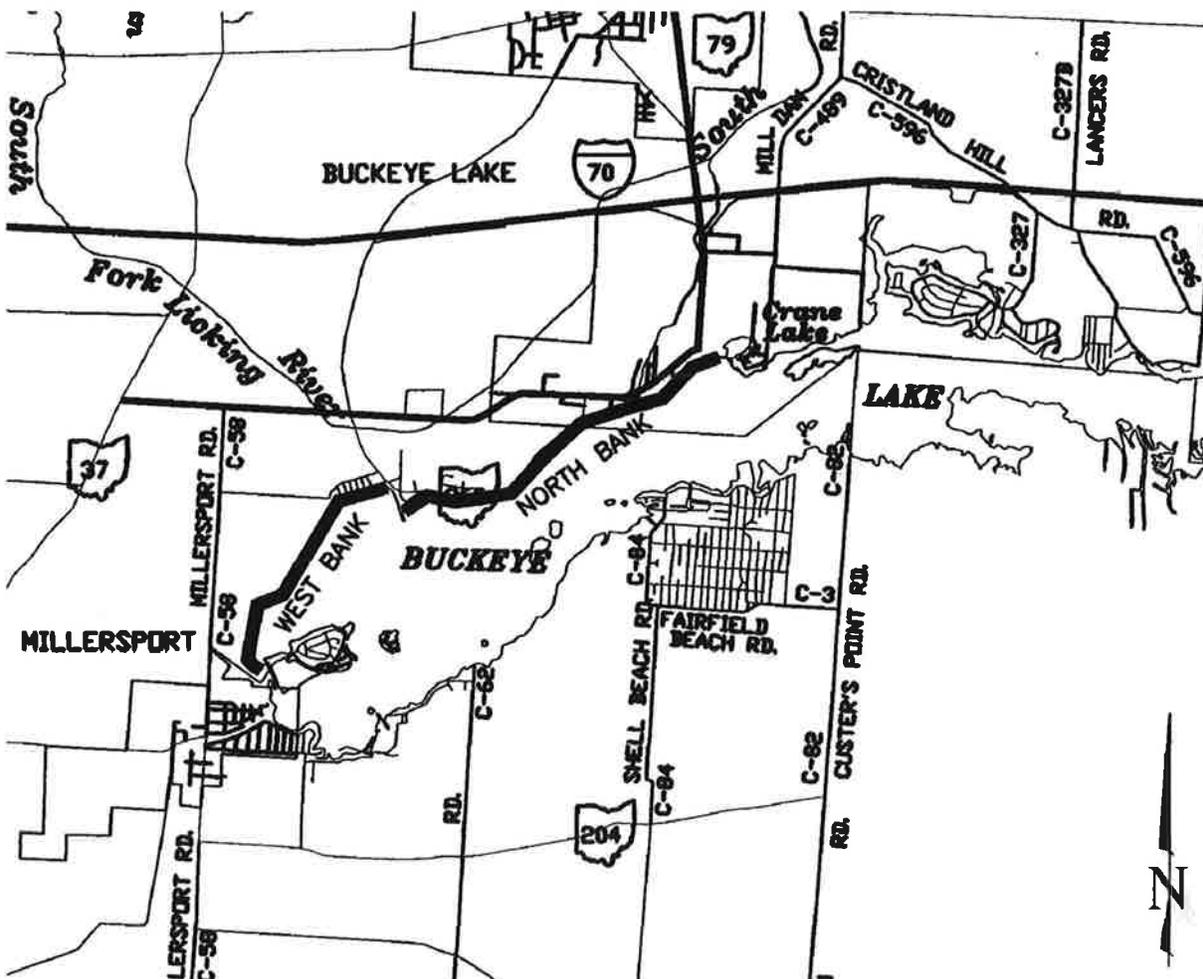
Plan of Buckeye Lake Dam

The dam is generally divided into two parts: West Bank and North Bank. The West Bank extends from the south end of the dam near Liebs Island north to about Mud Island and is

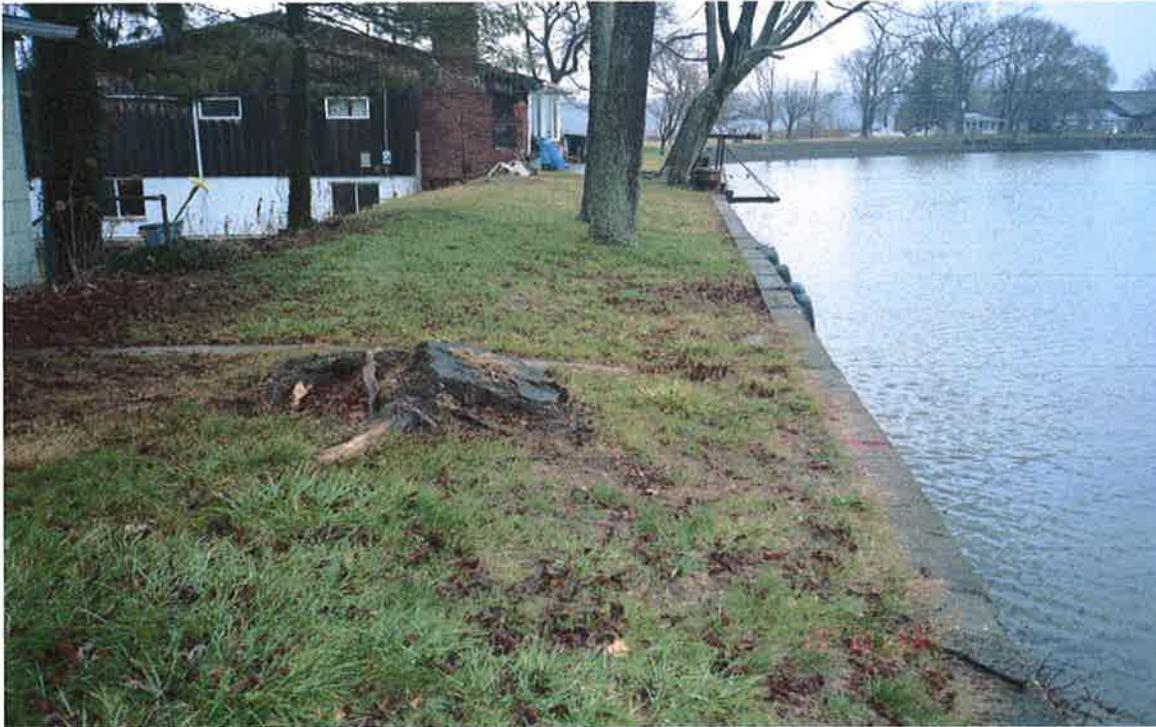
Photograph 2. The Existing Dam, Trees And Location Of Houses

operational and flood fighting activities. As a frame of reference, the Corps of Engineers' top width requirements are 25 feet and 24 feet, respectively, for embankment and concrete dams and a 10-foot top width for a levee plus 10 feet for access immediately adjacent to the landside toe of the levee. The Buckeye Lake Dam project is considered to be more representative to a Corps levee. The existing Buckeye Lake dam does not have 10 feet of clear access immediately adjacent to the landside toe because the downstream face of the dam is privately owned and heavily developed for most of its length as shown on Photograph 2

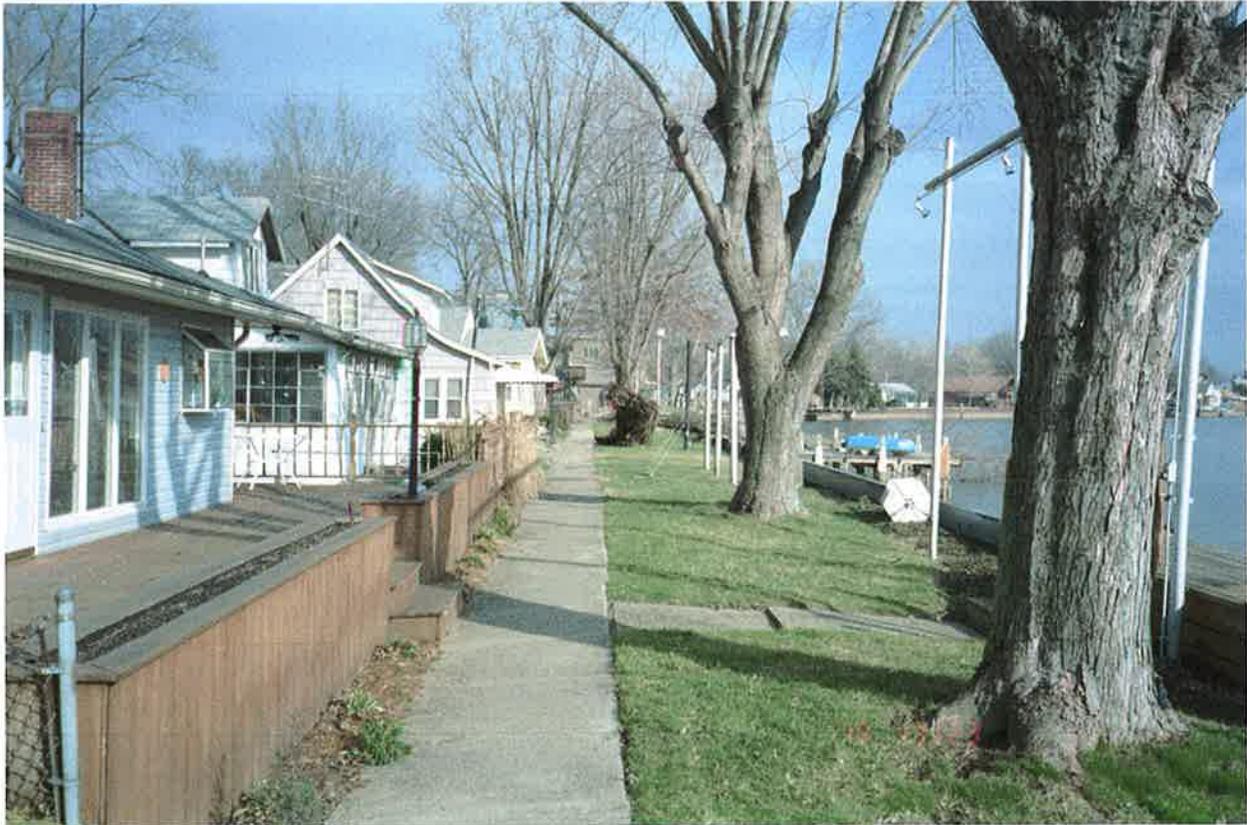
Photograph 3. Existing sidewalk

Pedestrian sidewalks currently exist along the dam. There is a sidewalk along the full length of the north bank; however, it is in disrepair at many locations (see Photograph 3.). The west bank sidewalk is not contiguous and as such the general public uses it rarely, if at all. ODNR proposes to construct a new sidewalk as part of this project. This will result in placement of the sidewalk further away from the homes on the dam, but many west bank residents do not see this as an advantage because they believe strongly that a new contiguous sidewalk will invite more pedestrian activity in front of their homes.

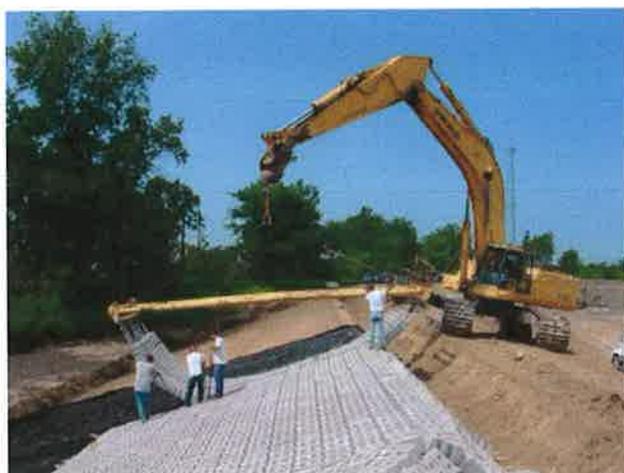
Photograph 4. Placement of Armorflex

6.1.3. Concrete Sidewalk. The third area is the 8-foot-wide concrete sidewalk, which is intended for access along the project by providing a solid surface for pedestrian traffic and an all-weather base for vehicle traffic. We recommend using a product such as “Armorflex,” an Armortec product, in lieu of the concrete sidewalk (see photographs 4 – 6). This will provide an equivalent bearing surface for vehicles, and grass grows in the lattice of the pavers, which provides a natural appearance. Photographs 4 - 6 show placement on the downstream slope of a small dam. The cost in place would range from \$5.50 to \$6.00 per square foot. This would relate to a cost of \$238,023 to \$259,362, respectively, or a savings somewhere between \$4,800 and \$26,142, depending on the contract unit price.

Recommend: If it meets ADA requirements, replace the 8-foot-wide concrete sidewalk for the entire length of the West Bank project with “Armorflex,” an Armortec product (or similar product), in lieu of the concrete. This will provide an equivalent bearing surface for vehicles, and grass grows in the lattice of the pavers, which provide a natural appearance. The cost in place of “Armorflex” would range from \$5.50 to \$6.00 per square foot. For the West Bank project, this would relate to a cost of \$238,023 to \$259,362, respectively, or a savings somewhere between \$4,800 and \$26,142, depending on the contract unit price. If the Armorflex
